2010 43QGP Allegro Bus

SIXTY-EIGHT-B-r1 – coach modification – RV SPARE TIRE

Crusingator's RV Continental Kit

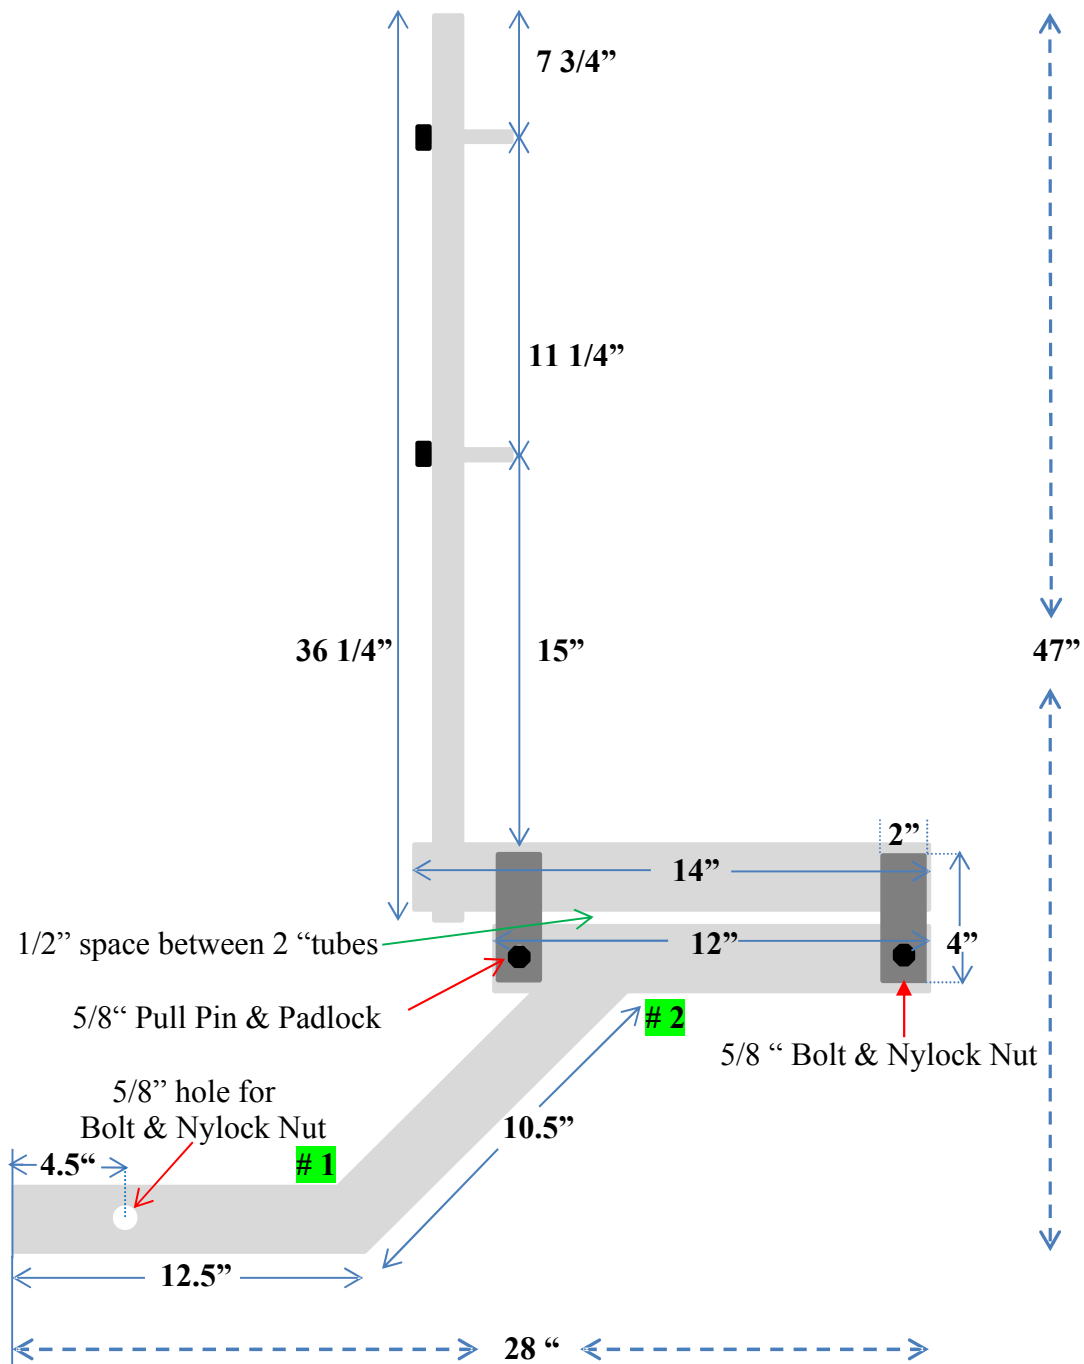
Designed to carry a 295/80R22.5 Michelin Tire

#1 and #2 are each a 60 ° (degree) angle

By design a 1/2" space between the two 2" tubes was made allowing room for the carrier to un-folded (hinge) open 135 °. Allowing the RV tire while mounted to its carrier to rest on the ground for removal.

Angles 1 and 2 were cut then welded at 60 ° (degrees) allowing clearance to prevent conflicts between the carrier and the toad vehicles tow bar.

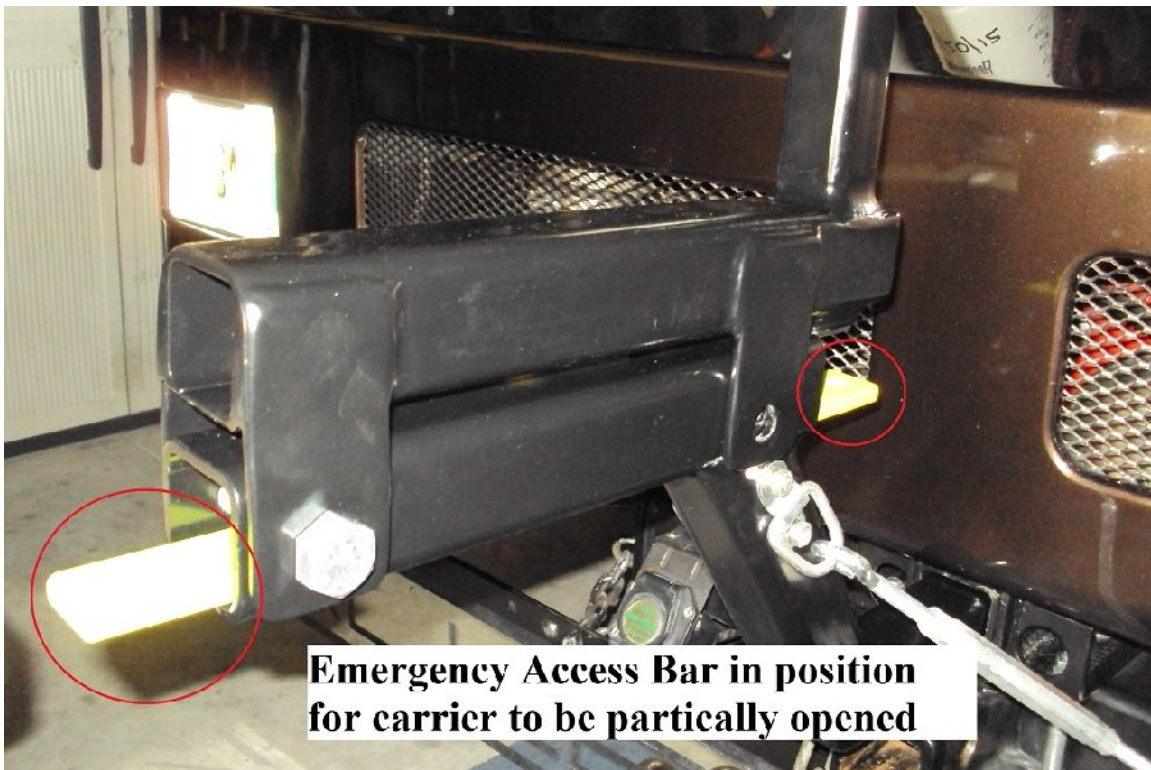
"Emergency Engine Access Bar" side view, painted fluorescent green to be quickly found.

"Emergency Engine Access Bar" top view.

Two separate metal components (Engine Access Bars) were fabricated to allow lowering the carrier part of the way to the ground. The first Engine Access Bar was named "Emergency Engine Access Bar" it is 3/8" thick by 1 1/4" wide by 16" long piece of steel bar. It is inserted into the lower opening (below the 5/8" bolt) of the lower square tube leaving about 5" of the bar exposed from the lower square tubing. With the bar in position the carrier can be lowered into a partially open position allowing the engine access cover to be opened. This engine access bar makes this a one person operation this bar was designed to be used primarily in an emergency.

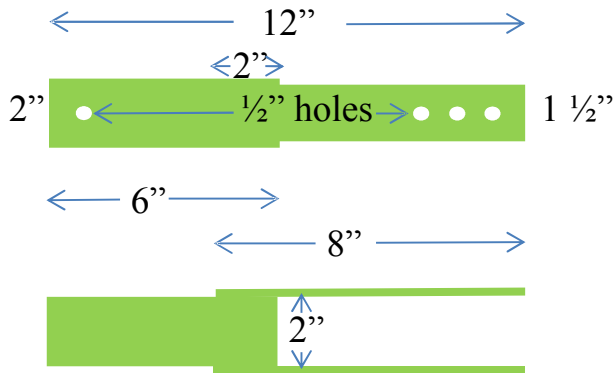
Side View of the Engine Access Bar

The second Engine Access Bar was constructed using heavier materials its use requires two people to lower the carrier utilizing this bar. As with the first engine access bar this one was fabricated to allow lowering the carrier part of the way enough to allow opening the rear engine access cover without requiring the toad to be disconnected.

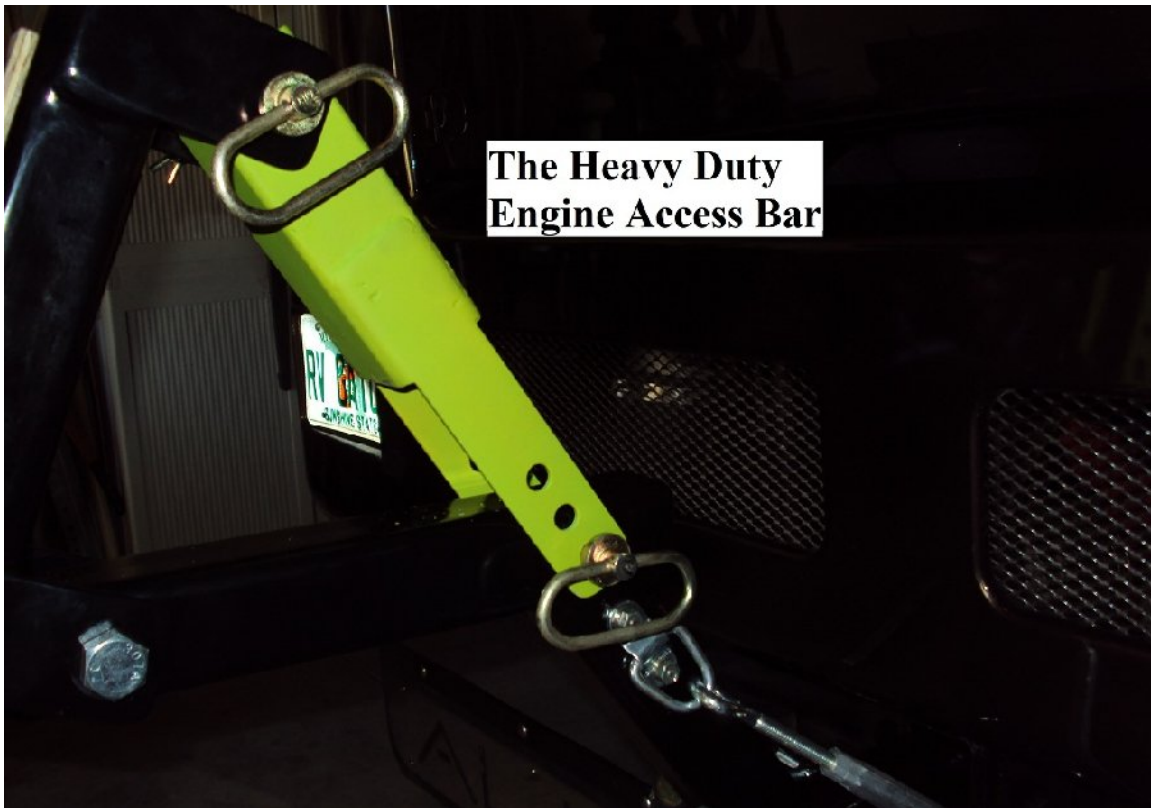
Top View of the Engine Access Bar

The above photo shows the Engine Access Bar inserted into the carrier using two 1/2" pull pins with safety clips thus allowing the tire and carrier to be tilted enough for allow opening the rear engine access cover. The toad does

not require disconnecting to perform this operation however it is easier to access the engine compartment if the toad has been disconnected and moved away from the coach. This is more of an option in the event the toad is connected and access to the engine becomes necessary for some form of repair.

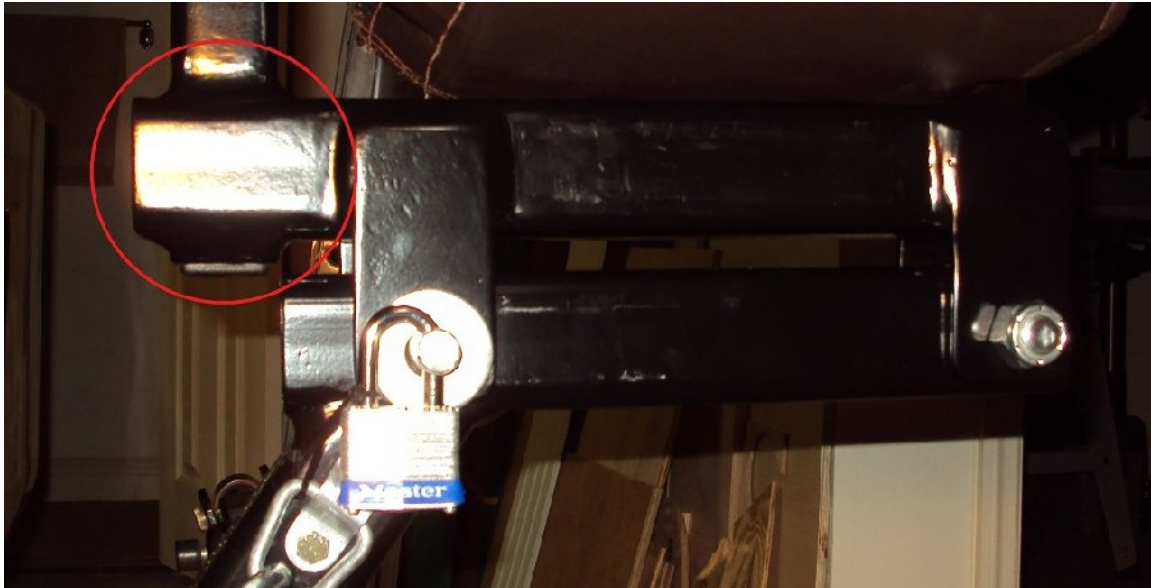
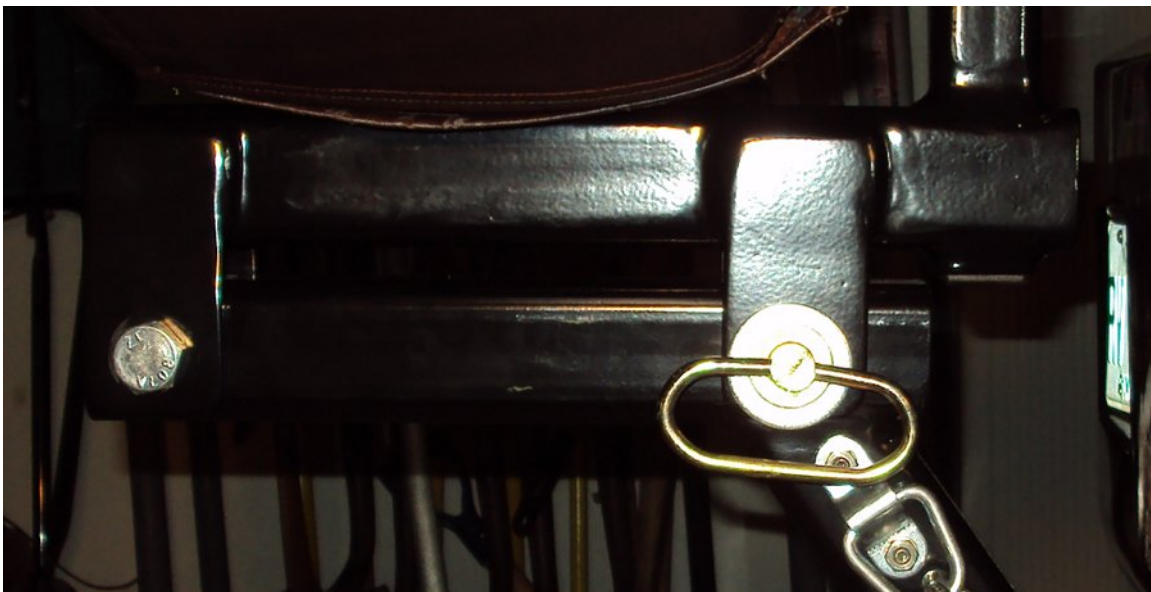
SPECIAL ATTENTION should be made in the type of construction utilized to mate the 1 1/2" and 2" tubing at the 90 ° angle. A 1 1/2 " square hole was cut thru both upper and lower sides of the 14" x 2" tube, allowing the 1 1/2" tube to slide thru the new opening made in the 2" tube, extending thru the lower side about 1/2 ". All upper, lower and inside angles of the two pieces were welded. This construction method allows the elimination/need for gussets to be welded to strengthen the 90 ° angle between the two tubes.

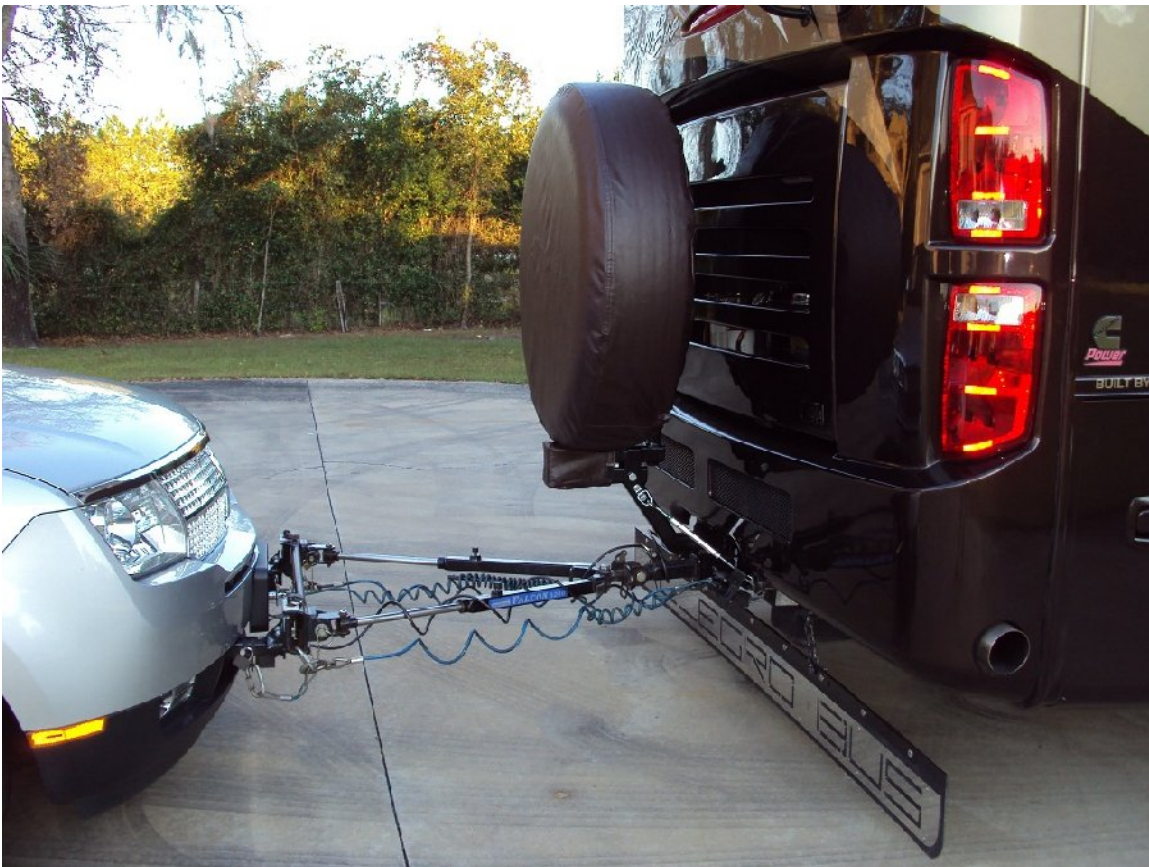
Prior to sand blasting and powder coating the two pivot flanges welded to the 14" upper tube and attached to the lower 12" tube with a 5/8" bolt were both bent outward enough to allow a stainless steel fender washer (with a 5/8" hole drilled thru it) to be installed between the lower tube and the two flanges. The two stainless steel washer's act as a bearing after the 5/8" pivot bolt is properly tightened, tight but loose enough to allow rotation. Turn buckles were installed along with tie down rings, one on each side of the carrier. They were attached with 1/4" (GRD 5) grade five hardware between the 4" Curt receiver bar and the tire carrier to prevent the approximate 1" side to side motion at the top of the carrier while driving down the highway. The reason the side to side motion exists is due to the two inch receiver not making a TIGHT FIT inside the Curt receiver, allowing a few thousandths of an inch gap between the carrier and receiver. After the turnbuckles are tightened their addition prevents the top of the carrier from waving side to side.
