2010 43QGP Allegro Bus

SIXTY-NINETH – coach modification - **DOOR AWNING OPENINGS.** Recently while cleaning the coach I found two openings on the back side of the door awning. Both openings allowed anything up to an inch to enter or exit the holes. Fortunately I only found dirt and a small amount of debris inside the awning cover however I suspect this could also be a nice home for a nest of wasps or hornets. If either were to make a home inside the cover an owner may get seriously injured while attempting to avoid being stung.

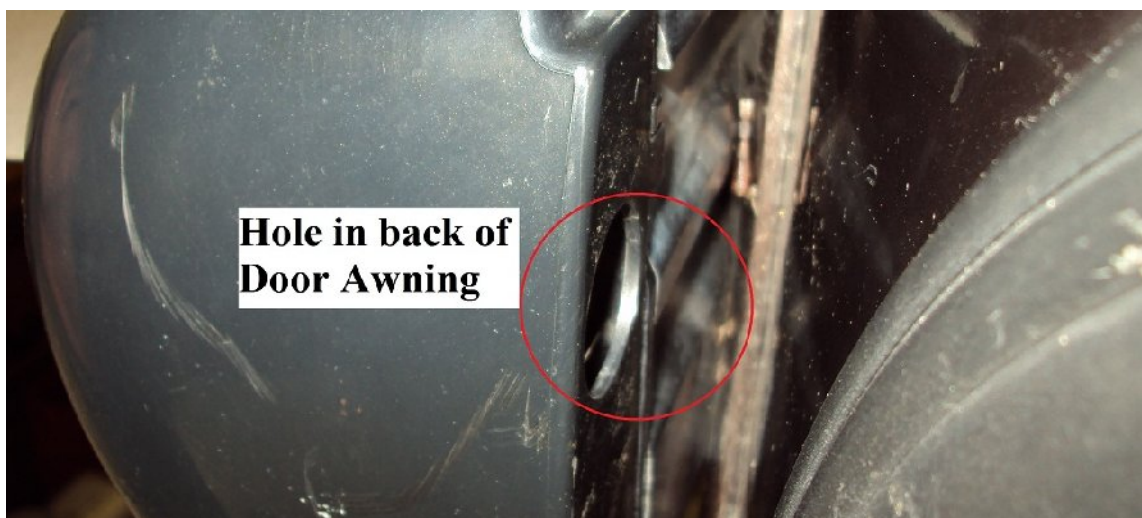
**Aluminum tape was applied over the push plug from the back side
Push Plug installed after cutting a hole for the wiring to exit the awning**

Two PLASTIC Push Plugs were purchased from Lowe's hardware section both plugs were pushed into the opening from the outside after which a piece of aluminum foil tape was applied over the plug to seal it in place. The left end plug required cutting a side opening in the plug to allow the awning control wiring to pass thru.
