2010 43QGP Allegro Bus

SEVENTYTH - coach modification – PART A TIFFIN POWERGLIDE CHASSIS RECALL 12V526.

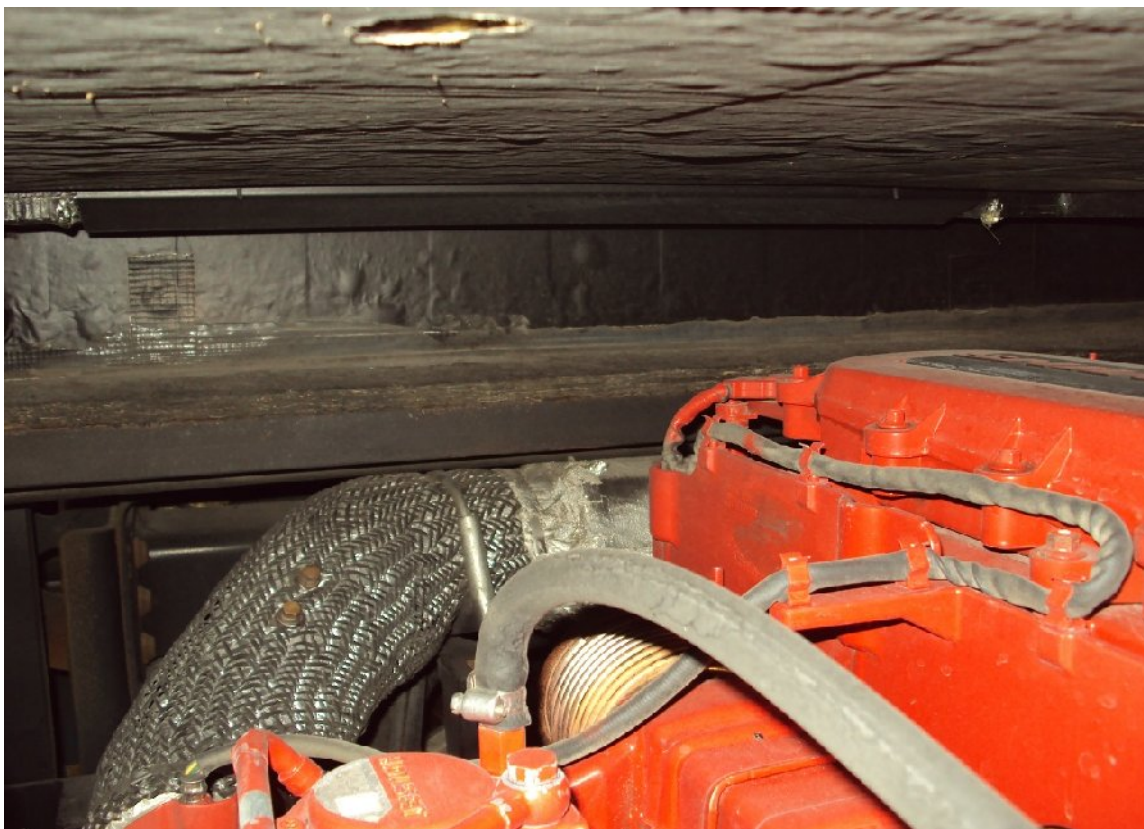
On our coach, the original (prototype) Powerglide chassis EPA 2010 with ISL450 many first steps were attempted at producing a production model chassis. One of the problems now being found with this recall is the additional 7 inch floor extending into the engine compartment on **SOME** chassis. That extension prevents more than about a one inch space between the bottom of the floor and the flexible exhaust pipe routed around the rear of the engine from the driver side to the passenger side of the chassis. The close spacing has prompted this recall based on either a fire or near fire problems with the floor.

Below is a photo of our 43QGP chassis with the extended ledge sitting almost on top of the exhaust transverse pipe.

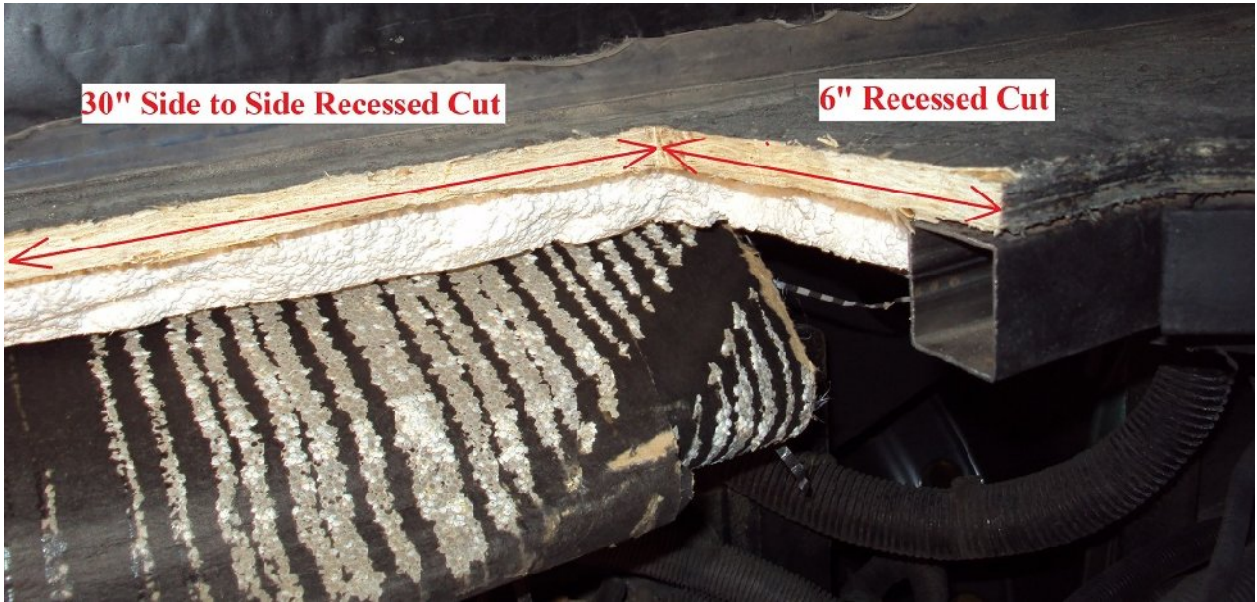
After removing the exhaust transverse pipe to allow better access to the section of floor to be modified while at the same time allowing me to test the bellows portion in this section of pipe checking for any hidden exhaust leaks.

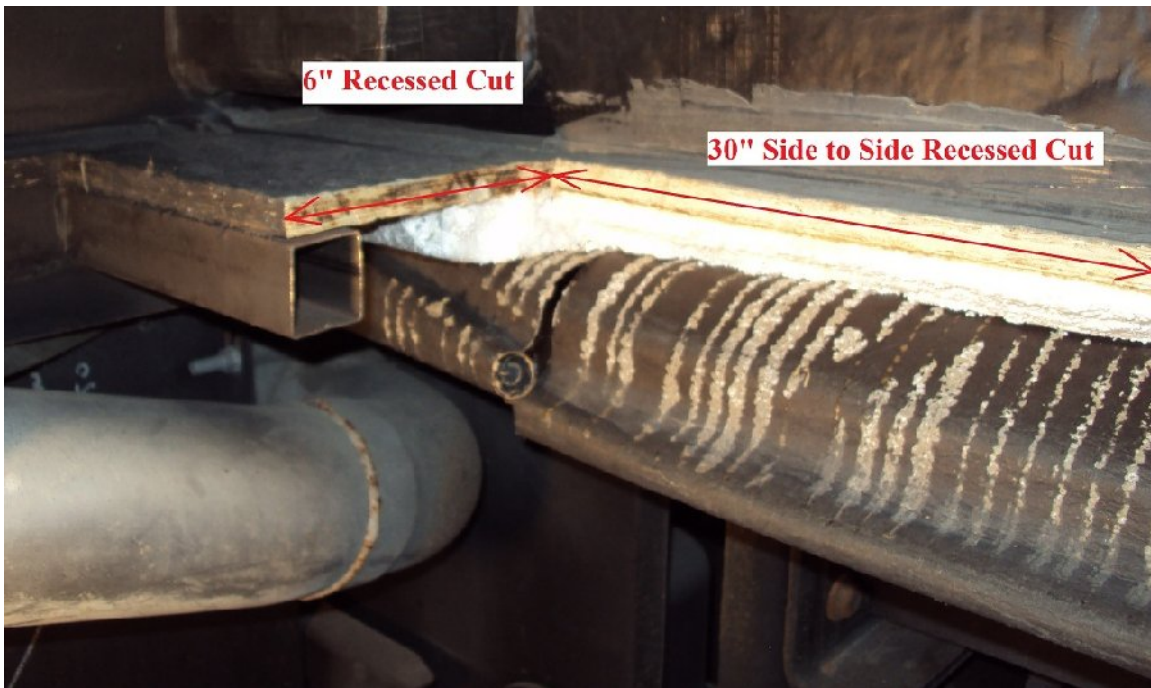
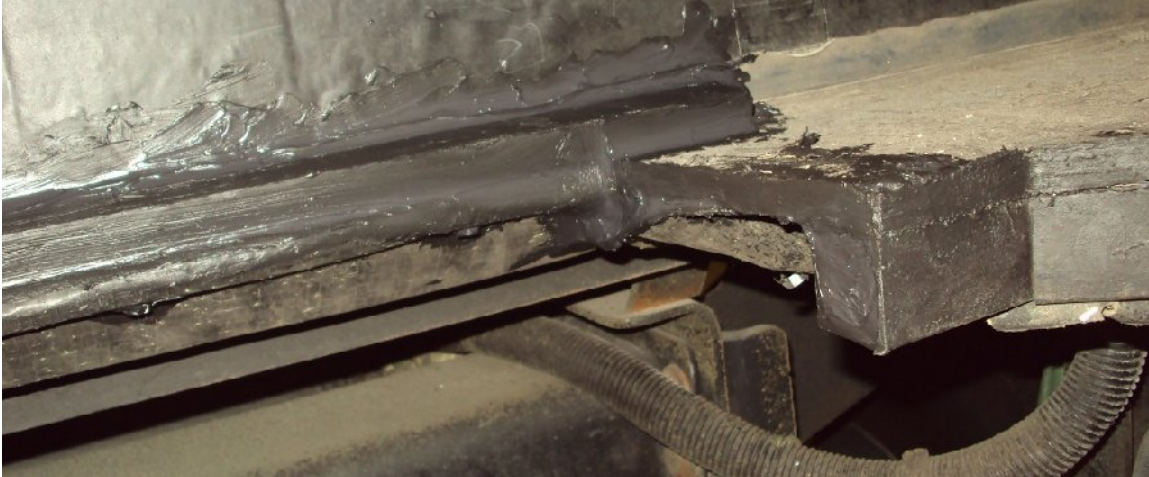
The fiber paper glued to the Styrofoam under the OSB floor was pulled back before cutting the steel tubing and OSB flooring to be used later to protect the finished floor modification.

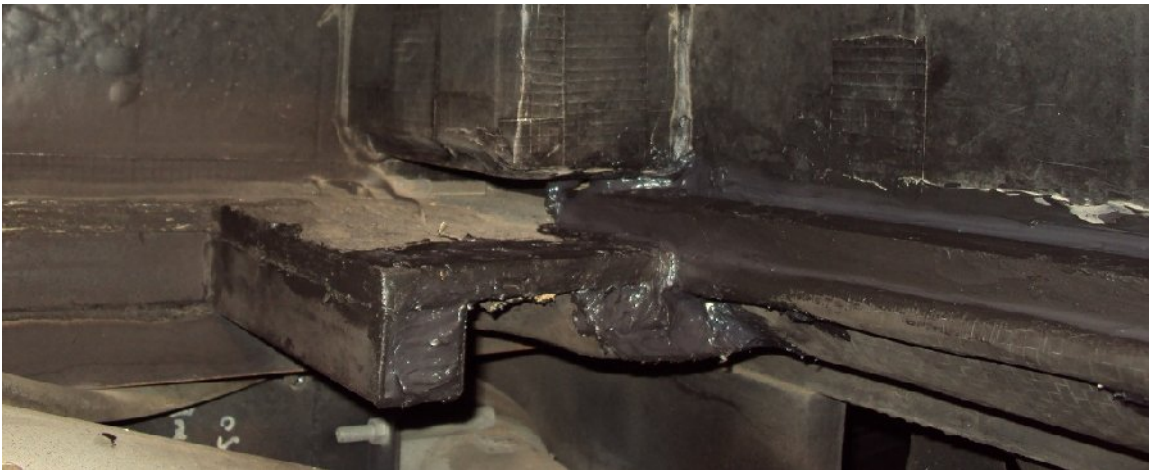
The Styrofoam was cut at an angle making it easier to pull the fiber paper over the Styrofoam where a $\frac{3}{4}$ " x $\frac{3}{4}$ " x 36" piece of pressure treated wood was used to sandwich the fiber paper over the floor. Self-drilling screws were installed from the bottom side thru the fiber paper thru the OSB floor and finally into the pressure treated wood. Two pieces of Styrofoam were used to plug the openings on the steel tubing before black silicone was applied over the raw metal and wood materials. The excess fiber paper was trimmed on the back side of the treated wood then the area was filled with silicone.

After a much need rest also to allow the silicone to cure Part B will take shape when the bellow section of the exhaust system is reinstalled. The new heat shield will then take its place.

After working on this file and seeing bare steel in several photos, the finished product will wait for a coat of black spray paint to be applied over the exposed metal.
