## 2010 43QGP Allegro Bus

### **SEVENTYTH - coach modification – PART B TIFFIN POWERGLIDE CHASSIS RECALL 12V526.**

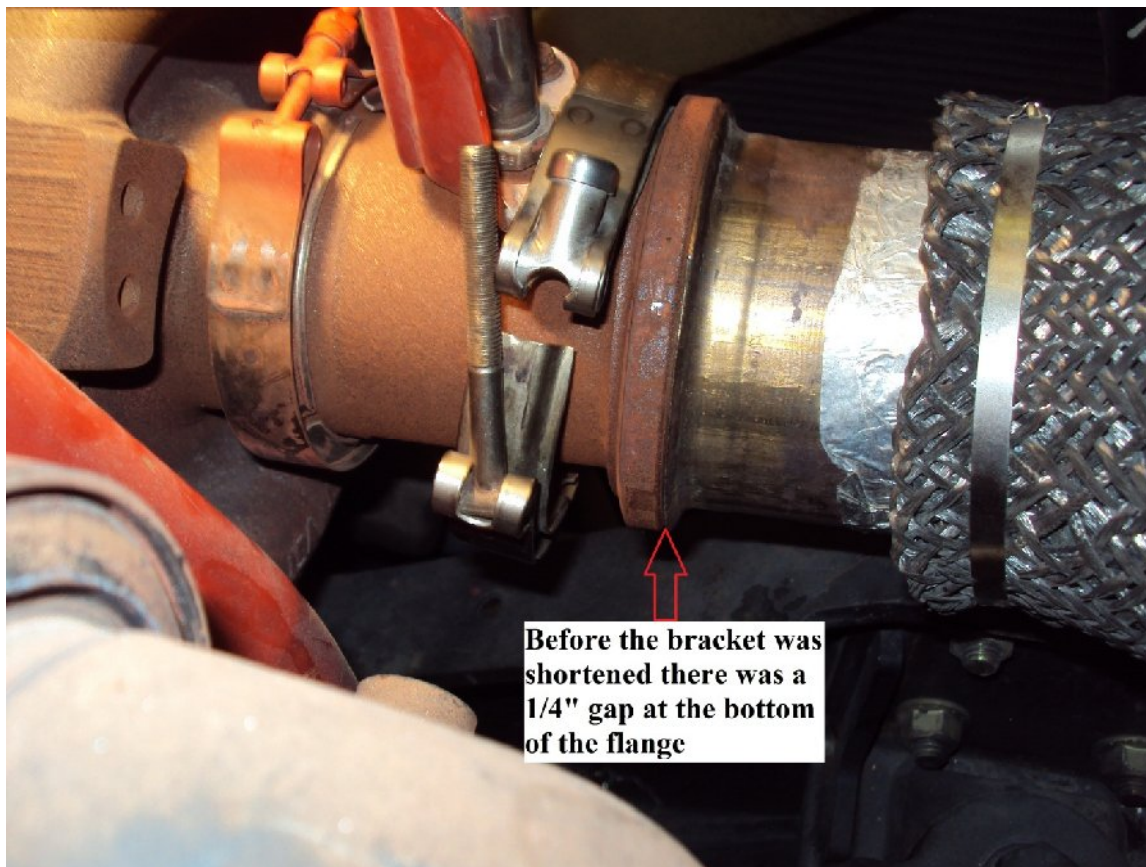
When the exhaust bracket shipped with the heat shield was installed the exhaust pipe would not properly mate with the turbo exhaust pipe flange. A photo was not taken at that time, this photo taken after the bracket modification (shortening) is used to demonstrate.

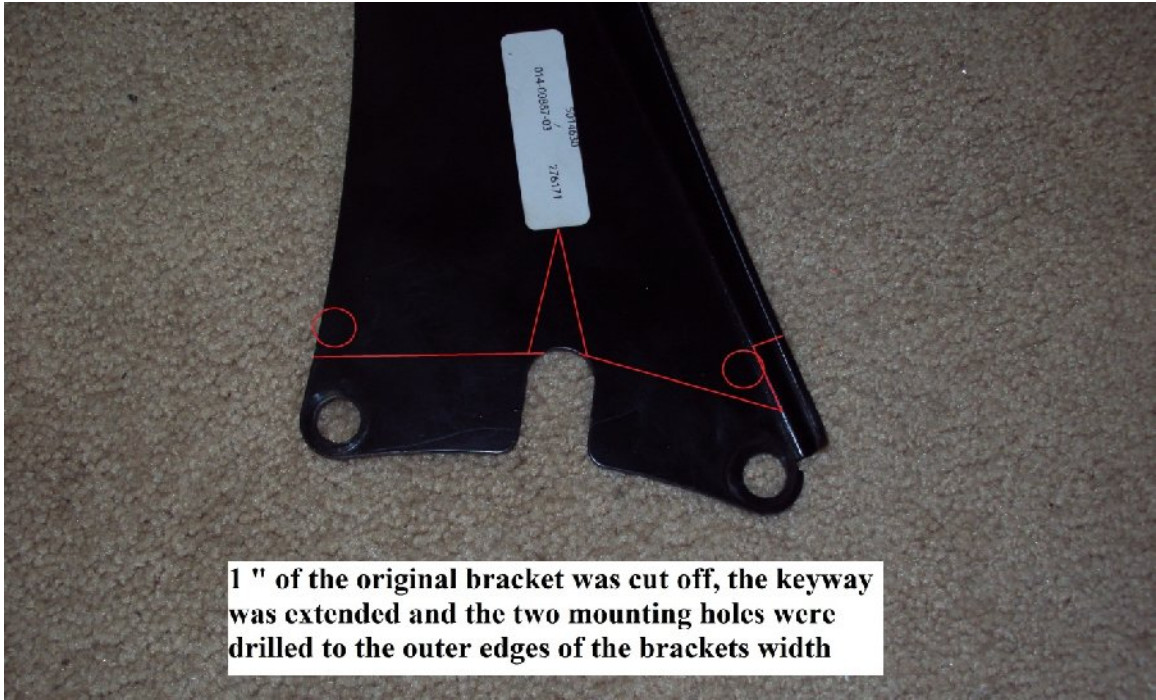
When the exhaust clamp is properly installed and tightened the two flange halves ALMOST KISS each other as can be seen in photo # 3.

**1 " of the original bracket was cut off, the keyway was extended and the two mounting holes were drilled to the outer edges of the brackets width**

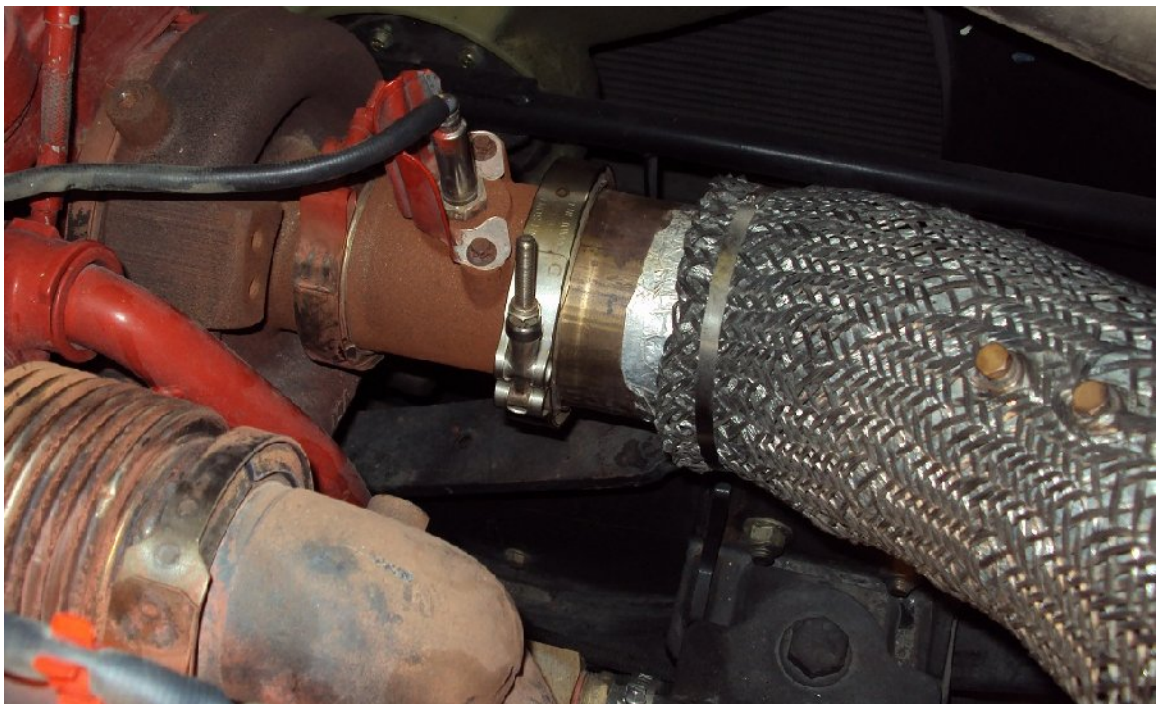
As noted above the width of the bracket became a problem after the bracket was shortened. I do not think there will be any future problems as the two bolts securing the bracket to the transmission housing tightened completely. The bracket was installed then the exhaust pipe was mated to the turbo flange in the flowing photo.

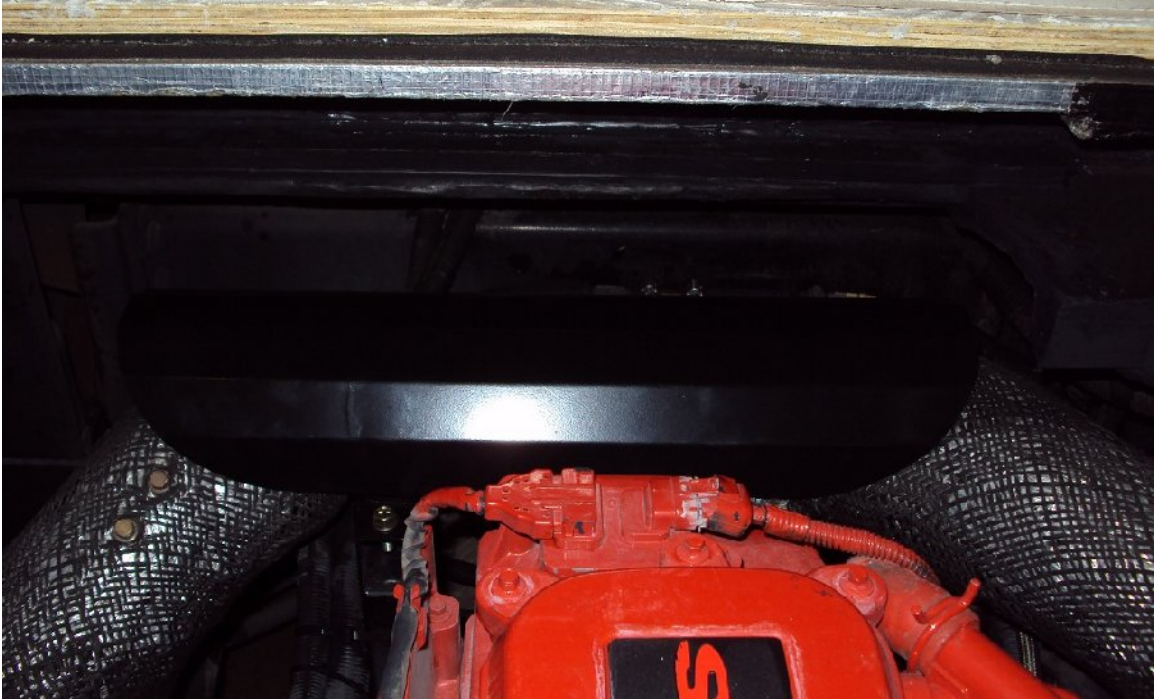
The photo is dark with the black heat shield on black floor color as the background, however after the floor modification there are now three (3) inches of open space between the floor and the heat shield.

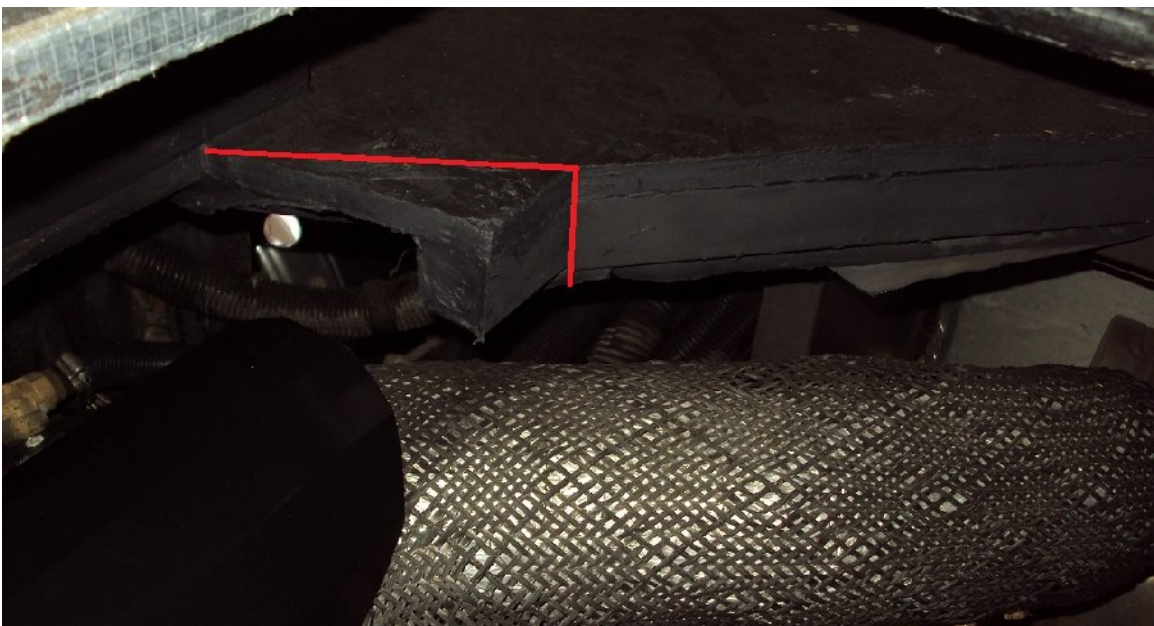
**IF** I were to be performing this 12V526 recall modification a second time, the small 2 1/2 inch corner in the center of the below photo would be cut at the same 45 ° angle as the adjacent tubing just to make a cleaner look.
