2010 43QGP Allegro Bus

SEVENTY-FOURTH - coach modification – INSTALLATION OF THE PROGRESSIVE INDUSTRIES HW50C – ENERGY MANAGEMENT SYSTEM.

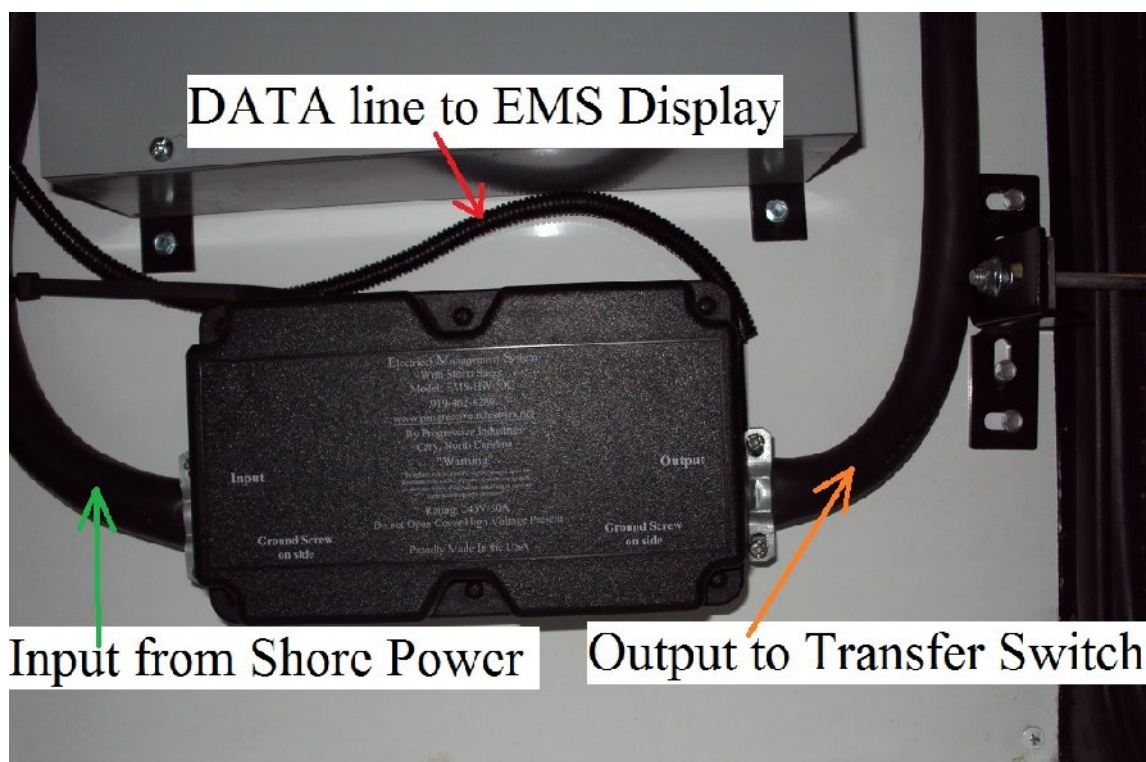
In an effort to make this installation as easy as possible a few items mounted in the bay along with our transfer switch panel were moved to provide room to mount the HW50C panel under the Tiffin 50-3 transfer switch.

The input power cord was moved from the Tiffin transfer switch to the input side of the EMS-HW50C. A short piece of cord approximately three feet was purchased from an electrical supply house the cord has three # 6 wires and one # 8 wire. That cord was connected to the output side of the EMS and wired into the Tiffin transfer switch. The Progressive supplied **DATA** line

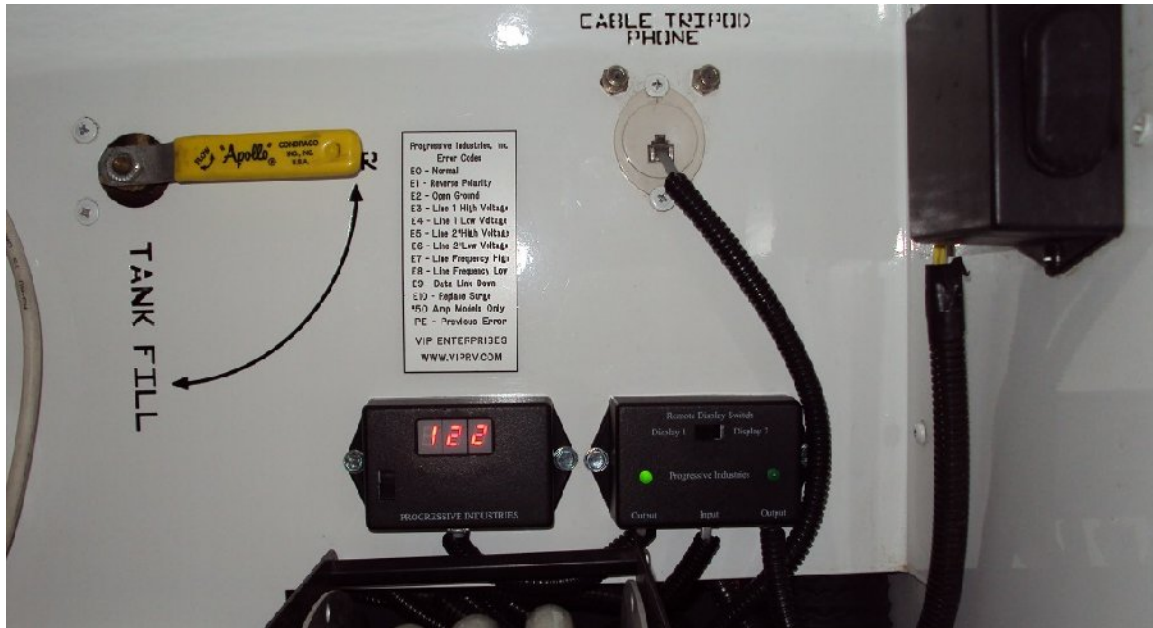
Some months later a second display and data switch was purchased making it convenient to install a second display which is located in our bedroom over the stack of drawers.

With the new switch the **DATA** line is connected to the input of the switch. The wet bay display 1 is connected to switch 1 and the second display is connected to switch 2. The cable between the switch and display 1 is a standard FOUR wire phone cable it IS NOT A DATA cable. The output cable from the switch to display 2 is connected to the wet bay house phone circuit again with a standard FOUR wire PHONE cable. Our coach has four phone connections, three inside the coach and one in the front passenger side compartment in addition to the wet bay phone connection.

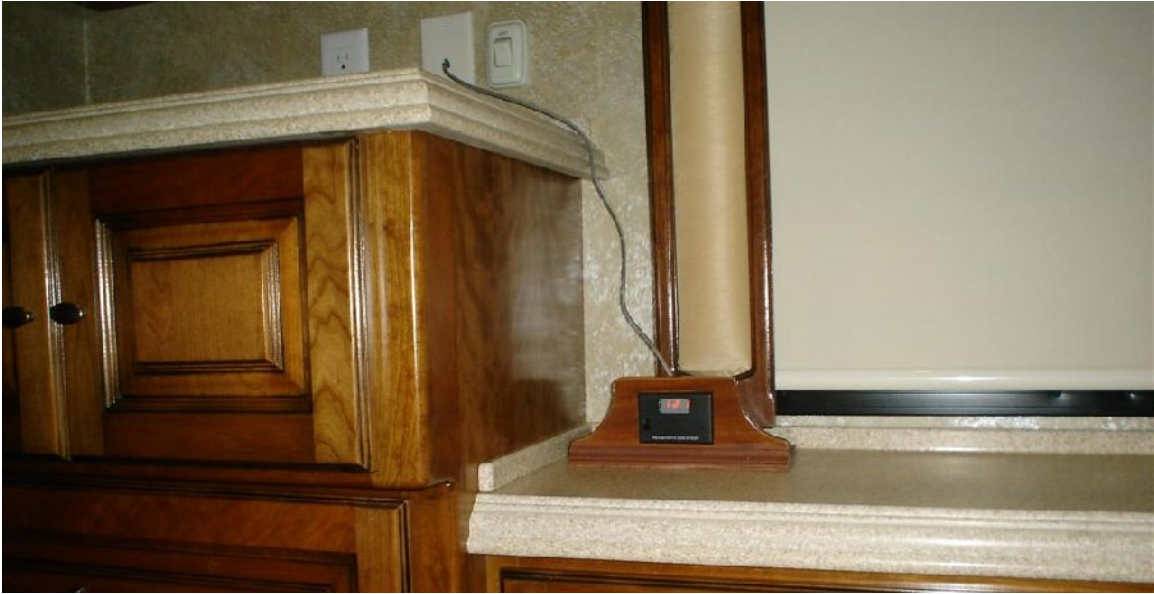
A display stand was built stained to match the woodwork in our coach the display can be inserted then the stand which may be placed almost anywhere in the coach. I find it very convenient to have the display located in the bedroom where it can be seen during the night to make sure shore power is operating and the coach is not running off the inverter.

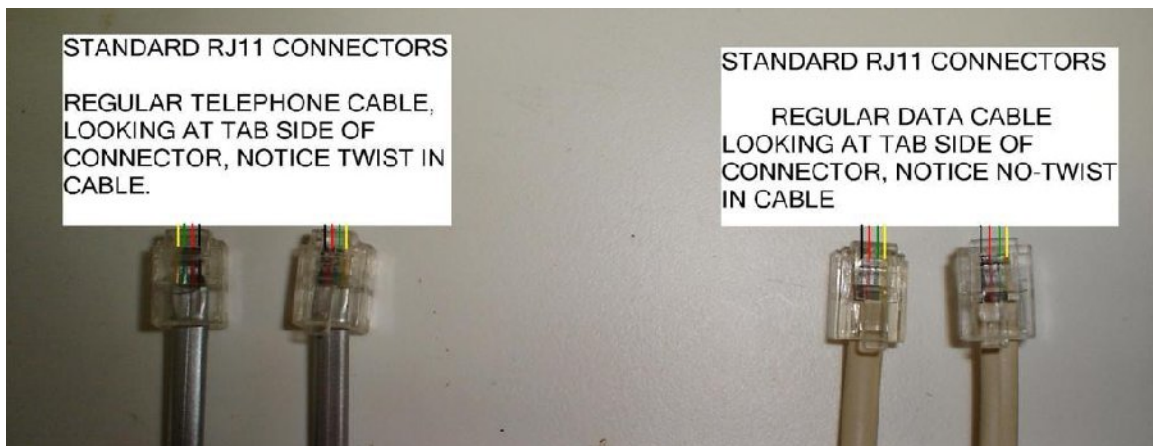
The PHONE cable connectors on the LEFT are standard four conductor RJ-11 connectors. The two connectors are mirror images of each other, the wires are reversed. The DATA cable connectors on the RIGHT are standard four conductor RJ-11 connectors however the cable ends match each other. **ONLY ONE DATA CABLE** is used when installing the PI-EMS unit. That DATA cable is installed between the EMS and the data switch or the display depending on a single display or a dual display.
