2010 43QGP Allegro Bus

EIGHTY-SECOND - coach modification – **INSTALLATION OF CLOSABLE AC-HP VENTS**. Not long after our coach purchase Cathey complained of the AC blowing on top of her head while styling her hair. Shortly after we were visiting the service center for warranty work when I found the slightly larger vents which could be rotated, opened or closed. I purchased four of them and went about installing two in our rear bathroom as seen in Crusingator's Modification file #26.

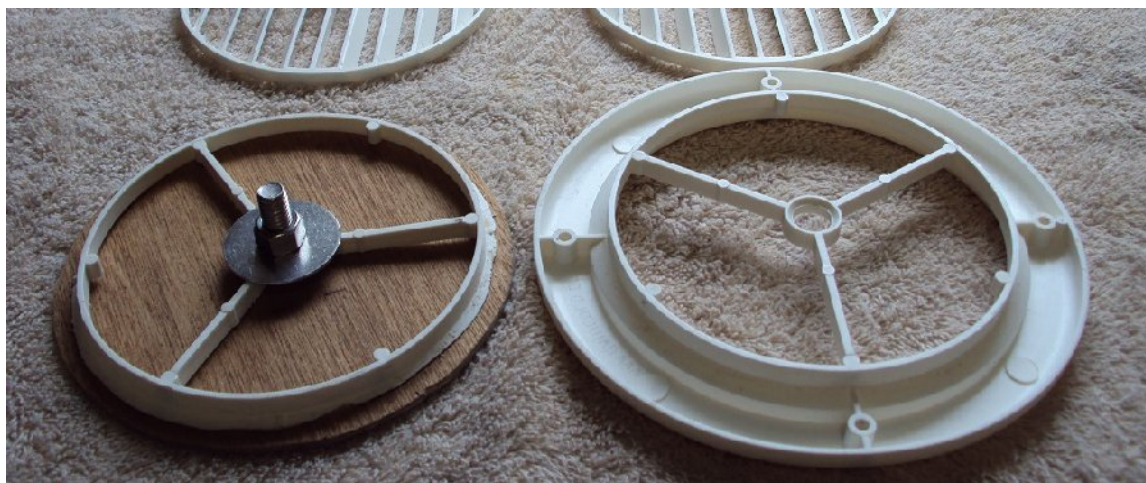
The previous photo shows two of the OEM vents. The outer portion of the left vents plastic was removed using an air powered body saw. Next I used a compass to draw a 6" diameter circle on a thin piece of Luan. A 3/8" hole was drilled thru the center of the Luan then a washer and nut were added to complete the template.

The first part of the modification was to remove the ten (10) OEM supply vents located in the salon, hall and bedroom. The new vents require a slightly larger hole in the ceiling, to make enlarging those holes easy yet keeping them centered I decided to destroy one of the old vents to make a template for enlarging the ten holes.

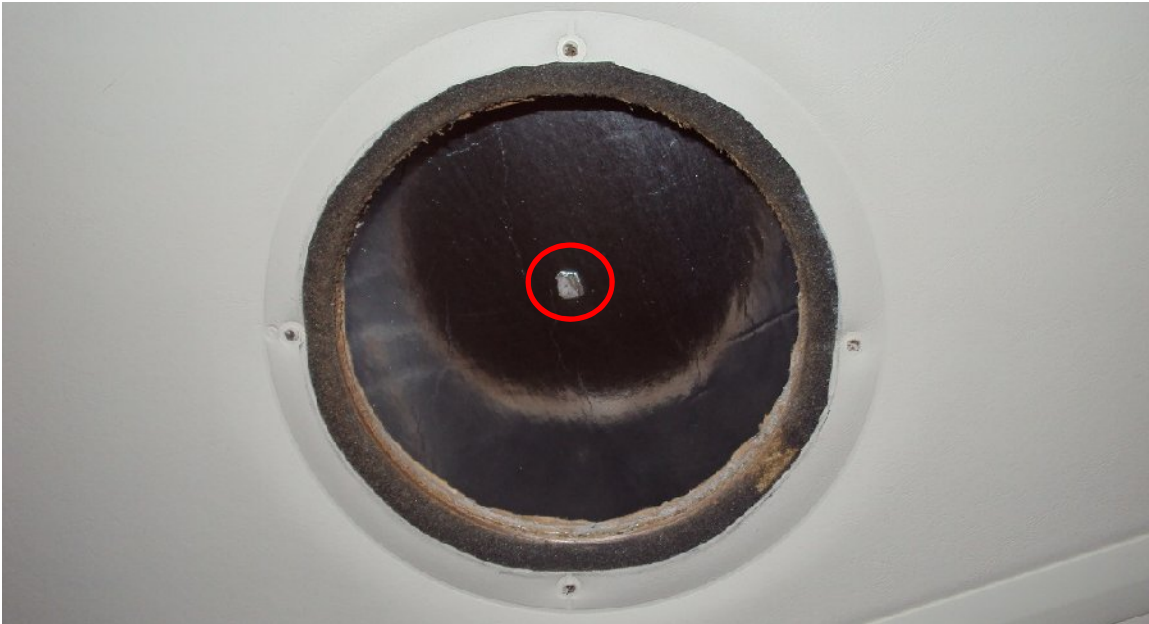
The above opening is one of the seven (7) shallower openings because it is in one of the two raised ceiling this one is located in the salon. One area usually damaged by Tiffin while cutting the vent openings is to allow the hole saws pilot bit to cut into the duct board as seen above in the **RED** circle. I always patch this hole with the aluminum tape.

With the template in hand, the template was inserted into the OEM vent hole, held centered with one hand then a sharp razor knife was used to cut around the template thru the vinyl and 1/4" foam pad. Next carefully remove the cut vinyl ring and foam pad exposing the Luan ceiling.

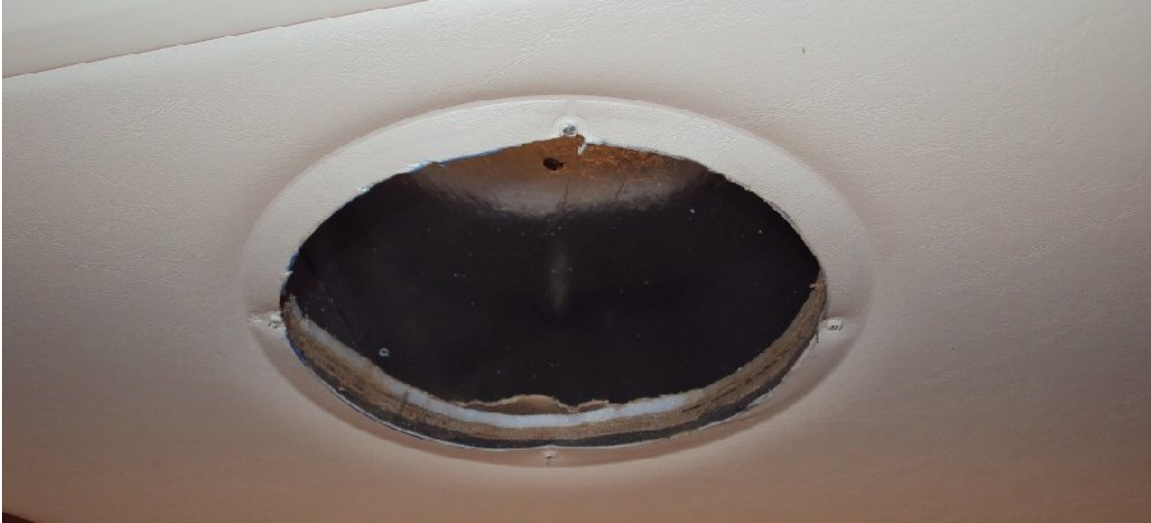
seven shallower locations. The duct board and Luan had been allowed to separate. This oversight on Tiffin's part could have been costly for them and aggravating for us.

As seen above this is just one of the seven untaped openings. I used tape to pull the duct board and Luan together prior to installing the aluminum foil tape in the openings as shown below.

The next step is to get the air powered body saw back out it is used to cut thru the Luan ceiling panel enlarging the hole to slightly over 6 inches in diameter where I had cut the vinyl previously. Now that the hole has been enlarged the next step is to tape the exposed Luan and duct board with aluminum foil tape to prevent damage from any moisture or condensation. I found Tiffin workers did not use the aluminum tape on a single one of the

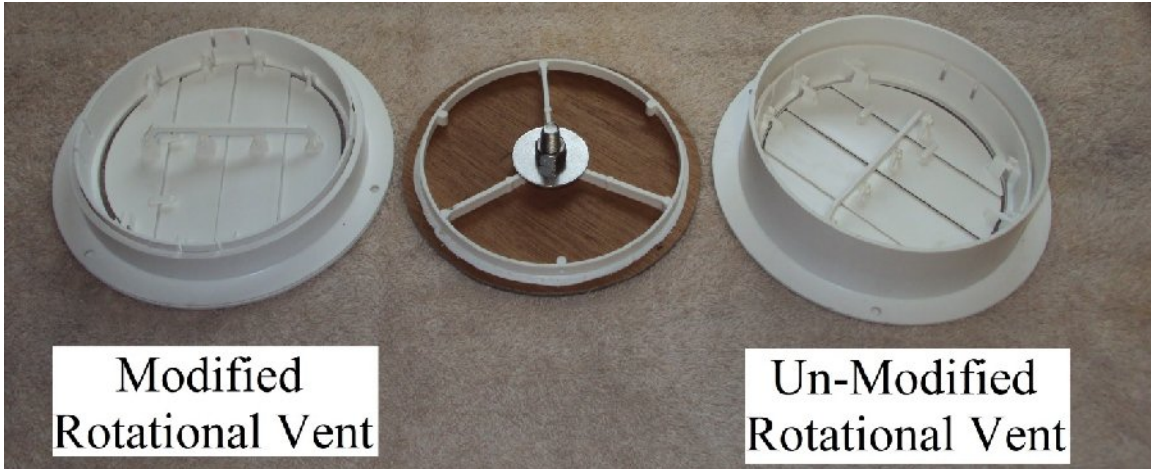
The above photo shows the height difference of the modified vent (left vent) versus the un-modified vent (right vent). The air tools below were used to modify the holes in the ceiling and the height of seven new vents.

Now at this point what can I do with the new vents? They are about 3/4 inch too tall for the shallower mount raised ceiling? If I install the new vents into the salon and bedroom ceilings the air flow will be sharply impeded. That required the modification of the new vents height or depth when used in those two raised or recessed portions of the ceiling, seven vents total. If it is found necessary in the future and additional 1/4 inch can be removed from the already modified rotational vents.

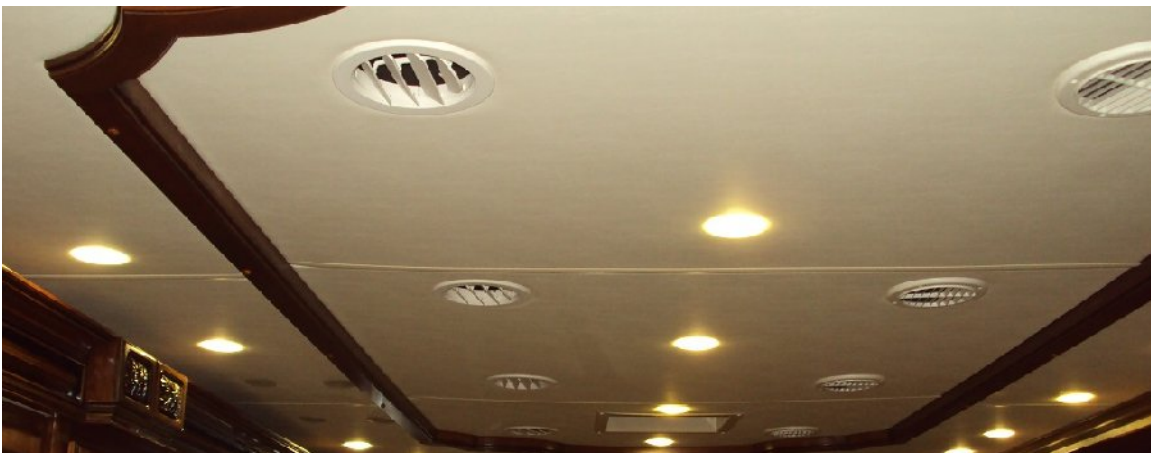
The finished ceiling supply vent modification.
