2010 43QGP Allegro Bus

EIGHTY-EIGHTH – coach modification – **STACKED DRYER FILTER & VENT CLEANING.** From habit, the dryer's lint filter is removed and cleaned after each load of clothes has been dried. After reading a recent discussion about cleaning the dryer's filter I decided to make sure the vent between the dryer and the outside of the coach was clean and unobstructed. A plywood plug was constructed and installed in place of the lint filter with a one inch hole in the center. The blower side of a shop vacuum's hose was connected to the filter plug then the vacuum was turned ON to blow any leftover lint out of the dryer's vent hose and the coaches outside vent cover.

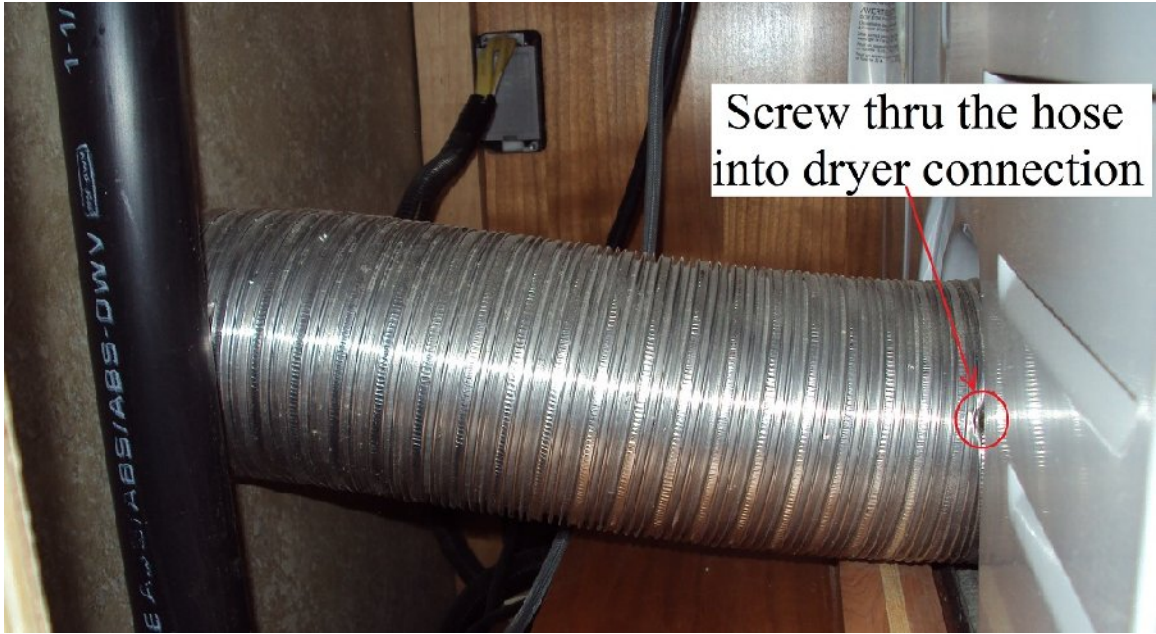
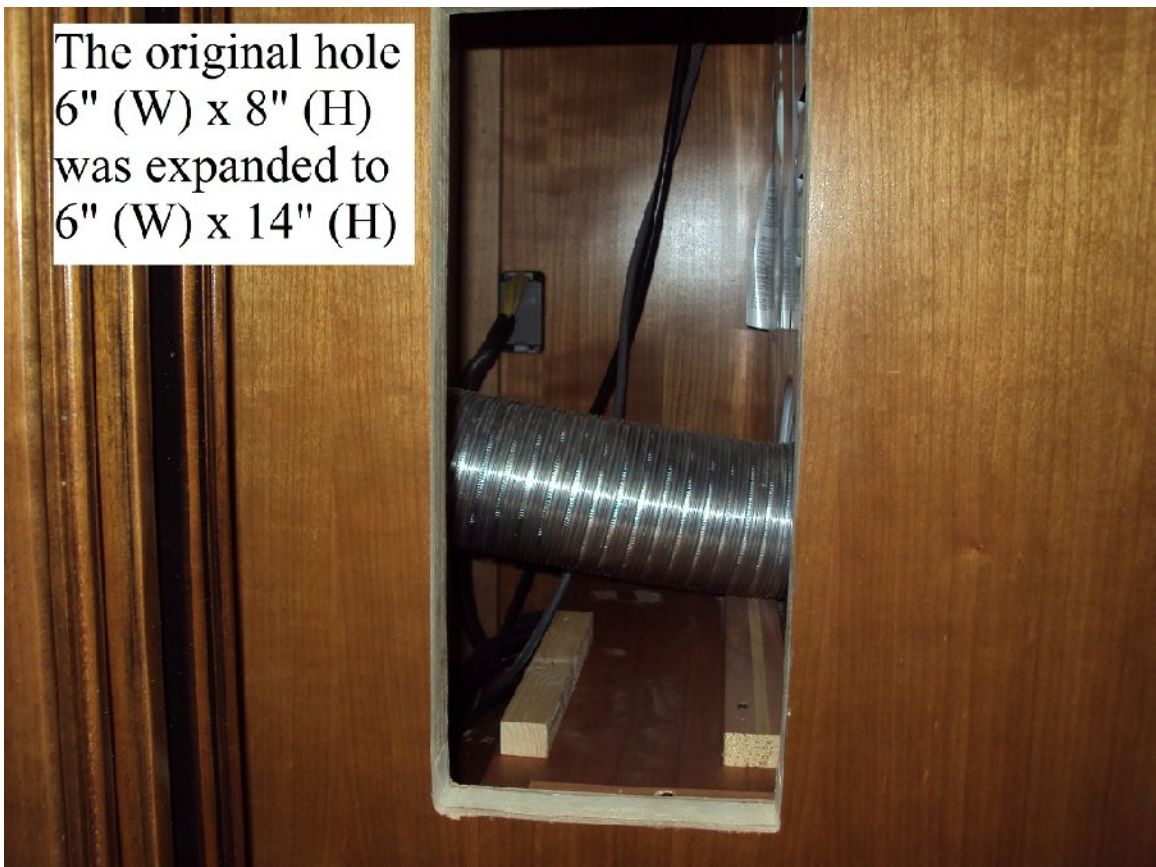
Having no idea of what Tiffin may have located on the other side of the double panel wall extreme care was taken by first drilling pilot holes inside the black box after each hole had been drilled I checked around inside the hole by inserting a finger to explore before drilling the next hole. One layer of paneling was opened at the time there is a $\frac{3}{4}$ " space between the two panels. After opening the outer panel the same procedure was used for the inner paneling, drill a hole explore around it with a finger before drilling the next hole. After the initial 6" x 8" hole had been opened I was able to see how much cavity was actually behind the dryer. Based on the actual size I decided to extend the hole from 8" tall to 14" tall. Just as well I did not decide to remove the dryer to explore as if I had the dryer hose would have

been destroyed as Tiffin connected the hose to the dryer with a screw then pushed the metal dryer hose thru the coach's side wall while pushing the dryer into place.

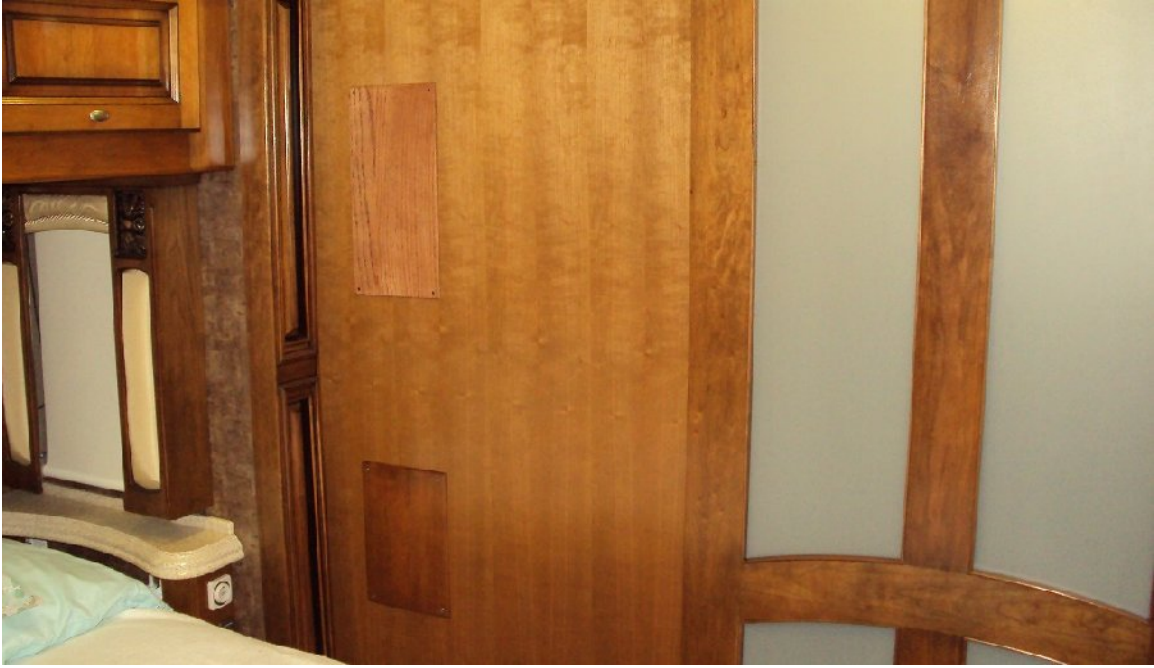
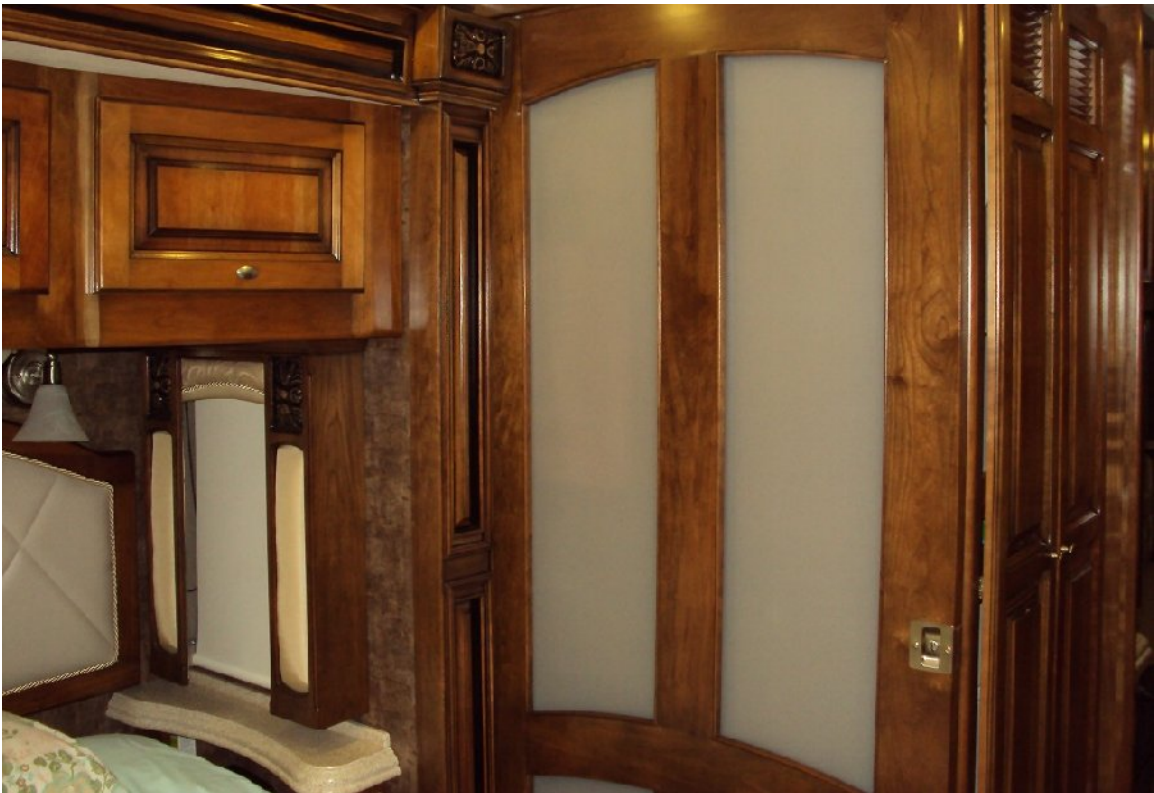
After cutting the access hole four pieces of $\frac{3}{4}$ " x 1" wood were glued between the two panels, wood clamps were installed until the glue had dried. A piece of $\frac{1}{4}$ " hardwood was cut 8" x 16", sanded edges beveled then stained to serve as a access cover for the dryer vent cavity.
