2010 43QGP Allegro Bus

NINETIETH - coach modification – **A/C CONDENSATE DRAIN COLLECTOR**. Tiffin installed three separate A/C condensate drains from the AC units routing them to the lower left corner of the coach's rear cap. That is good and bad, the good part is they are located together the bad part is they were cut off about two feet short IMO. When the condensate is draining the water runs off various components splattering over everything. I desire to place a bucket under the drains to collect the condensate rather than have the water run all over the garage floor, to do that the condensate needs to be controlled or collected.

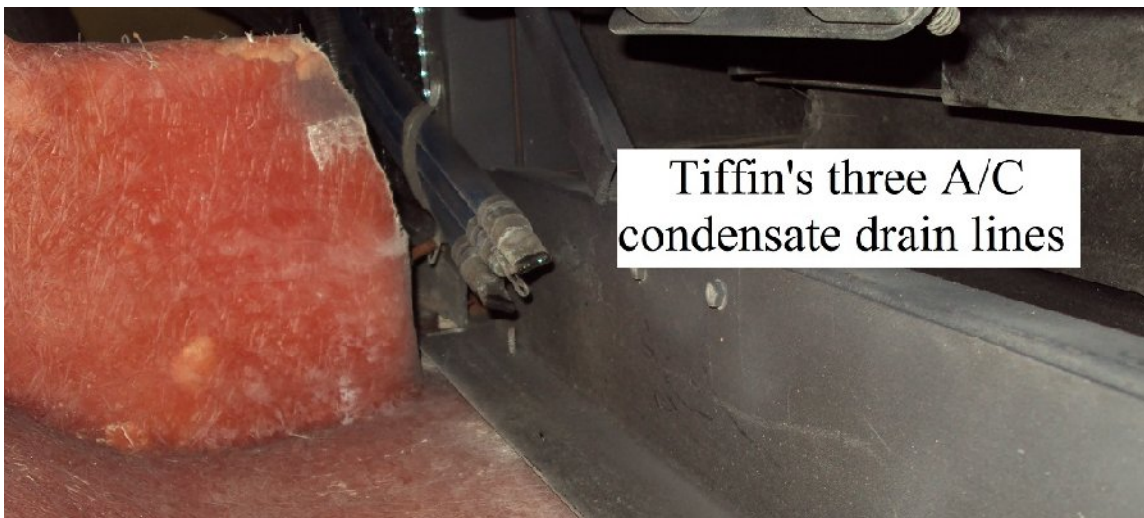
The above photo shows the three condensate drain lines they terminate about two feet shorter than I think they should.

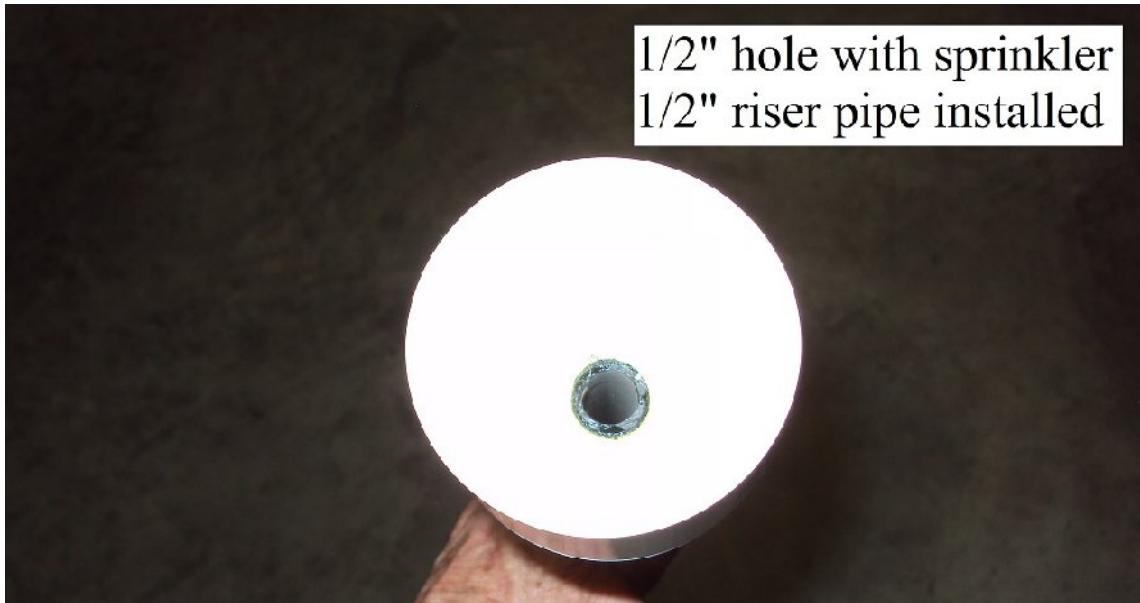
First a 1/2 hole was drilled thru the top center of the cap, the hole allows the 1/2" sprinkler riser pipe to be screwed up thru the hole projecting about a 1/32 of an inch above the bottom of the cap. A few drops of contact cement were applied and allowed to cure overnight.

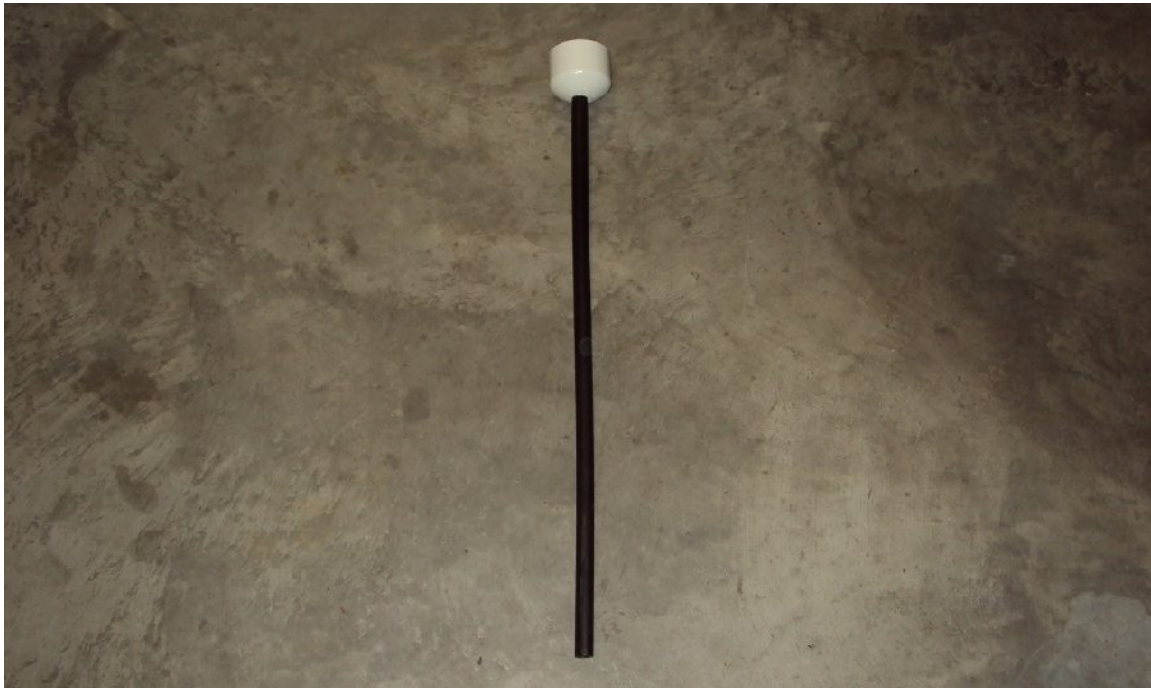
Three of Tiffin's screws were removed to allow the zip ties to be anchored then reinstalled. The cap was not mounted against the duck bills to allow for proper drainage.

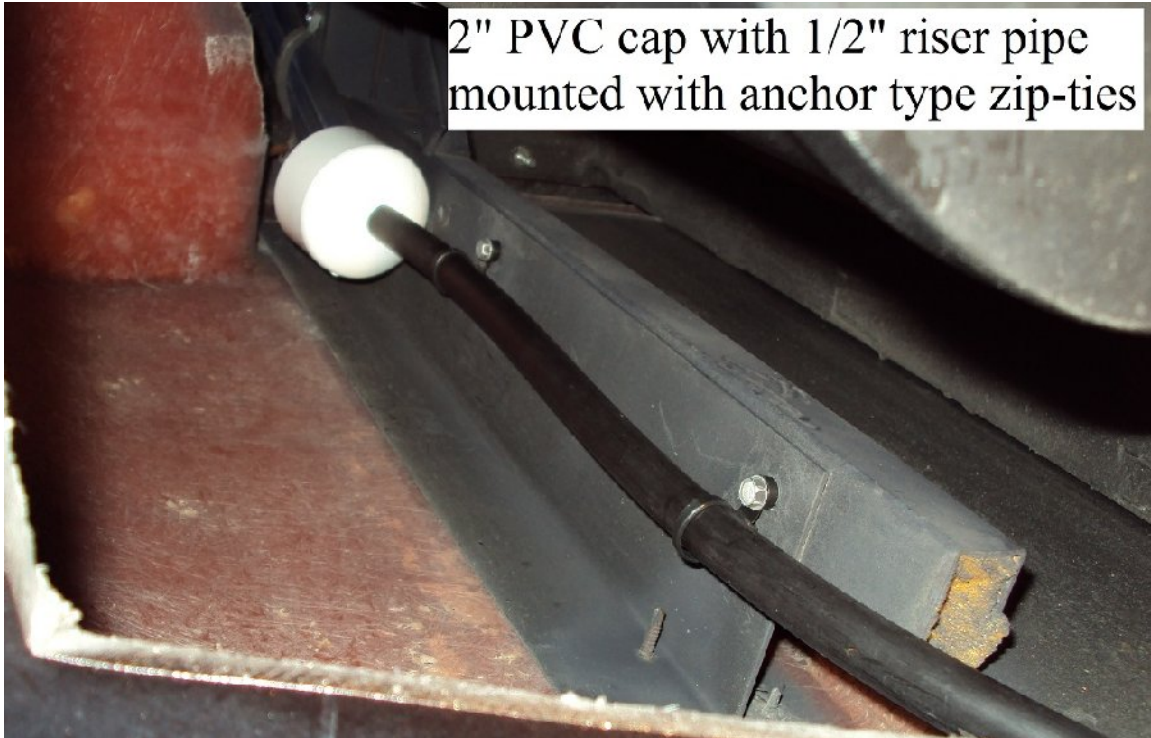
2" PVC cap with 1/2" riser pipe mounted with anchor type zip-ties

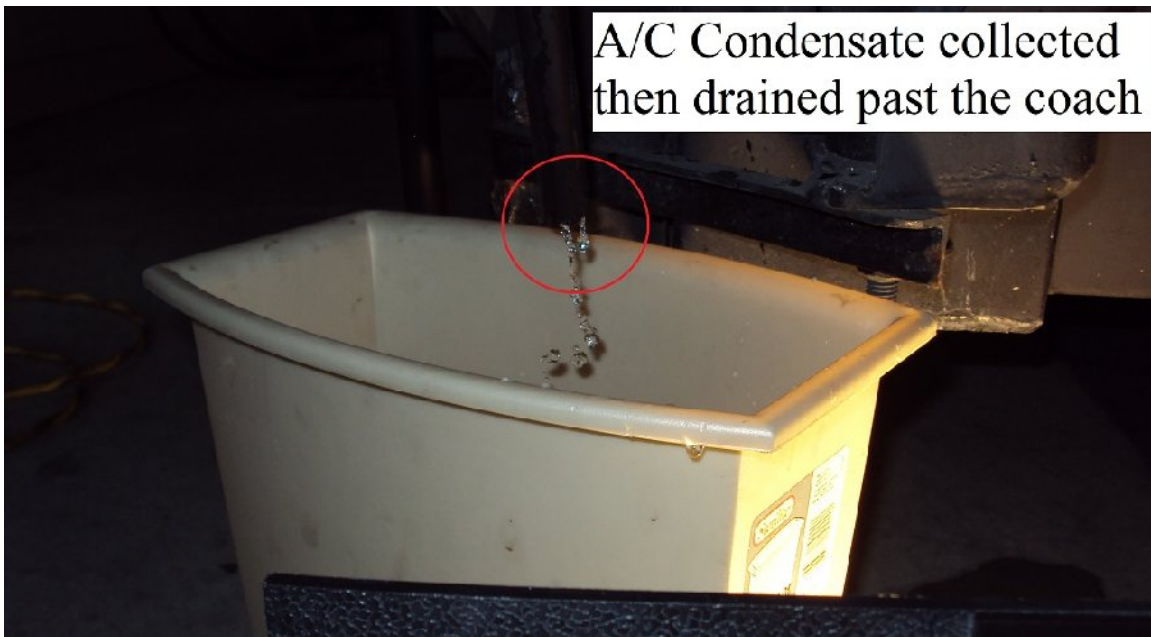
A/C Condensate collected then drained past the coach

As seen above a bucket or trash can be placed under the drain OR a hose may be connected to the drain and routed outside or to a drain.
