2010 43QGP Allegro Bus

NINETY-EIGHTH coach modification **DOOR STEP MUD FLAP.**This photo shows the Tiffin installed guard to prevent mud and other debris from getting on the steps, the guard is show inside the **GREEN** box.

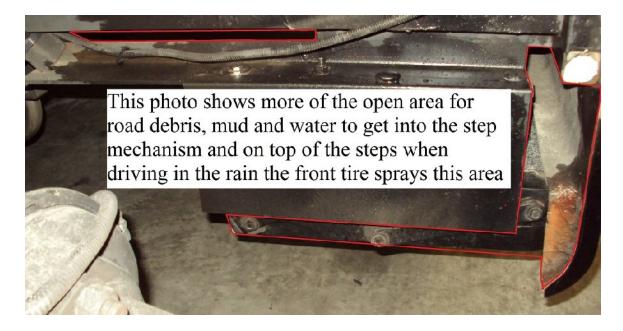
Step areas open to mud and debris are shown in **RED** above and below.
