## 2010 43QGP Allegro Bus

### **NINETY-NINETH** - coach modification – **COOLANT HOSE**

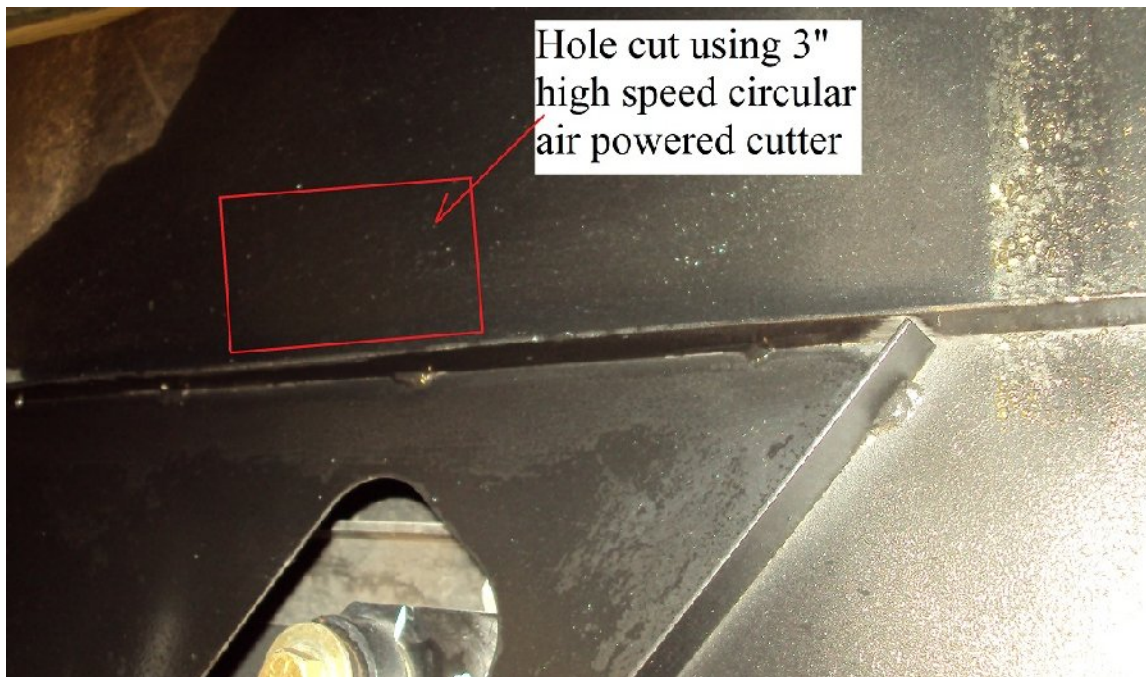
The above photo was taken after the D/S tag axle wheel had been removed to allow access. The mud flap was bent up out of the way allowing access to the metal radiator shroud shown above.

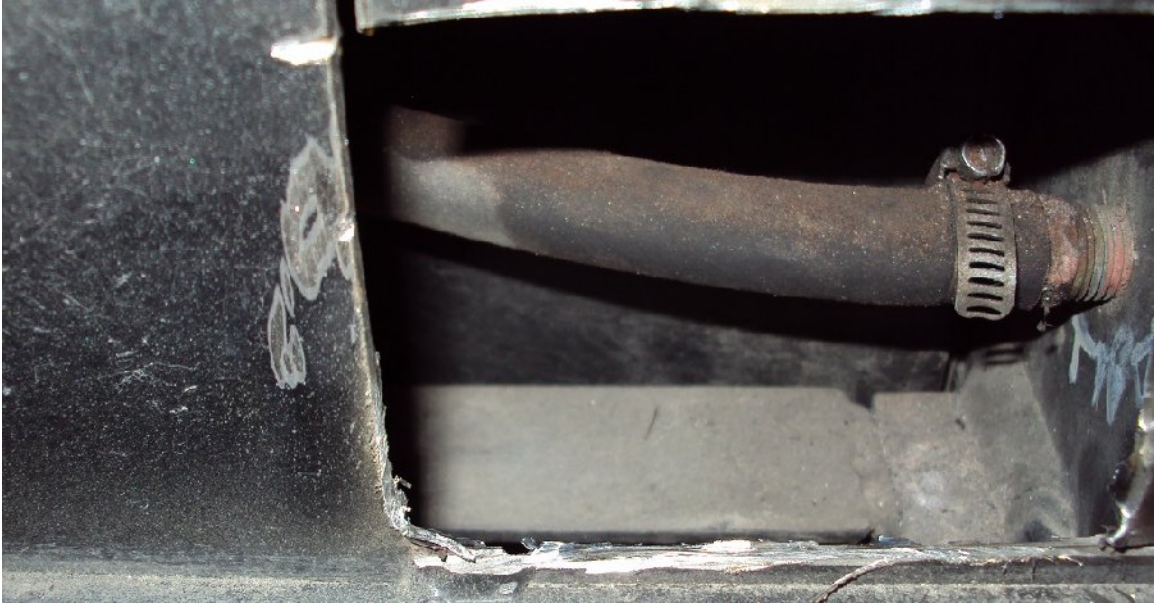
Shown above is the access hole cut with the air cutter to gain access to the OEM coolant hose and hose clamp. As seen in the below photo the OEM hose was abandoned in place as access to three hose straps was un-accessible after the coach had been assembled.

Access to the coolant hose, hose clamp and hose barb was gained by cutting the above square hole.

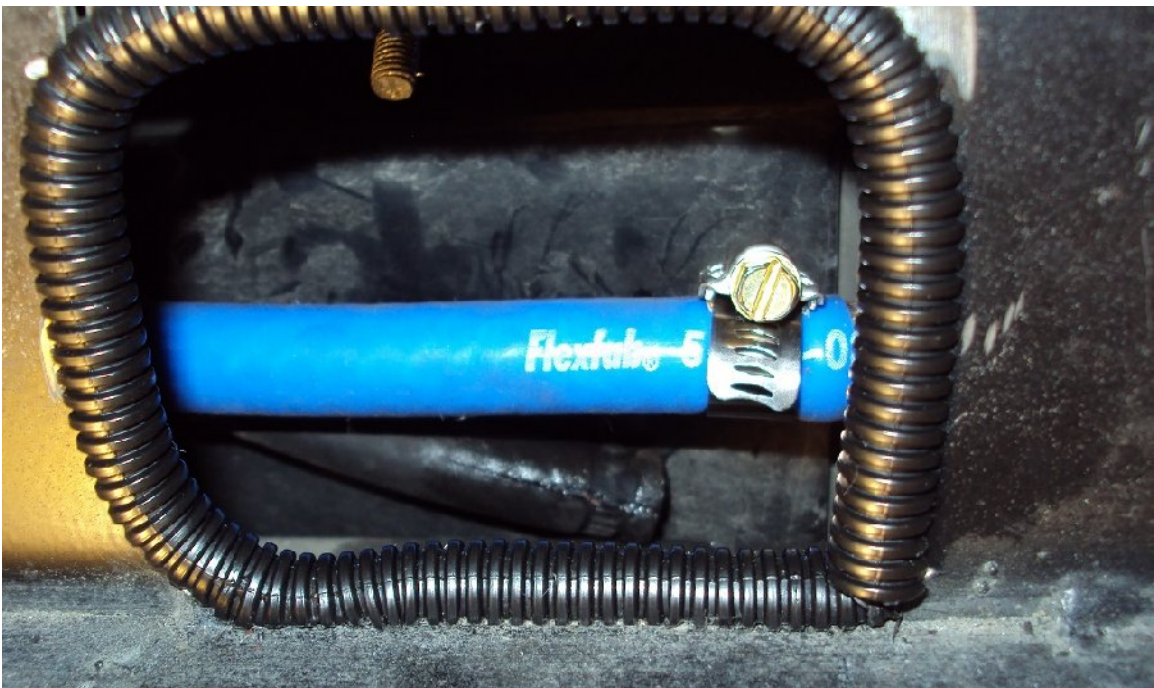
Photo of the new silicone coolant hose, lined hose clamp and abandoned in place OEM coolant hose. Split loom was installed around the cut to prevent the raw metal edges from cutting me or other nearby components.

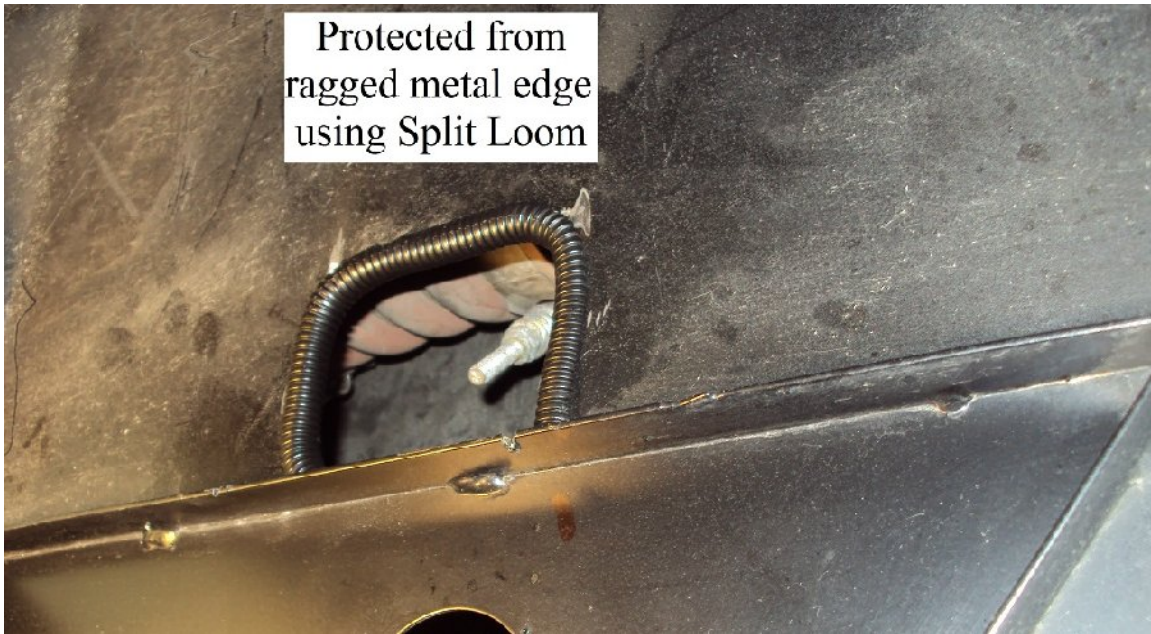
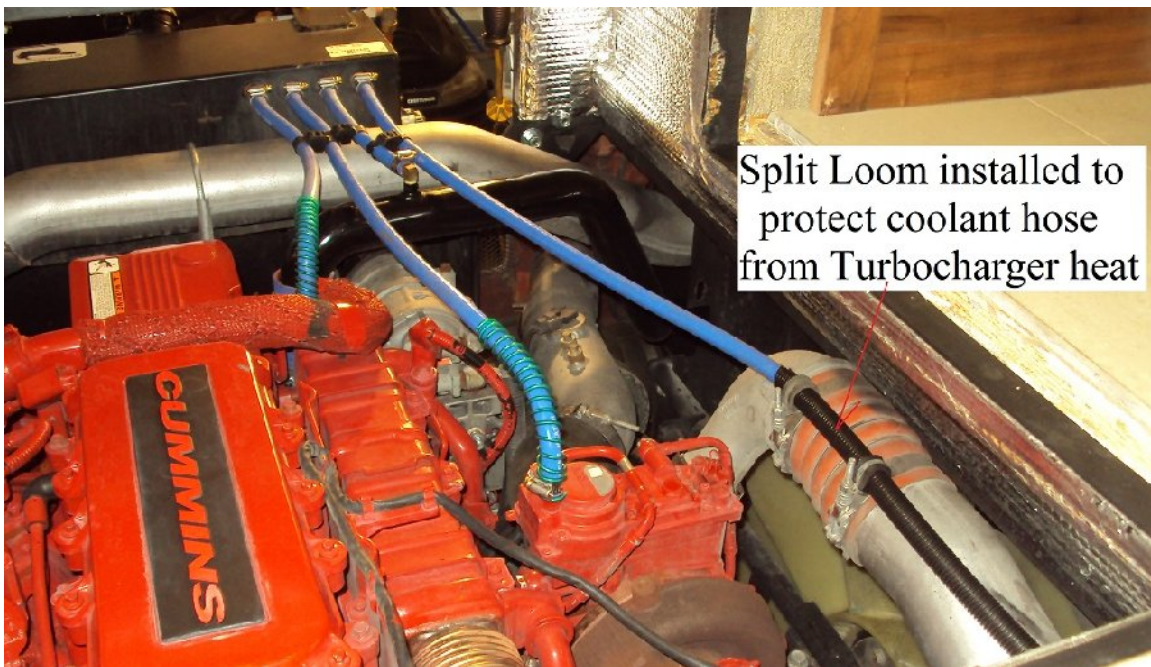
Ted's Custom Springs were made using "Vinyl Coated Multi-Purpose Clothes Line Wire", the wire is steel with an external green vinyl jacket. The wire was wrapped tightly around a 3/4" wooden dowel after winding about 12" of the spring shape on the dowel the "spring" was cut into two equal lengths. The bare metal ends of the "spring" were coated with multiple coats of clear nail polish in hopes of preventing rusting of the steel. Total cost of project was under \$ 58.00. The 3/8" silicone hose cost was \$ 3.75 per foot for 11 feet of Flexfab 5526-038 hose. Each lined hose clamp wholesale cost was \$ 1.62 for 8 hose clamps, plus \$.06 per dollar in taxes.
