## 2010 43QGP Allegro Bus

**ONE HUNDREDTH - coach modification – AIR FILTER MOUNTING BRACKET MODIFICATION.** During installation of the K & N air filter the air intake hose for the engine was rubbing against the metal of the rear bathrooms closet wall. To prevent further damage to the hose during installation of the K & N air filter a pad was placed between the hose and metal to prevent further damage to the hose until a modification could be made to prevent the hose from rubbing.

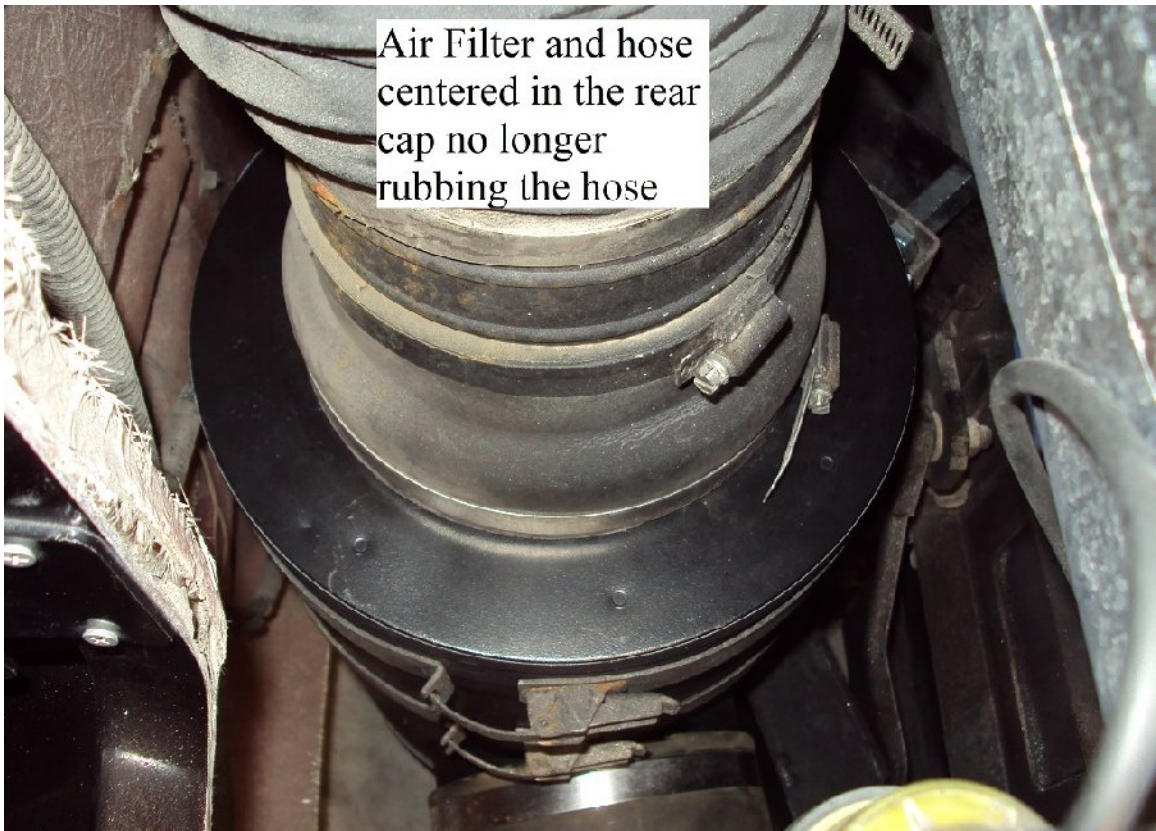
It is clear to see the difference installation of the stud nuts made to move the air filter away from the closet rear wall.

Comparing the above and below photos the  $\frac{1}{2}$ " bolts, lock washers and stud nuts push the air filter bracket straps forward about  $1\frac{3}{4}$ " which almost centers the air filter between the closet wall and the rear cap fiberglass.
