2010 43QGP Allegro Bus

ONE HUNDRED-THIRD - coach modification – REAR CLOSET WALL SAFE INSTALLATION. This is another project that began by digging through the Tiffin warehouse in search of treasure. Our 2010 Allegro Bus did not come from the factory with the wall safe option. We found a boxed wall safe with one small problem the plastic keyhole cover was missing, that problem solved by robbing a cover from another damaged wall safe.

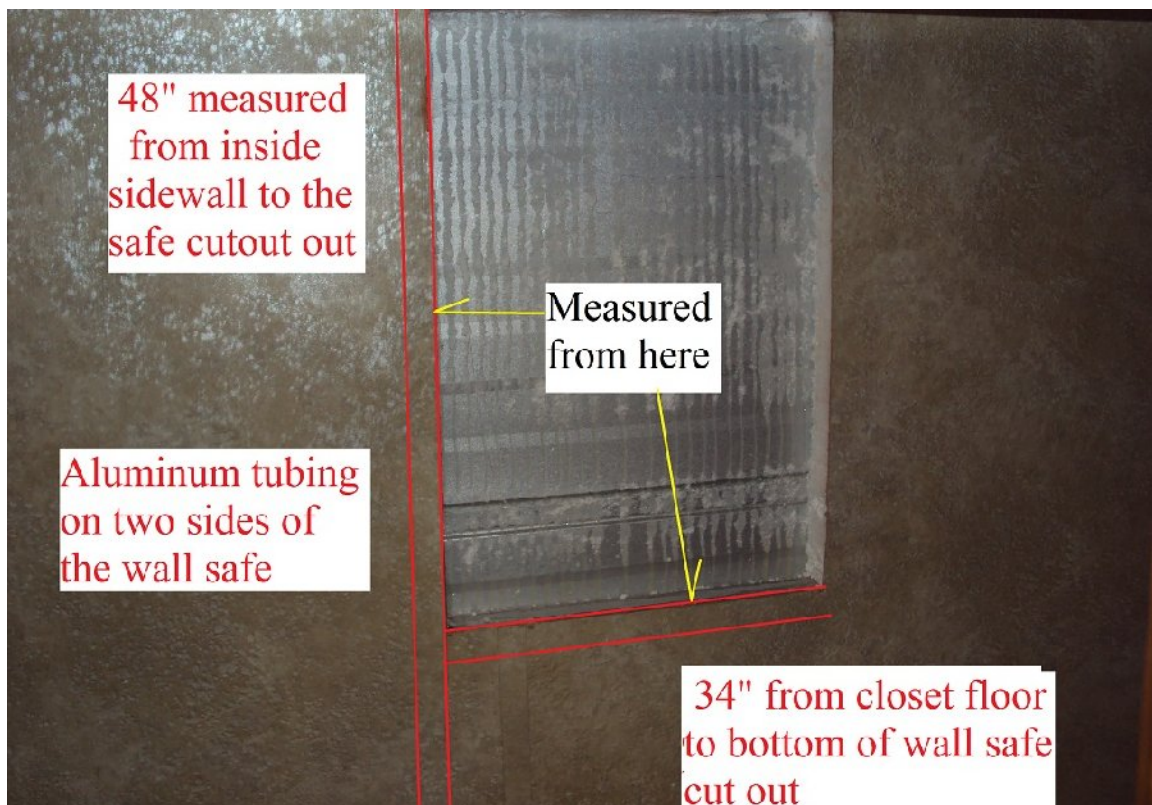
After spending time researching the aluminum framing of the coaches rear wall in hopes Tiffin built the rear wall and it's framing the same with or without the wall safe option I found after speaking with Don Boyd , Tiffin does not frame for the wall safe unless it is ordered as an option. After receiving that information from Don, I requested a drawing of the rear wall framing for our coach. After another week and many days of attempting to locate the aluminum framing with a stud locator I was able to locate two aluminum frame tubes, one vertical at the center of the closet (48 inches) and another horizontal framing tube at 34 inches from the closet floor.

As seen in the previous photo, after locating the two aluminum framing studs the dimensions of the wall safe were outlined on the rear wall, the paneling was cut with a saber saw after first making sure the blade would not cut through the sheet metal on the outside of the rear wall. Why not cut through the rear wall, because the 120 VAC wiring for the three AC/HP units, all in-roof 12 VDC wiring and the three condensate drain lines are all routed behind the wall where the safe will be mounted. After cleaning the foam from the area exposing the sheet metal the center of the metal was carefully cut to allow viewing of the wiring and condensate lines. The wiring and tubing locations can be seen after the sheet metal was carefully removed using tin snips.

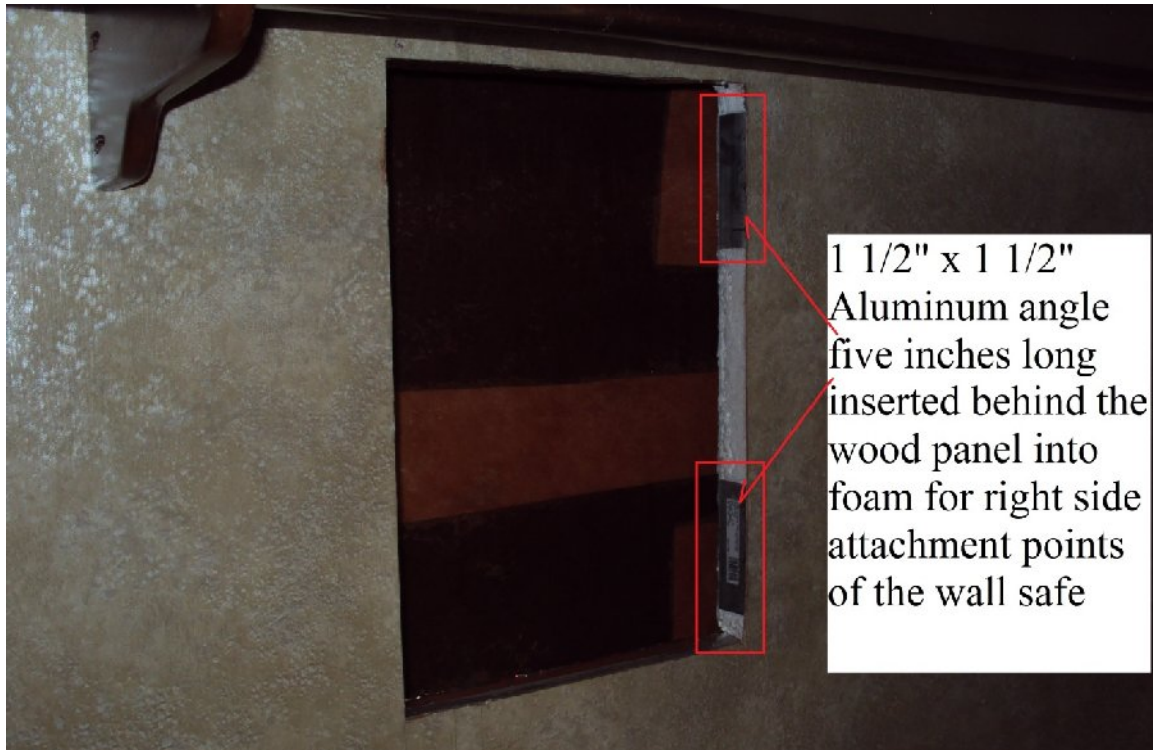
As the right side of the rear wall did not have any framing just wood panel and foam, I needed to figure a way to add something to screw a couple of safe wall anchor bolts into. Finally decided to install two 1 1/2" x 1 1/2" x 5 inch pieces of aluminum angle behind the closet wall board and over the foam, this would provide a 1/8" aluminum structure for installing two self-drilling screws to secure the right side of the safe.

At this point everything is ready for the installation of the wall safe, well almost. I checked and photographed everything in the rear cap area to document the location of all structures in the event it ever becomes necessary to gain entry into the rear cap for any reason. After installing aluminum foil tape over the framing and the exposed foam the rear wall of the safe was insulated with a 1 inch thick piece of AC duct board which was taped to the safe with foil tape. If this were an OEM wall safe installation the rear of the wall safe would have been covered with aluminum foil insulation and taped with aluminum tape to prevent excess heat from entering the closet through the back of the safe.

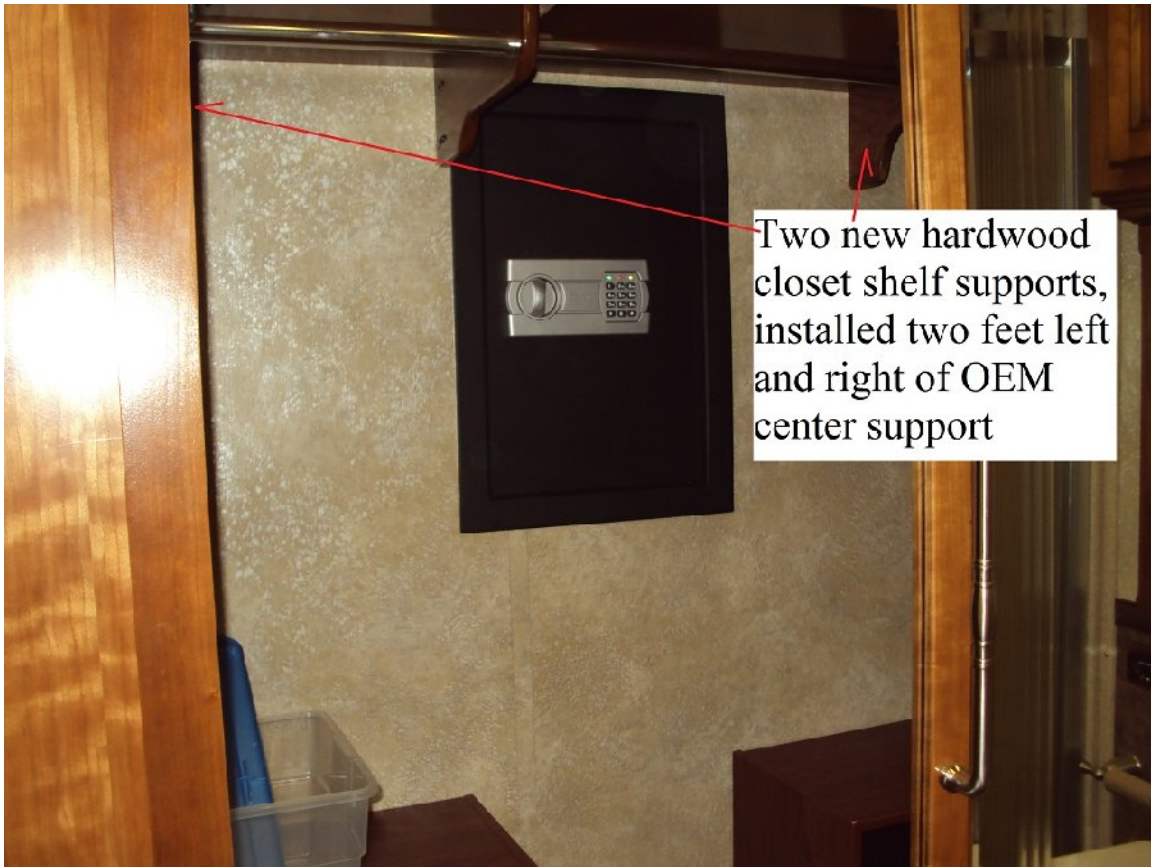
Prior to installing the safe, a bead of silicone was applied to the closet wall behind where the lip of the safe would cover it. The safe was inserted and

secured into the wall with four ¼” by 1 inch self-drilling screws, two installed on each side of the safe. The OEM wall safe mounting screw holes were covered with aluminum foil tape to prevent fumes from entering the closet as the wall safe was designed and built for use in a house with at a minimum of 2 x 4 wall studs. Tiffin coach wall safes are installed in a rear wall 1 ¾ inches thick this requires new holes and covering of the original mounting holes. The installation was completed by finishing the caulking around the outside lip of the safe.

Another problem found during this modification was the rear closet rod was dipping/bowing about one inch below horizontal at its center. In order to provide additional support to the rear closet shelf and attached clothes rod two additional shelf supports were fabricated, stained and installed two feet to the left and two feet to the right of the center of the closet.

Above is a photo of the finished product another Crusinator Modification.
