2010 43QGP Allegro Bus

ONE – HUNDRED - ELEVENTH - coach modification – OTD AWNING LED LIGHTING MODIFICATION. In an attempt at keeping our coach up to current coach standards, we decided to install LED lighting on the Over The Door awning.

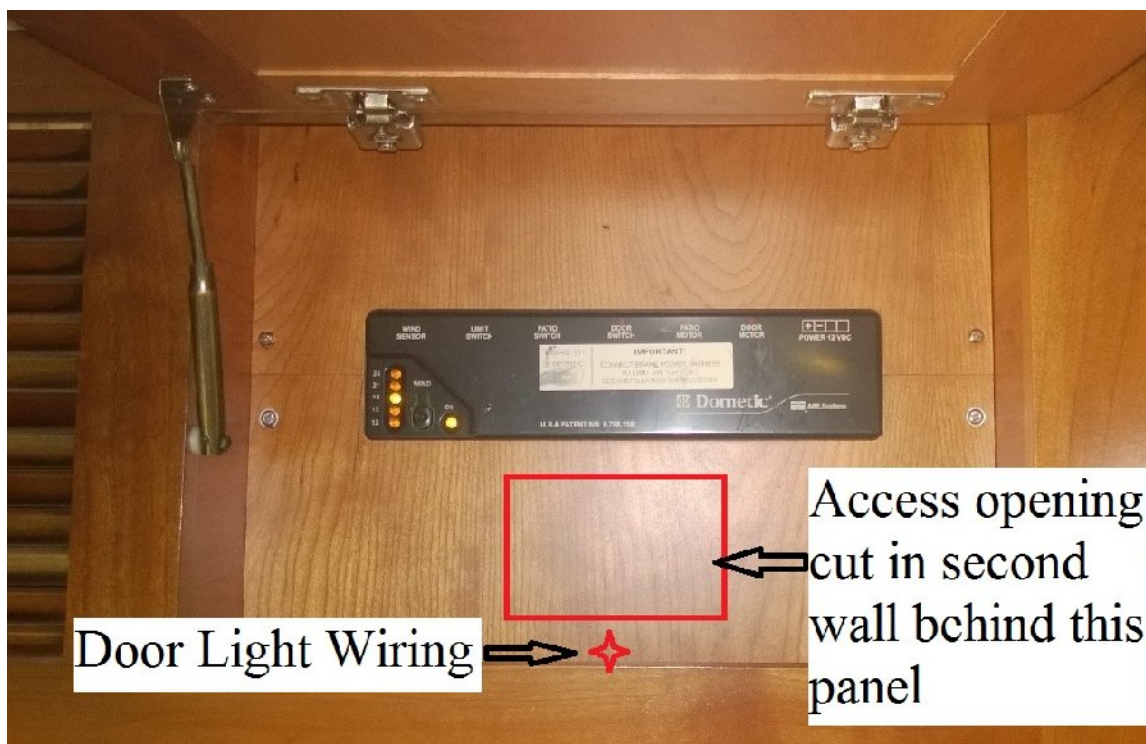
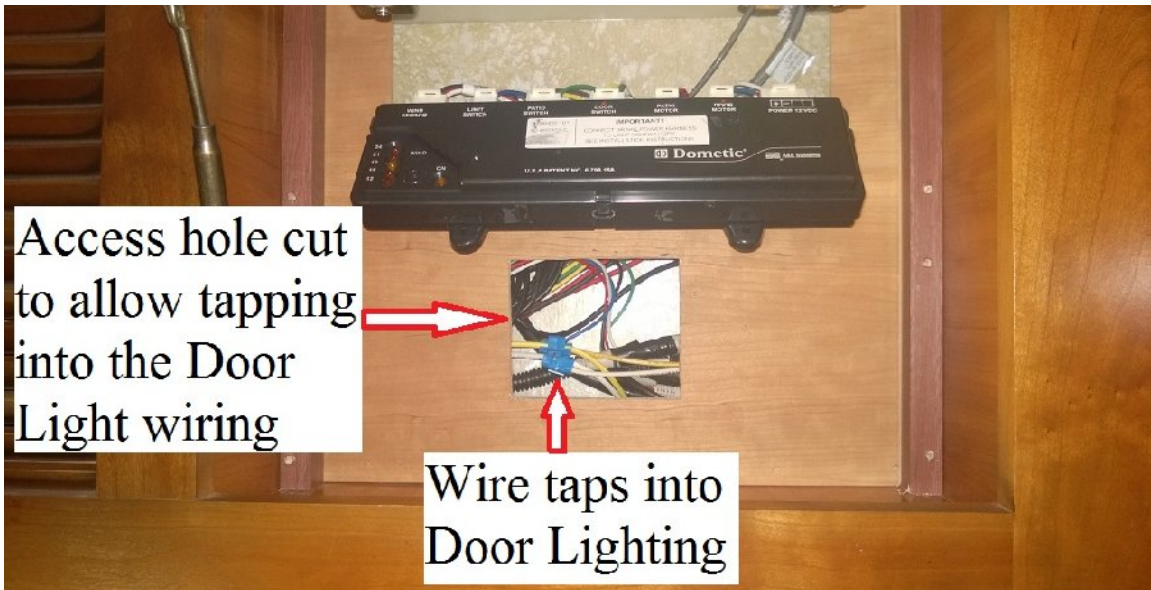
After some disassembly of the two compartments over the co-pilots seat I was able to locate the wiring for the door light and the wiring for the door awning power where they penetrated the coach side wall. After removing the two pieces of paneling in the awning control compartment as shown below.

As show in the above photo, an access hole was cut in the hidden panel allowing me to tap into the door light wiring. After tapping the two new wires were routed into the next compartment where I was able to access a hole Tiffin had drilled thru the outside wall of the coach to route the power leads for the door awning. After removing the top half of the panel I was able to access the inside coach wall where Tiffin drilled thru the wall to route the awning wiring.

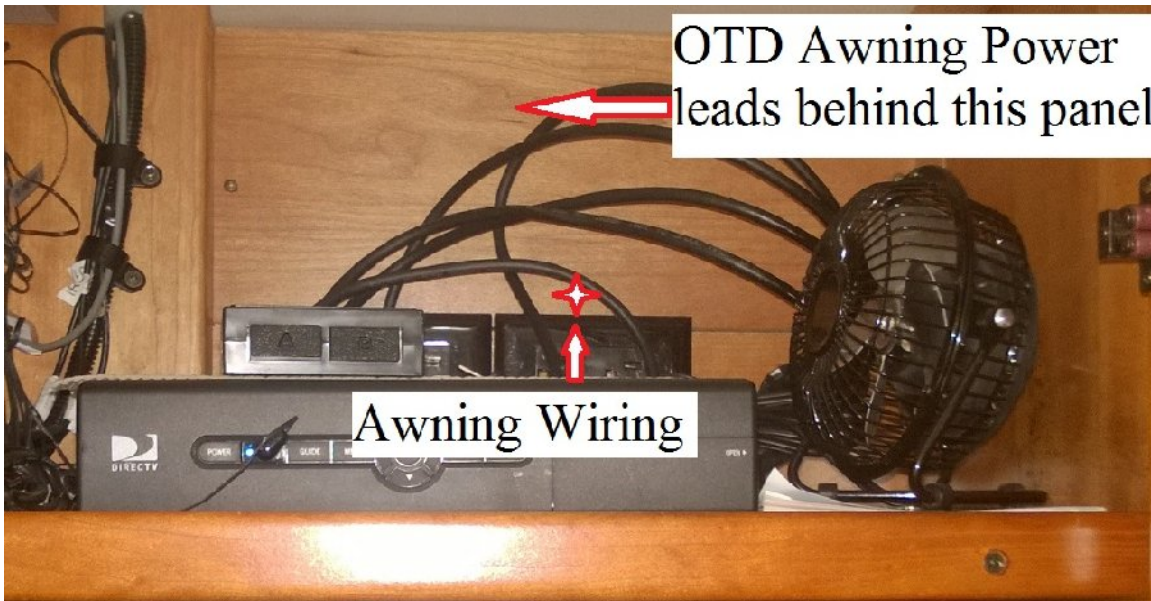
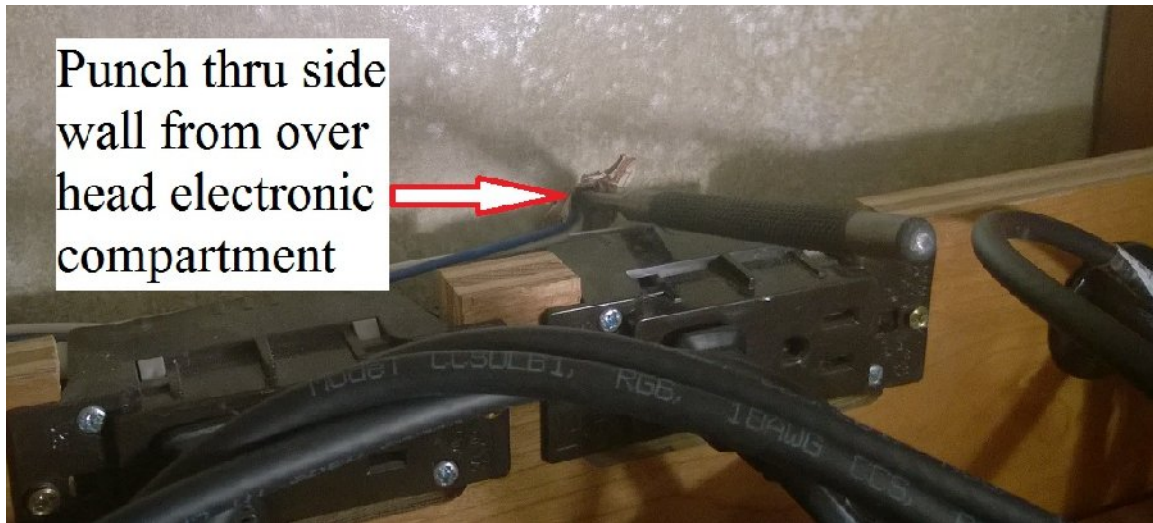
As seen above a pin punch was driven thru the hole drilled in the wall for the awning wiring. Care was taken making sure the punch did not damage the door awning wiring. Tiffin used some form of hard rubber to seal the hole drilled thru the wall. Every time the punch was removed the hole would attempt to re-seal itself.

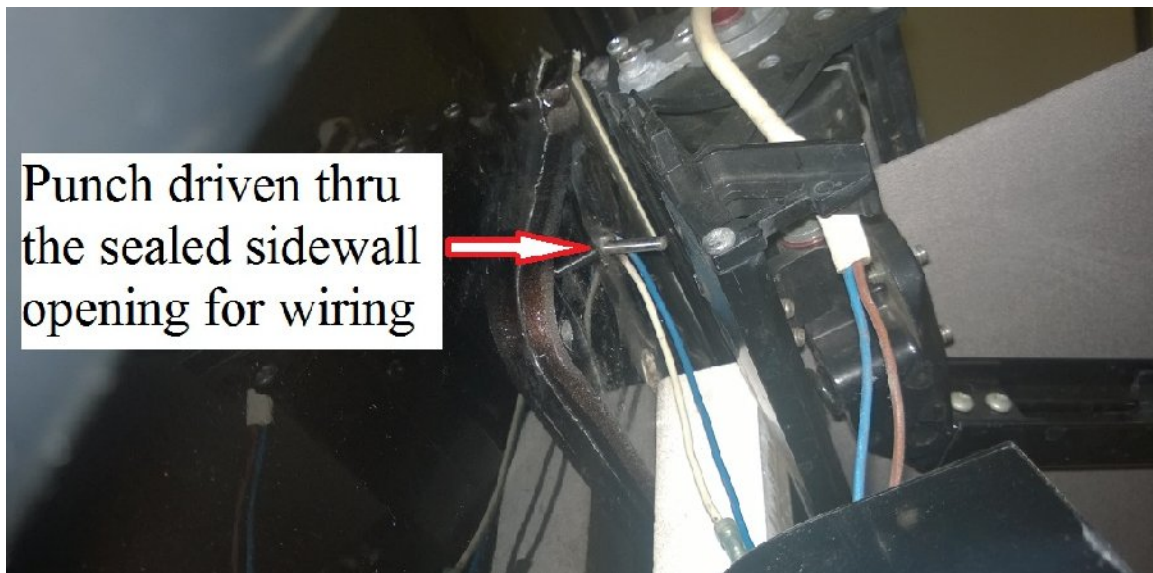
Finally able to push a twin lead 22 gauge zip wire thru the hole where the wiring was connected to a 48 inch section of high intensity LED lighting. The twin lead zip wire was carefully attached to the top of one set of awning arms with aluminum foil tape to prevent damage to the wiring when the awning was opened or closed.

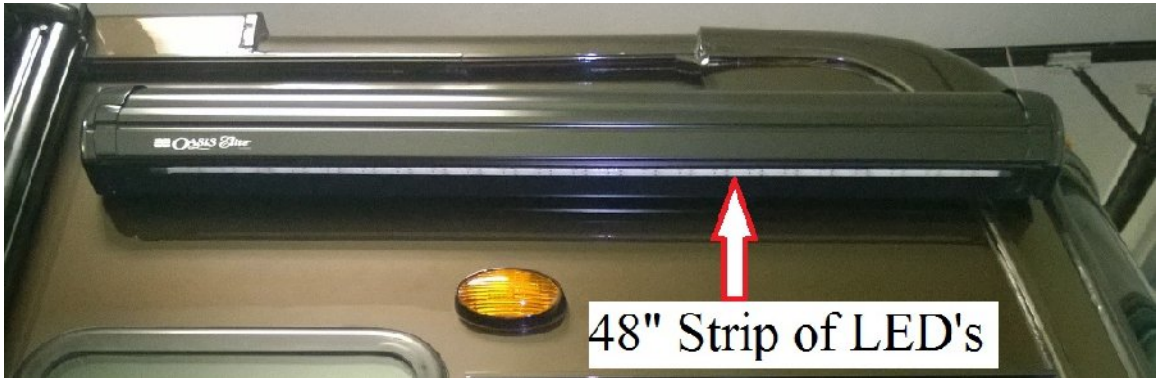
The 48 inch section of LEDs has 3M tape adhered to the LED strip allowing the strip to be stuck to the bottom of the aluminum awning housing.

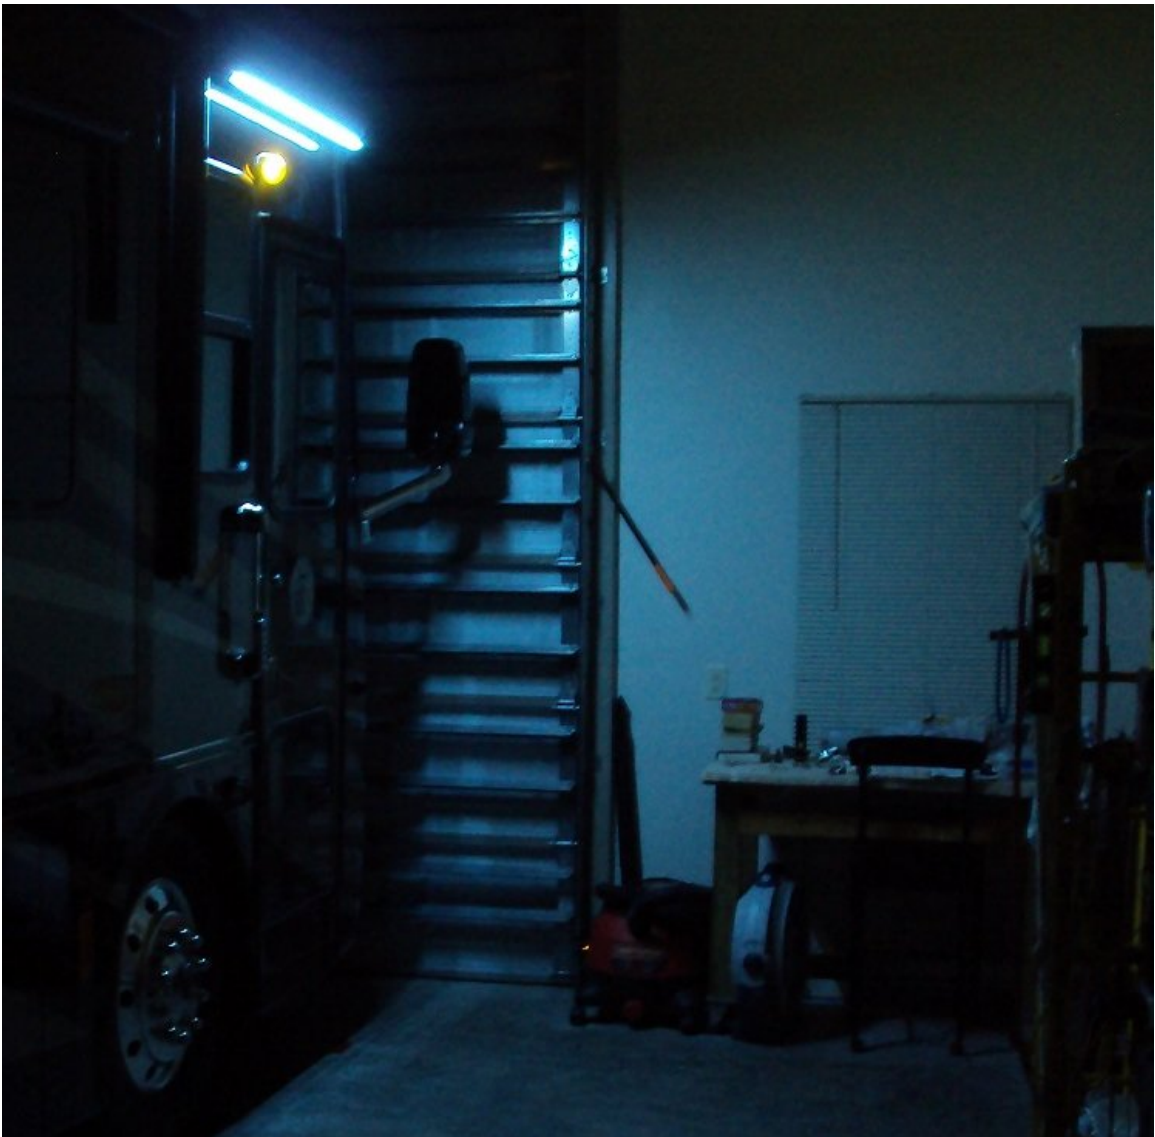
As seen below even with the modification 101 – Interior and Exterior Step Lighting turned OFF there is plenty of lighting around the door of the coach.
