2010 43QGP Allegro Bus

ONE-HUNDRED-SEVENTEENTH - coach modification – **HALF BATH WALL ANCHOR**. Tiffin on coaches with a half bath anchors the top of the wall to the ceiling and the bottom of the wall to the floor preventing the wall from moving, well most of the time the wall does not move. Tiffin worked on the walls floor anchor a couple of different times the first year of ownership. Each FIX would work for a while before working loose, when that happened the bath room door would swing open and crash against the countertop of the galley slide while driving, this usually happened while driving in the mountains while taking curves going up or down.

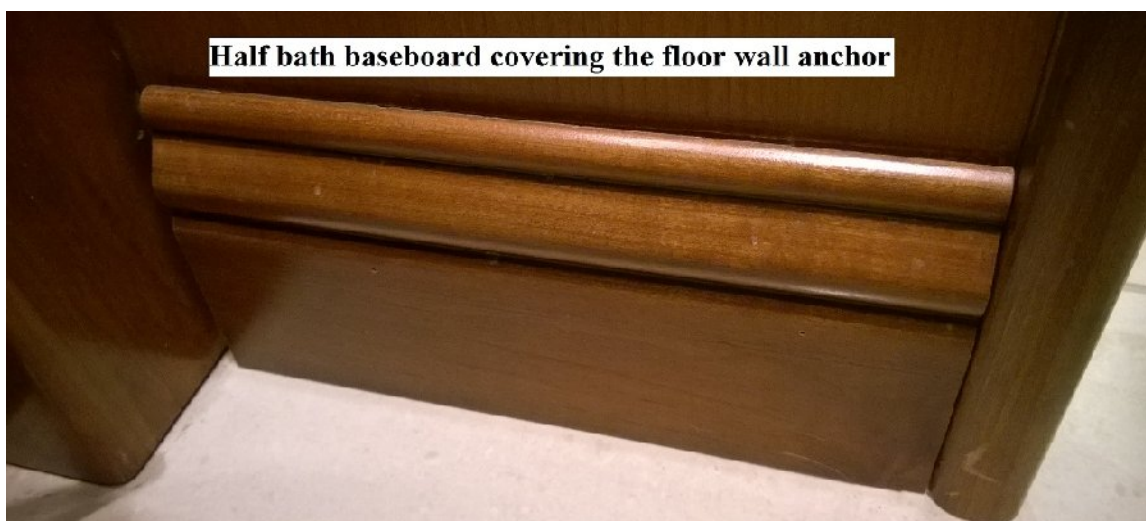
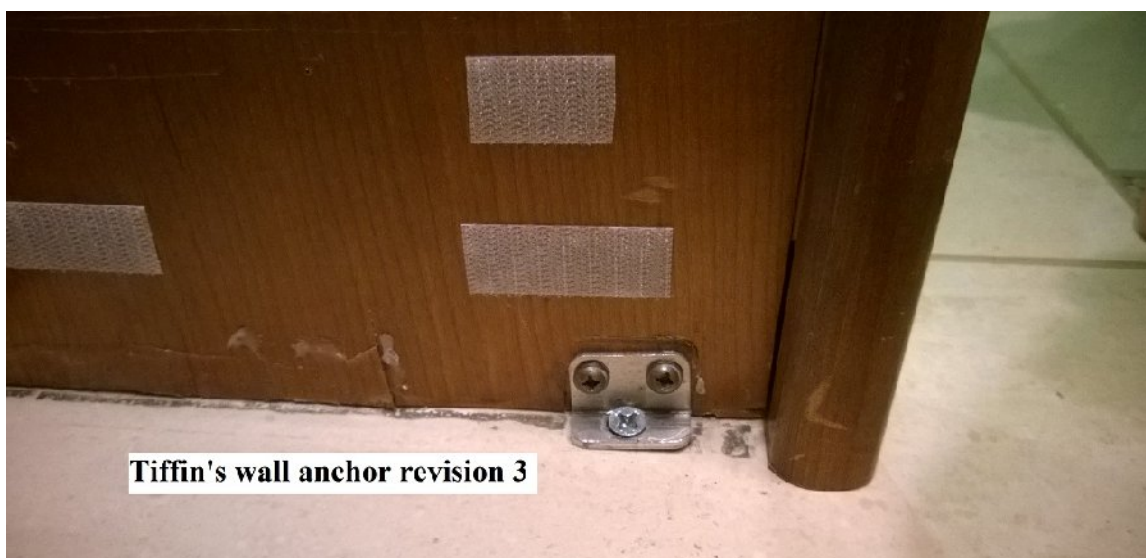
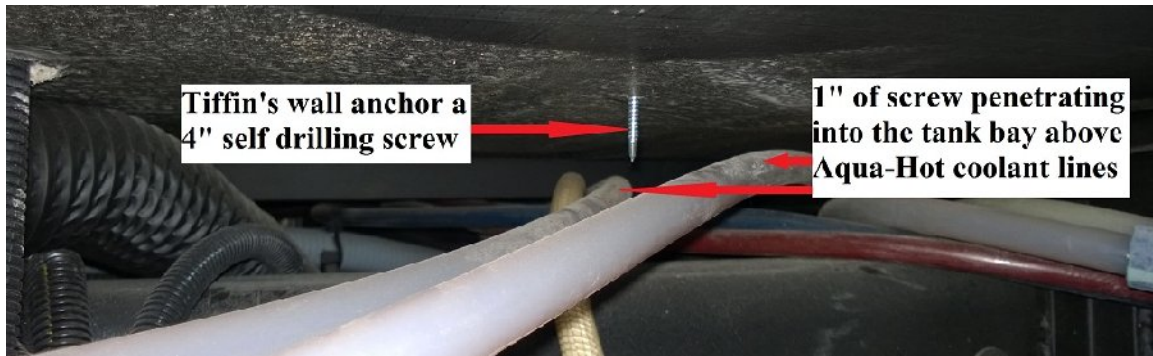
The first time Tiffin's service center tech replaced the original wall anchor screw he increased the diameter of the screw. Over time that screw loosened allowing the wall to move which allowed the door to pop open when the coach chassis flexed while driving.

The next attempt increased the length of the wall screw as shown above, the floor panel is 3 inches thick allowing one inch of the screw to project into the tank bay also shown above.

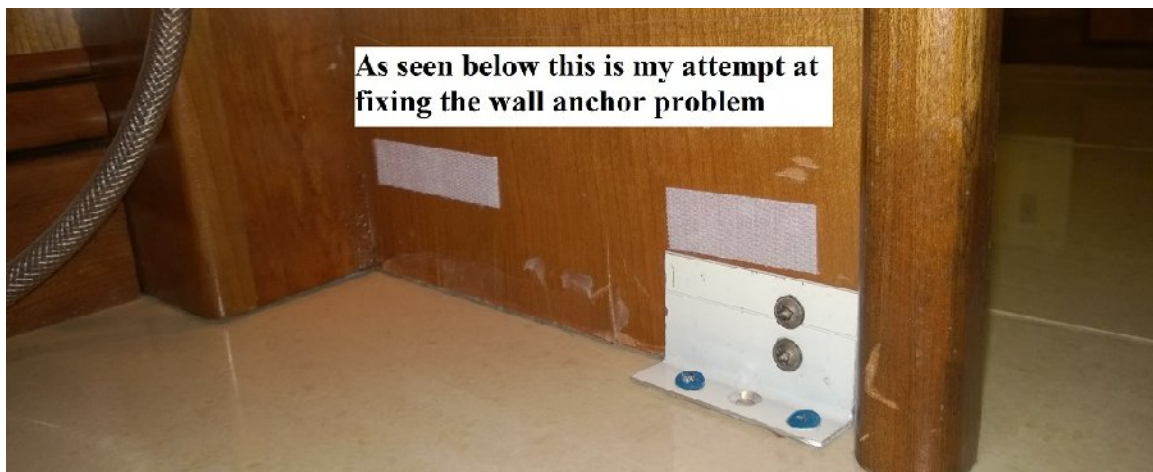
The above is my attempt at correcting the wall moving problem. The hole thru the floor for the Tiffin installed self-tapping screw was plugged. A new piece of aluminum was cut then fabricated to anchor to both the wall and the floor with two attachment points. The wall screws were not hard to install however the floor anchors were another story. One inch long TapCon screws were used the screws require a 5/32" hole drilled thru the tile before screwing the TapCon into the tile. Believe me the tile is hard before both holes were drilled the tile burned up one bit requiring a second bit to finish the holes.

Previous to this modification the baseboard had been removed so many times Velcro was used to prevent using more nails.
