2010 43QGP Allegro Bus

ONE-HUNDRED-TWENTY-FIRST - coach modification –
GENERATOR COOLANT DRAINING. Our coach was manufactured during January 2010 that makes the generators coolant six years old at this time. Decided it was time to drain, flush and pour in new coolant. In an effort to keep as many liquids the same between the coach's engines (coach and generator) I decided to use Cat ELC, this coolant is comparable with the Shell Rotella ELC coolant Tiffin used in our Cummins ISL9 engine and the Cat ELC coolant is easy to find. Our coach has a 10KW Onan generator many Tiffin owners have the same generator. First order of business, locate the generators coolant drain plug.

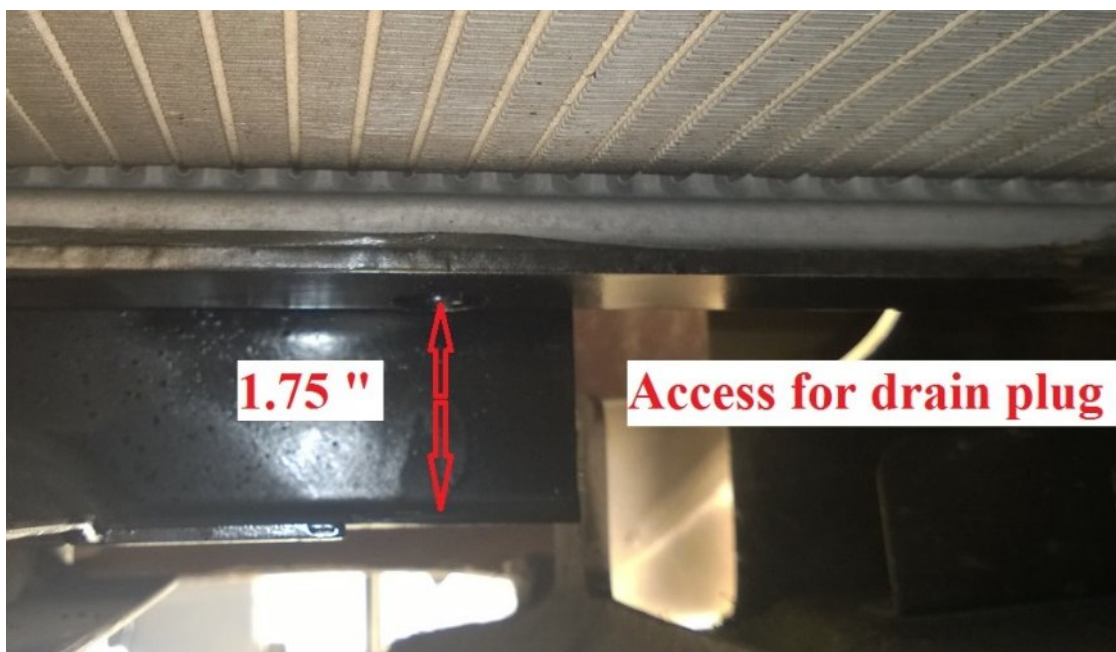
I found the drain plug however the drain plug is inaccessible until modifications are made for access. Tiffin mounted a pair of angle rails under the sides of the generator the angle rails are used to support the generator, and also enable the generator to be extended out of and retracted into the front cap. As stated I found the drain, however at least on our unit the drain is not accessible without making a modification to gain access to the plug. As seen in the photo the angled metal leaves only 1 3/4" access to the drain plug.

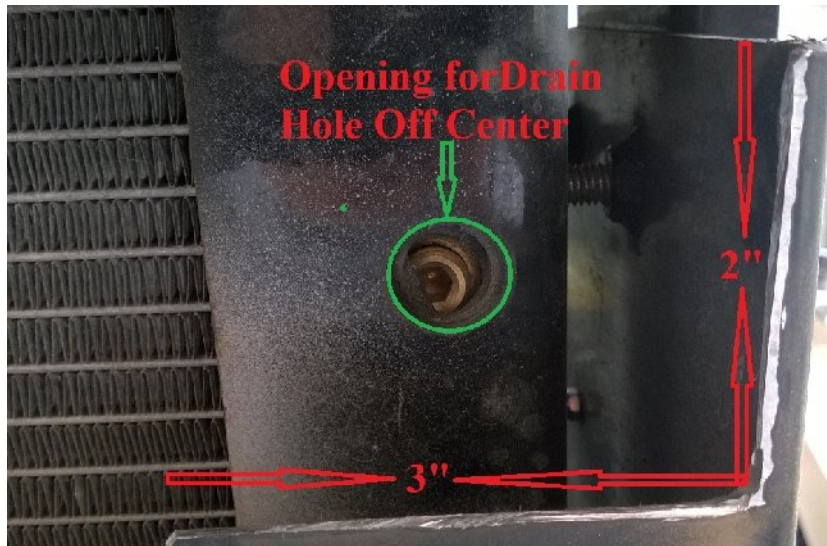
The angled metal prevents access to the ¼” hex brass drain plug, actually with the angle metal in place, not only could I not see the drain plug I would not have been able to remove the plug because the access hole cut into the angle metal was not centered under the plug. I could not see that problem before cutting and removing a 2” x 3” piece of the angle from the support. The 2 inch and 3 inch cuts can be seen in the below photo.

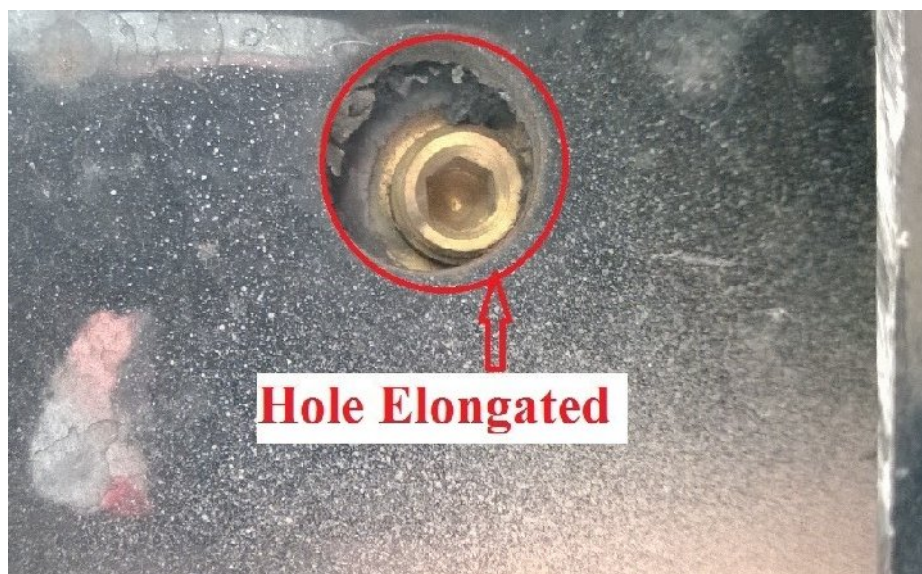
Tiffin installed rubber foam between the generator and the two angle metal pieces this acts as a vibration cushion, a small razor knife was used to cut away excess rubber that was blocking access to the plug. At this point I found the drain plug was offset from the hole in the angled metal making plug removal impossible without first enlarging or elongating the original hole, elected rather than drilling a larger hole to just elongate the original.

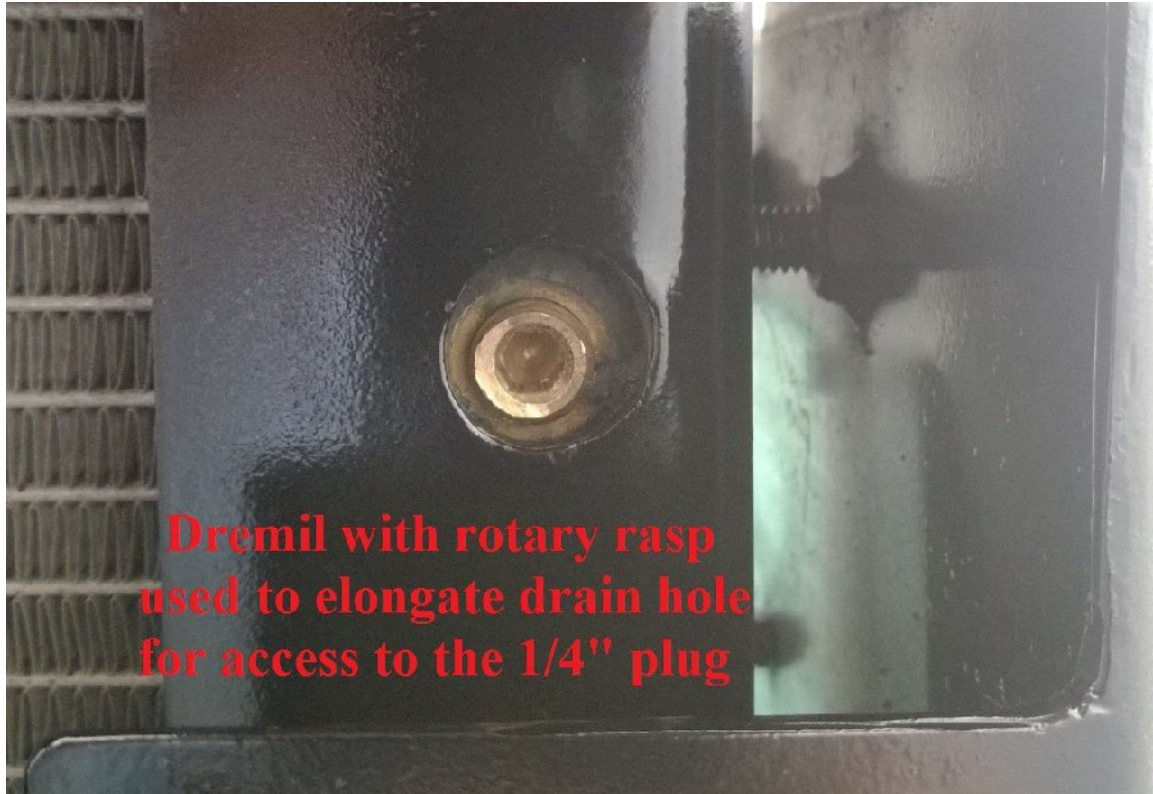
Decided the easy method would be to use a 1/8" dermal with a rotary rasp, the original hole was elongated which allowed access for removal of the drain plug.

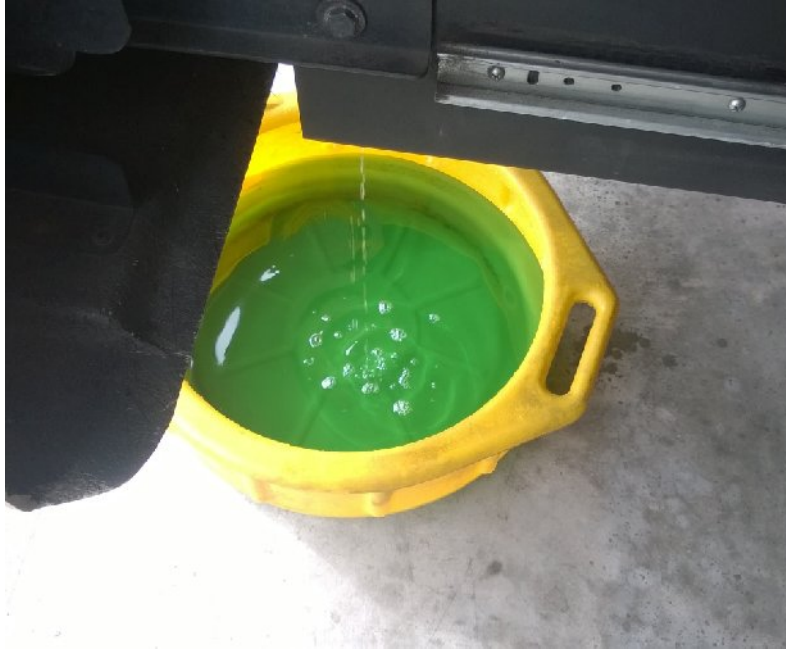
After removing the plug the generators radiator cap was pulled out of its mount, the cap was removed along with removing the drain plug. The long hose between the radiator cap and the radiator has to be pulled up and kept STRAIGHT otherwise there will be a kink in the hose, coolant will not be able to drain nor will the coolant be able to get past the kink in the hose to fill the radiator. After draining the original green coolant, the plug was reinserted enough to contain about 6 quarts of tap water. The generator was started and allowed to run long enough to slightly warm circulating the water which was used to flush the cooling jacket of the generators engine. After warming the engine the flushing water was drained. I ran three flushing cycles using tap water before using DISTILLED water as a final flush of the coolant system. The generators coolant reservoir was filled and flushed at the same time as the radiator. After the distilled water had drained from the generator's radiator the drain plug was installed and tightened. As previously stated when pouring in new coolant the hose needs to be pulled up and out to prevent a kink in the hose, a kink will prevent the

complete refilling of the radiator. There are two small hoses connected to the radiator fill fitting, one hose is connected to the top of the engine's coolant jacket this hose allows air to be purged from the engine when pouring in new coolant. The second hose is connected to the coolant reservoir depending on the temperature of the engine, coolant will be pulled into the engine for cooling or purged back into the coolant reservoir as the coolant expands while the engine is running.
