2010 43QGP Allegro Bus

ONE-HUNDRED-TWENTY-SECOND - coach modification – **DASH HEATER HOSE INSULATION.** In a continuing effort to get as much hot engine coolant to the dash of our coach both heater hoses were recently insulated.

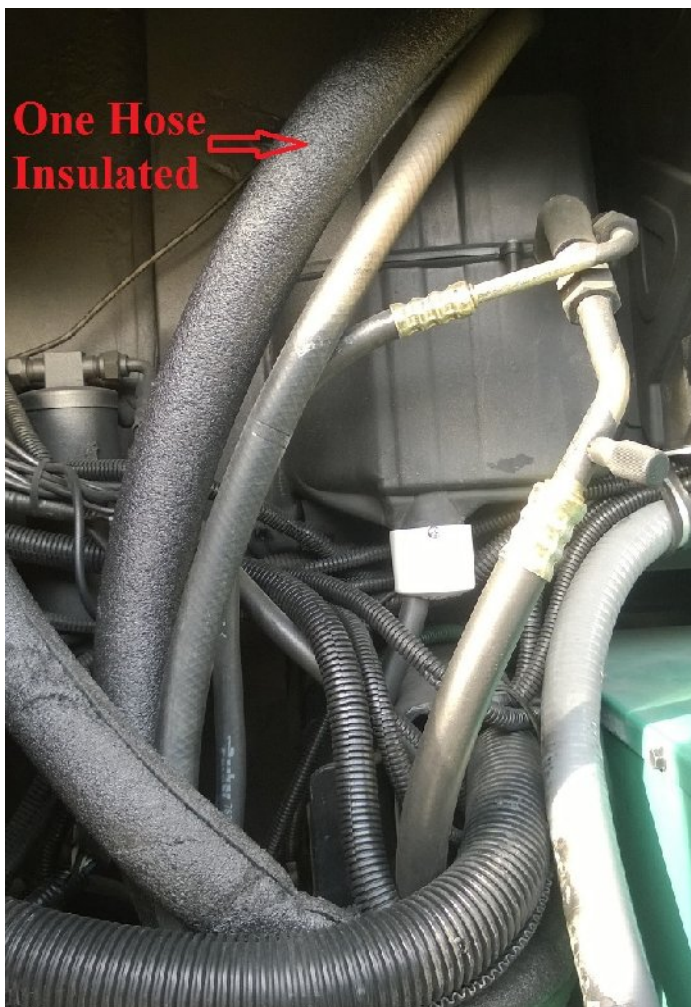
Heater hoses on our Powerglide chassis are 1" OD hoses, 1" pipe insulation with sealing tape were installed over both front cap heater hose's before the sealing tape was removed, after both side of sealing tape were removed the two sides of the insulation seal together making a permanent seal around the hose.

The below photo was taken after one of the two dash heater hoses had been insulated.

The second hose had the same insulation installed; both hoses were insulated as far back toward the engine as physically possible. At the bottom of the first photo four heater hoses along with several large electrical looms are routed thru the open chassis frame channel between the generator and right chassis frame.

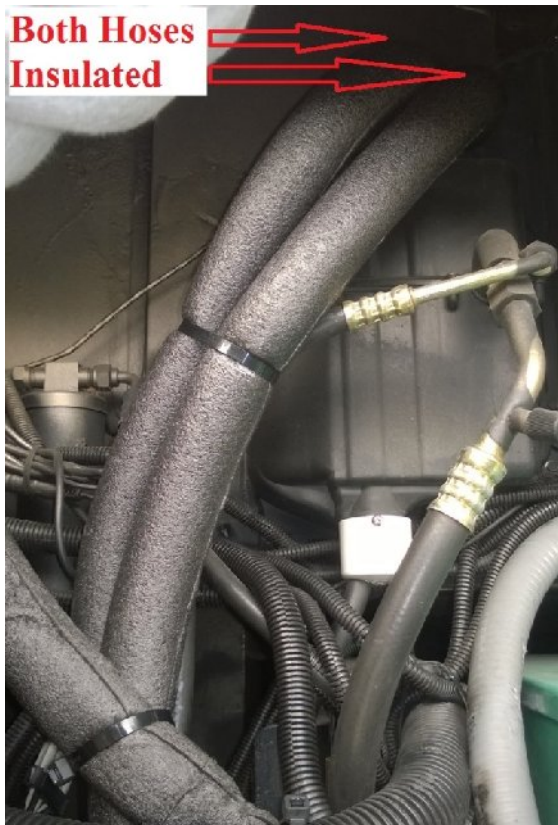
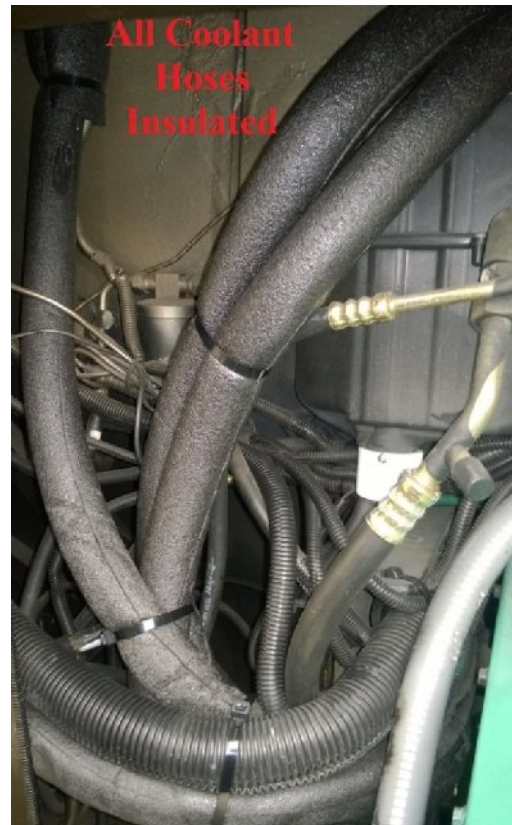
After the hoses had been insulated large zip ties were used to secure all four hoses and wiring looms tight against the inside of the chassis frame.

Securing the hoses and wiring is necessary to prevent damage to either the hoses or wiring when the generator slide is extended or when the generator slide is closed.
