2010 43QGP Allegro Bus

ONE-HUNDRED-TWENTY-FIFTH - coach modification – MODIFICATION TO PREVENT COACH STEP SHOULDER BOLT FROM BREAKING.

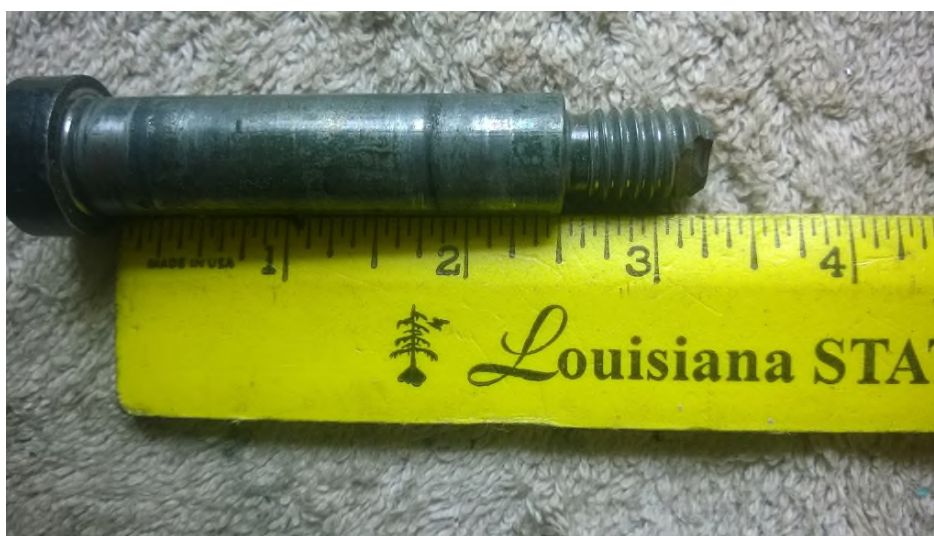
The above photo is the Shoulder Bolt from our coach. It is easy to see how the metal has been scoured over the years this photo was taken after the bolt had been cleaned to remove sand and rust from five years of use. The tack weld used to secure the bolt had broken many years ago, since that time I checked and tightened the bolt when needed.

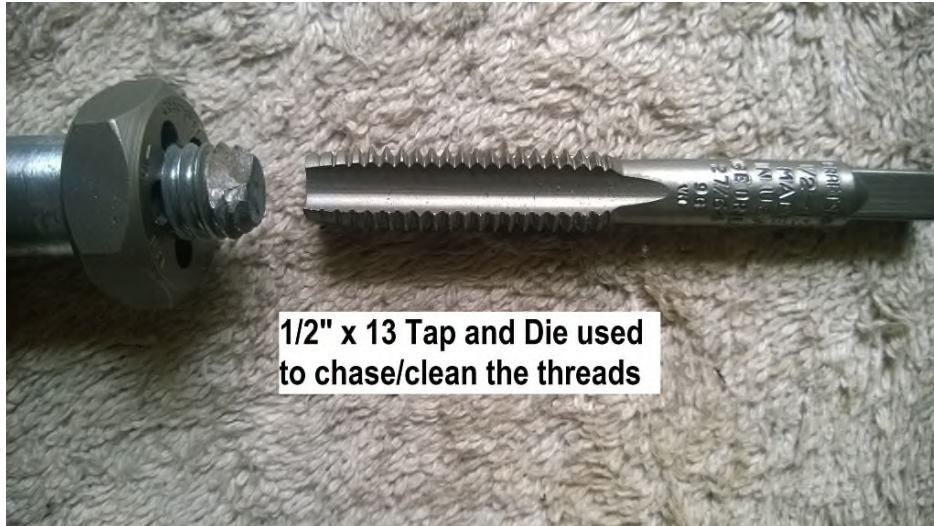
1/2" x 13 Tap and Die used to chase/clean the threads

After removing the shoulder bolt, fan gear and step motor the Coach Step mount was thoroughly cleaned before running a 1/2" x 13 tap thru the shoulder bolt mounting hole this was done to clean the threads. The threads on the shoulder bolt were first cleaned with a wire brush then chased with a 1/2" x 13 die to finish cleaning the bolts threads.

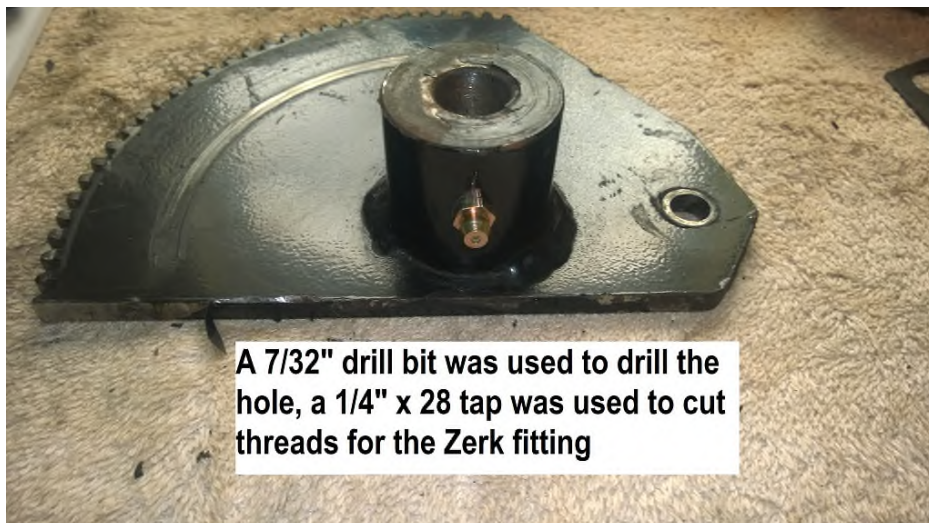
A 7/32" drill bit was used to drill the hole, a 1/4" x 28 tap was used to cut threads for the Zerk fitting

The fan gear was installed in my six position 6" vise mounted to a 17 speed drill press. After leveling the fan gear in horizontal and vertical planes a 7/32" hole was drilled equidistant thru the side of the shoulder bolts mount. After the hole had been drilled a 1/4" x 28 TPI (threads per inch) tap was used to create threads so a Zerk fitting could be installed thus allowing the shoulder bolt and its mount to be lubricated.

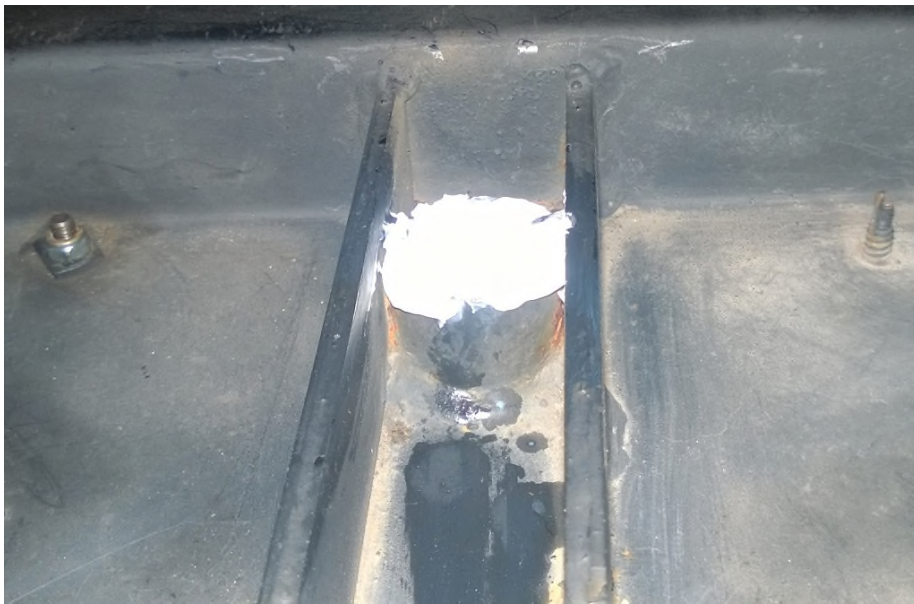
grit that was allowed entry into the cavity between shoulder bolt and fan gear mount. How does it enter it appears over time the shoulder bolt threads allow water, sand and other grit to move down the threads into the shoulder bolt cavity where it plays havoc with the shoulder bolt.

In an effort to prevent water, dirt or other debris from entering the shoulder bolt cavity by slipping past the bolt threads I sealed the top of the bolt threads with clear silicone, I know when CURED the silicone will be clear.
