## 2010 43QGP Allegro Bus

**ONE-HUNDRED-TWENTY-EIGHTH - coach modification – LAMINATE FLOORING IN THE BEDROOM.** After five years the bedroom carpet was beginning to look a little used, especially where the bottom of the bed box dug across the carpet when the bed retracted.

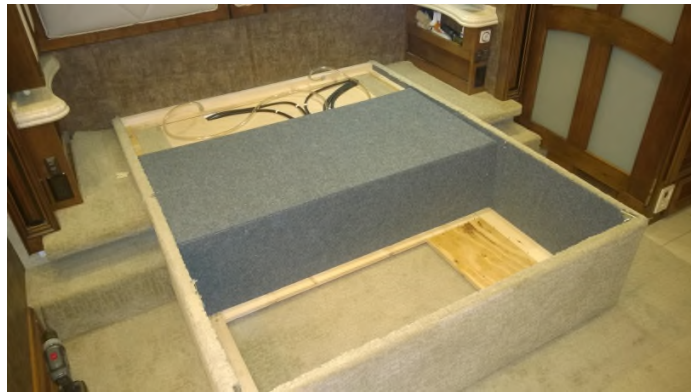
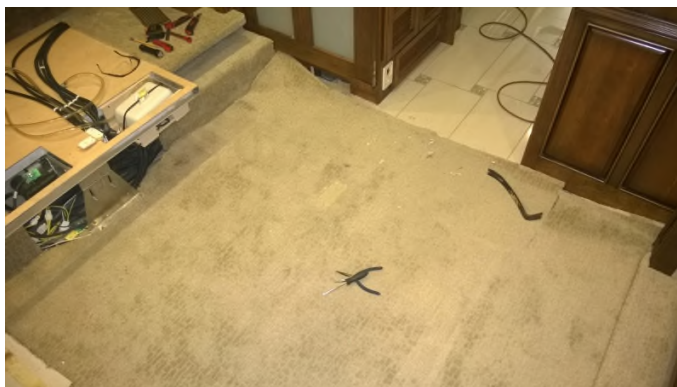
After looking thru the photos, decided to skip showing photos of bed, mattress, bed board, hinge and top board. Rather the photo shows the results of disassembly of those items. Next item to be removed was the portion of bed box covering the

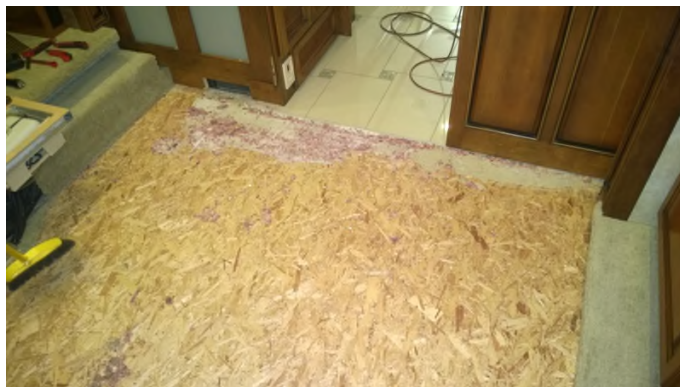
carpet under the bed. After we got to this part the work began as there was no turning back after the carpet was cut into pieces for removal. After the carpet had been removed we discovered where water had leaked past the DS slide gasket and ran onto the

flooring causing a small area of mildew to grow. After treating the area the next work was to remove the 1/2" of grout on top of the OSB near the hall. An area of about 6 square feet took many hours, working with an oscillating saw, belt sander, along with a chisel and hammer to remove the excess grout making a smooth surface.

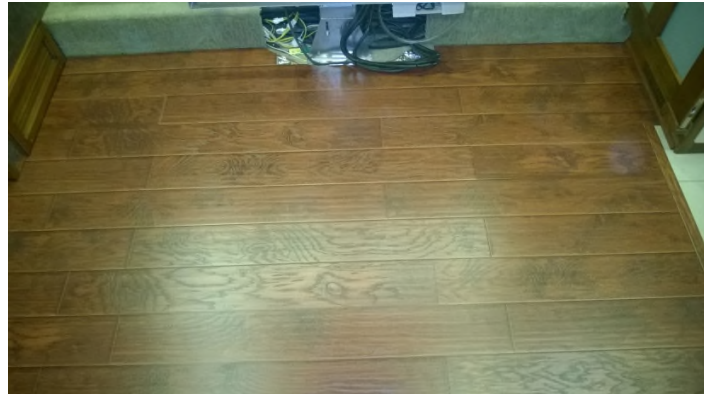
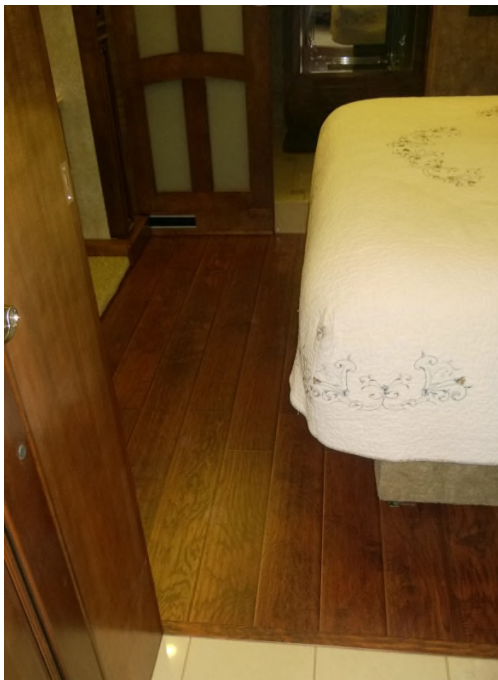
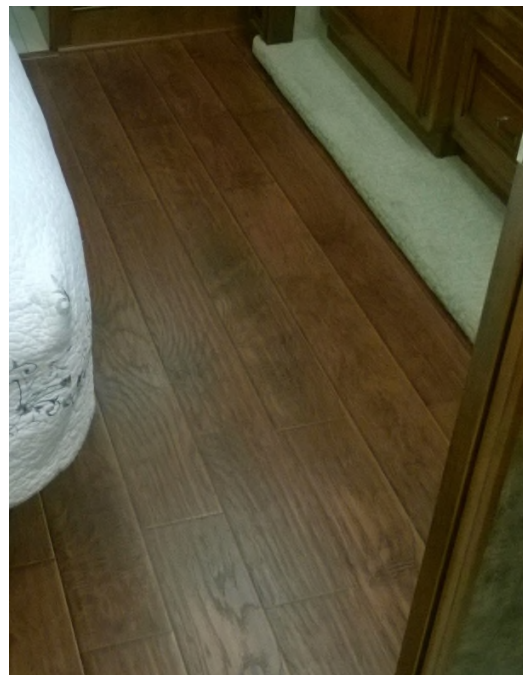
coach bedroom carpet with the same flooring. The flooring is a 14.3 mm thick laminate purchased from Sam's Club by the name Canyon Oak.

Total square footage was a little over 61 Sq. Ft. Ripping out the old carpet and padding, cleaning everything off the OSB flooring, installing underlayment and the new laminate turned into a really loooong two day project.
