New 4/0 Power Cable for the 12 Volt Fuse Panel

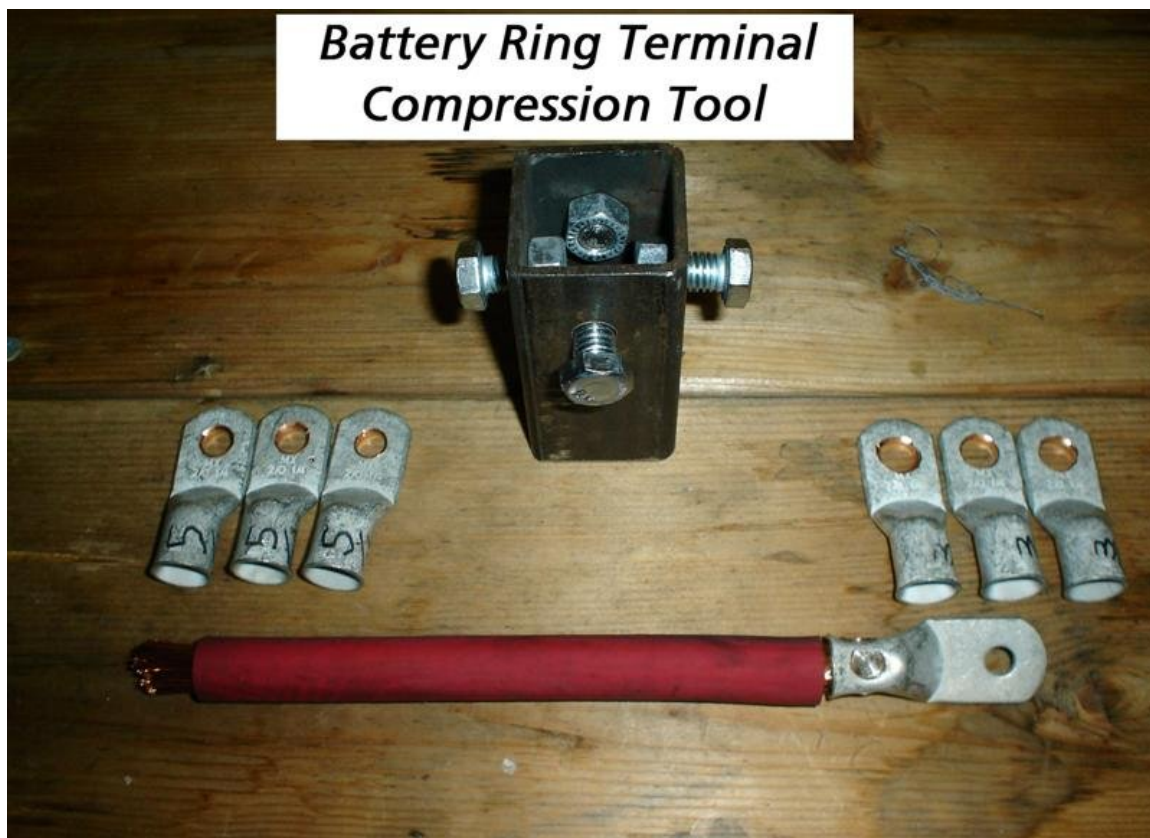
After checking various websites the best price found was at auction on E-bay from Trystar cable this company auctions on E-bay under the name coppercableman. I bid on and won 50 feet of RED 4/0 welding cable at that point not knowing the length of cable needed to complete this project. The only other components needed were the compression type 4/0 battery ring terminals. I bid and won those terminals on E-bay, I purchased a dozen terminals again not knowing how many would be needed for the complete project. I did not have a compression tool which is necessary for installing the compression ring terminals on the 4/0 cables. This problem was overcome by building my own ring terminal compression tool.

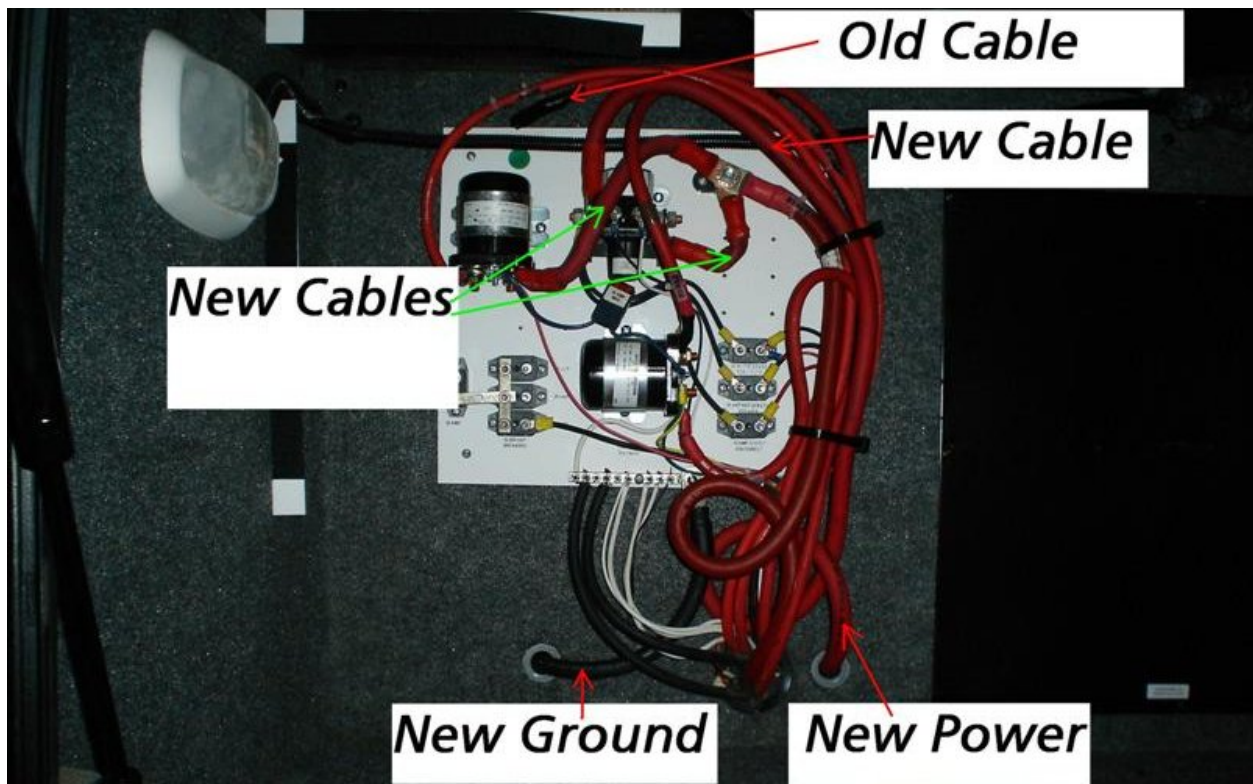
Below is a picture of the passenger side rear compartment on my 2007 40QSH Phaeton. Tiffin installed a # 4 RED cable from the 4/0 Coach Battery power terminal on the upper right corner of the panel to the Fuse panel solenoid (center

top of panel) then installed a second jumper from that point to the second solenoid (Drivers Side Front Slide Motor) in the upper left corner of the panel.

This created a huge voltage loss at the fuse panel when the driver's side slide was being operated. I removed those two # 4 jumpers and replaced them with two new 4/0 power cables (seen in above picture) both cables are connected to the coach battery power terminal and then one cable is run to each solenoid.

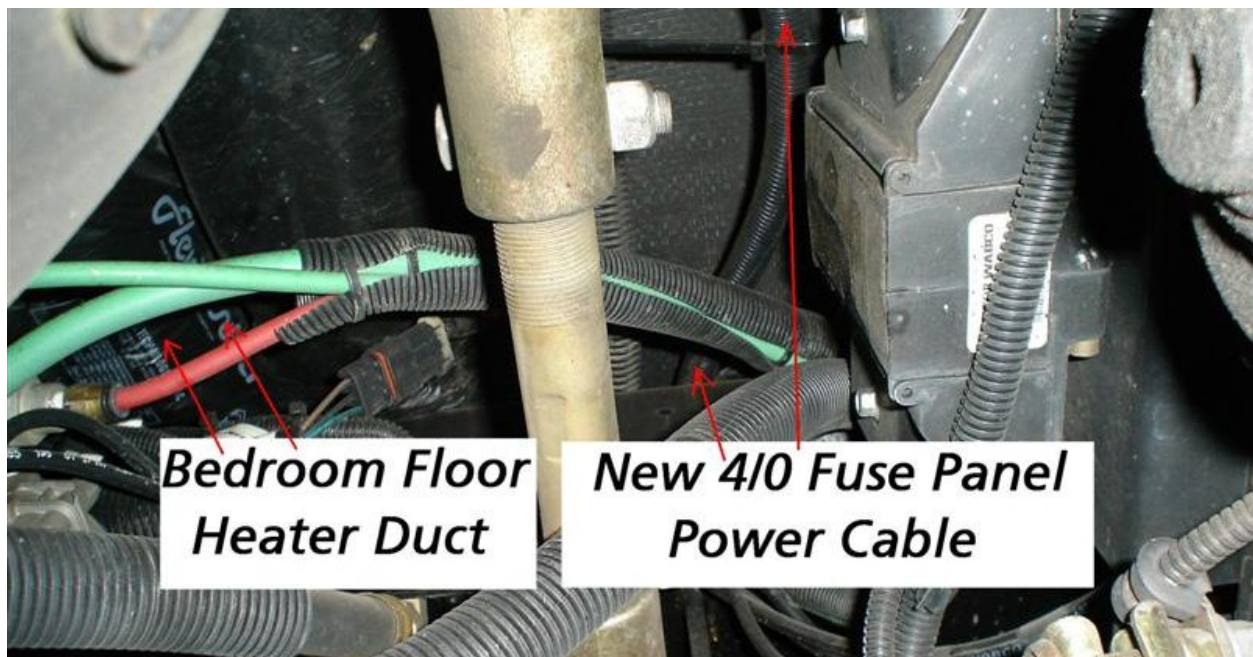
All new cables is encased in convoluted wire loom to protect against damage and tied to other cables or frame components to prevent movement. In the above picture the cable was routed into the area between the two frame rails over the coach rear axle and through a hole left by Tiffin when they installed the two bedroom floor duct insulated hoses.

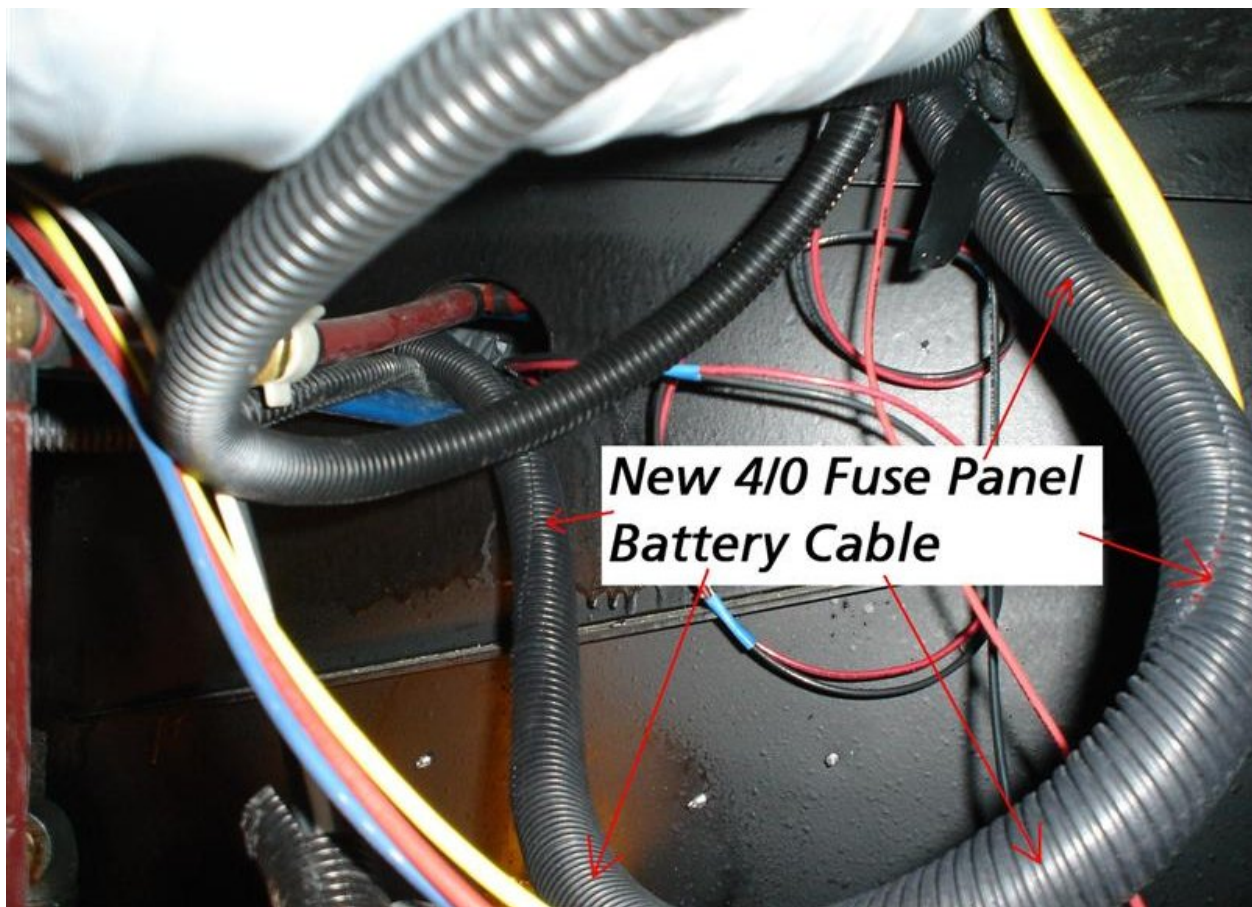
The next picture is of the new cable in its loom with a foot or so of slack in the event I need additional cable in the future. You can see where the cable enters the water heater compartment along with the hot and cold water lines connected to the water heater and water heater expansion tank and exits through the ceiling.

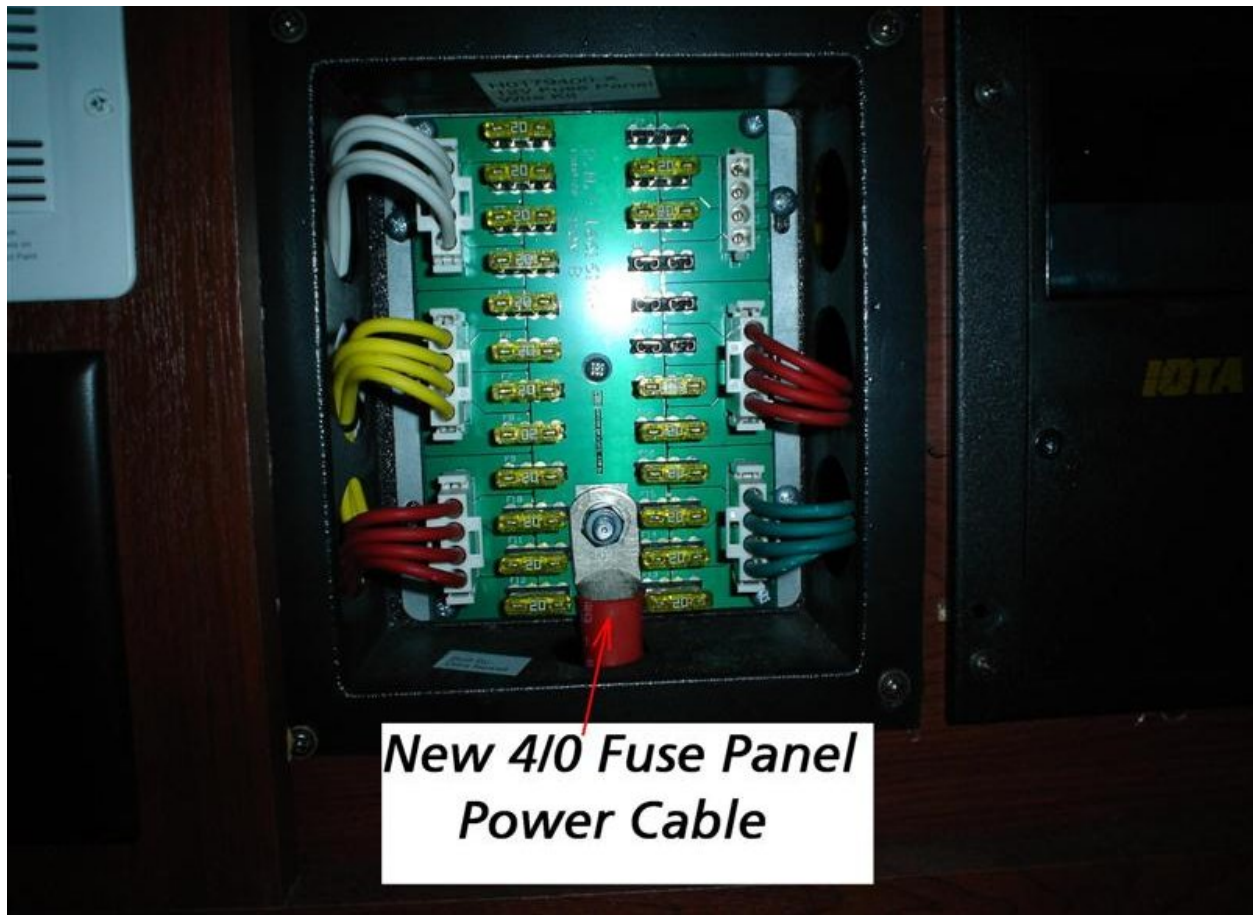
I routed the cable under the refrigerator and into the bottom of the 12 volt fuse panel as seen in the below picture. Each compression terminal is covered and protected by a piece of heavy duty red heat shrink.

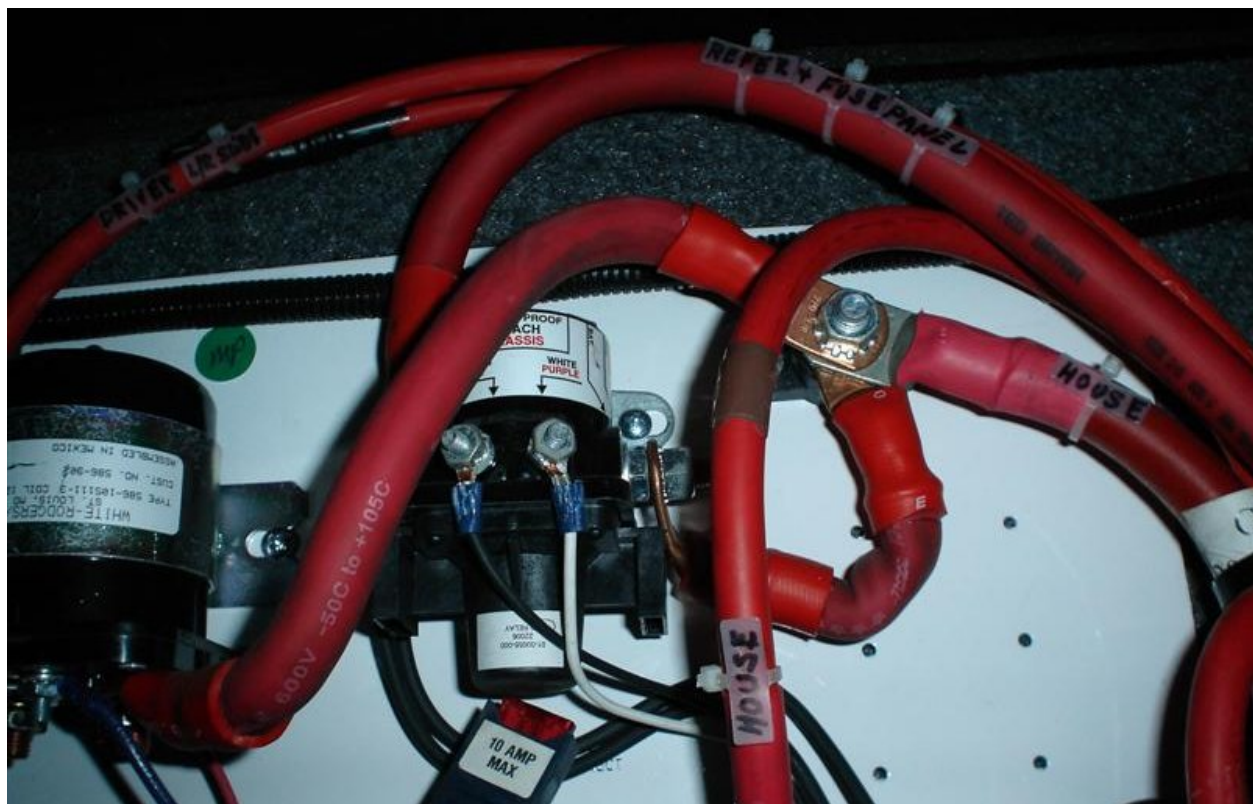
The opposite end of the new 4/0 cable attached to 12 volt power solenoid. Notice the two new 4/0 cables providing power from the house batteries to the solenoids.
