# White-Rogers Solenoid Problems

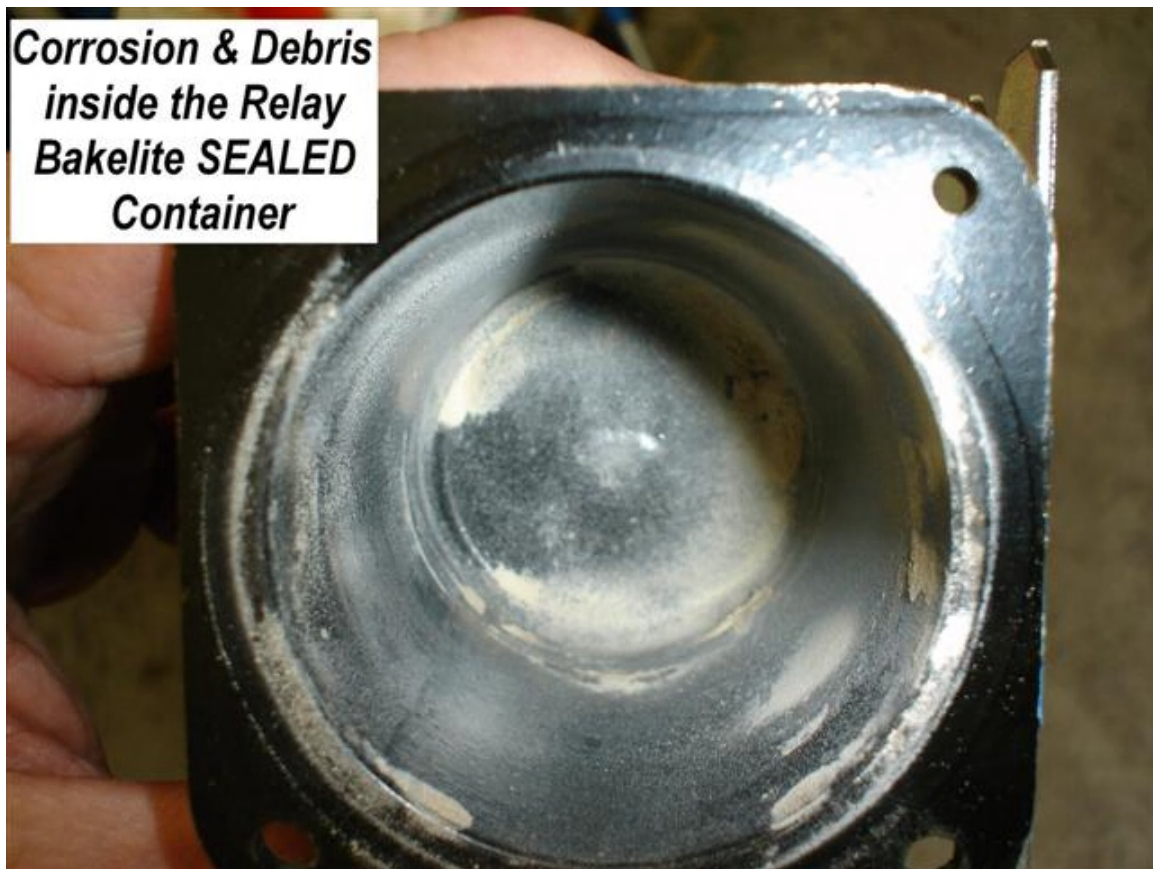
While traveling to Red Bay last year, our motor home intermittently stopped charging the house/coach batteries while underway. I reported the problem to Tiffin who told me it was the "Charging Solenoid" and gave me another solenoid to replace the intermittent one with. I replaced the old solenoid and everything was OK until last weekend, when the charging solenoid began to once again intermittently charge and not charge while on the road. I resorted to hitting the solenoid with my rubber mallet to get its attention a couple of times until we were able to get back home. Once home I decide to disassemble my old spare solenoid in hopes of finding a repairable problem.

Disassembly of the two part Bakelite sealed container requires the removal of four pop rivets holding the solenoid together. I drilled the four pop rivets out with a drill bit sized to allow re-assembly of the solenoid with # 8 x 32 stainless steel screws with Nylock nuts.

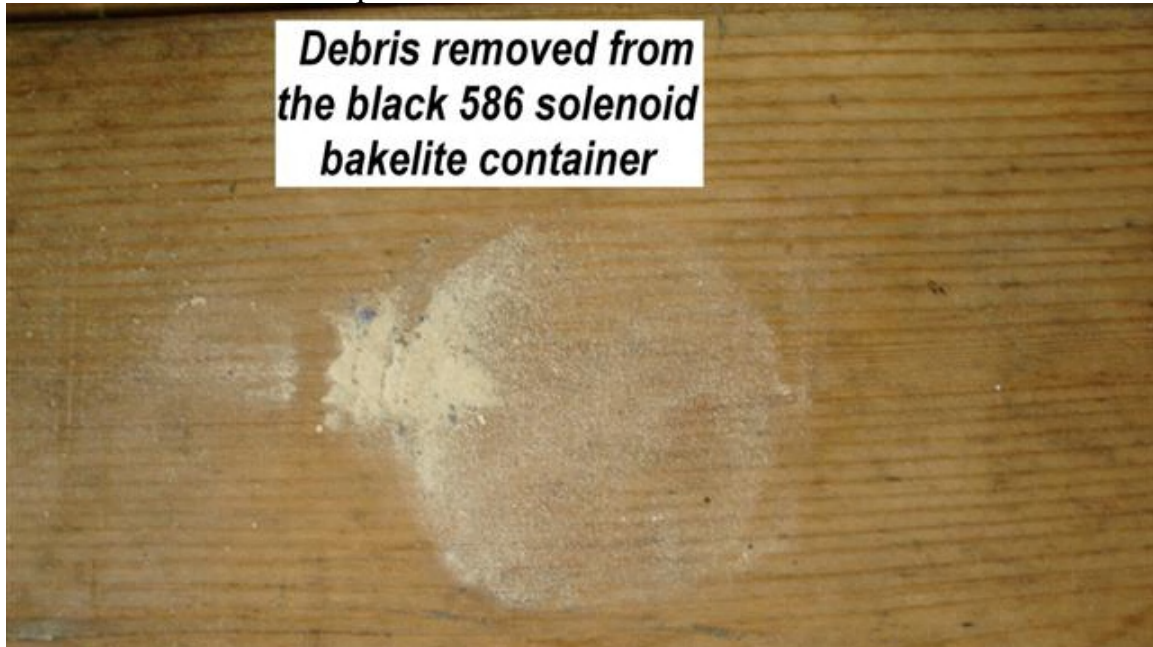
The following picture shows the amount of corrosion and debris removed from the SEALED assembly, the debris looked more like fine sawdust or

sand than anything else. After dumping most of the residue only a little effort was needed to wipe the inside of the Bakelite case clean.

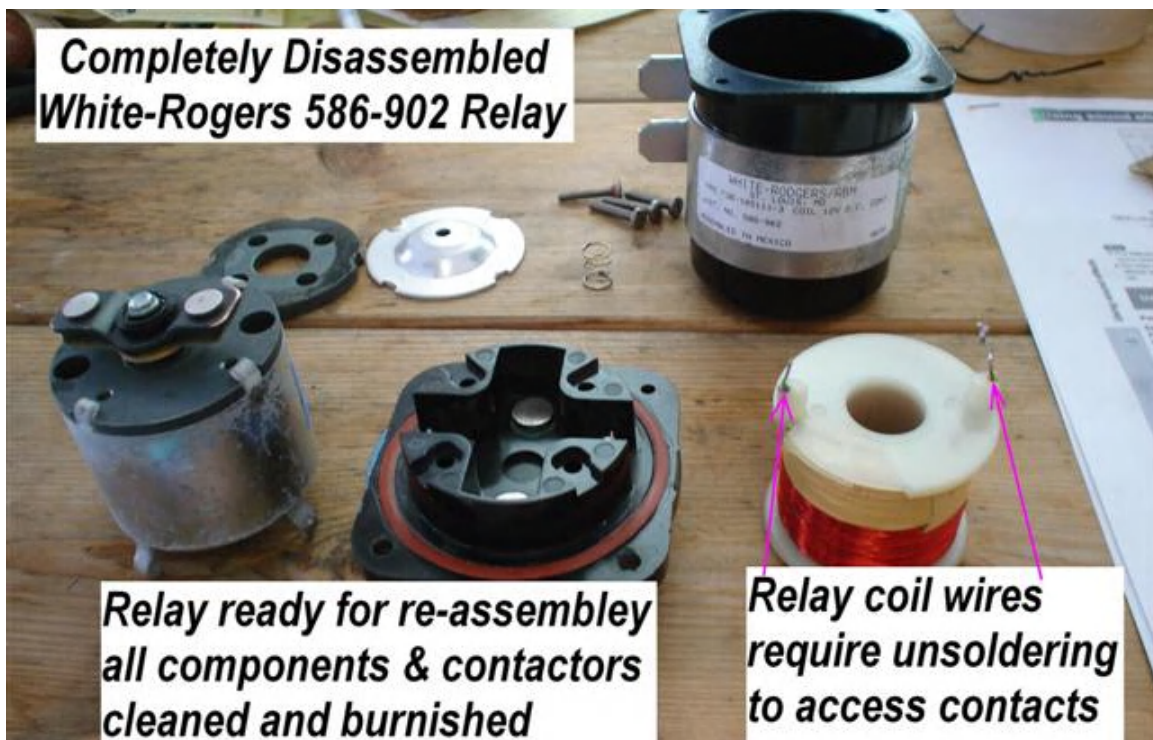
Looking at the above picture should be enough evidence as why the charging solenoid was intermittently charging the house/coach batteries. A little careful filing to clean the contacts then burnishing the contacts to remove any file marks while leaving a smooth surface as seen below.

Everything has been cleaned, burnished and is ready to be reassembled. Make sure to re-install the SPRING shown in the above picture between the two contact sets during reassembly. Slide the coil into place making sure to place the two coil wires so they can be re-soldered to the terminals. Install the four screws used to hold the electromagnet assembly to the terminal top portion. Now solder the two electromagnet coil wires to the terminal post set. Reinstall the bottom Bakelite case over the electromagnet, line up the four screw holes. Install the four # 8 x 32 stainless steel screws and Nylock nuts to complete the solenoid reassembly.

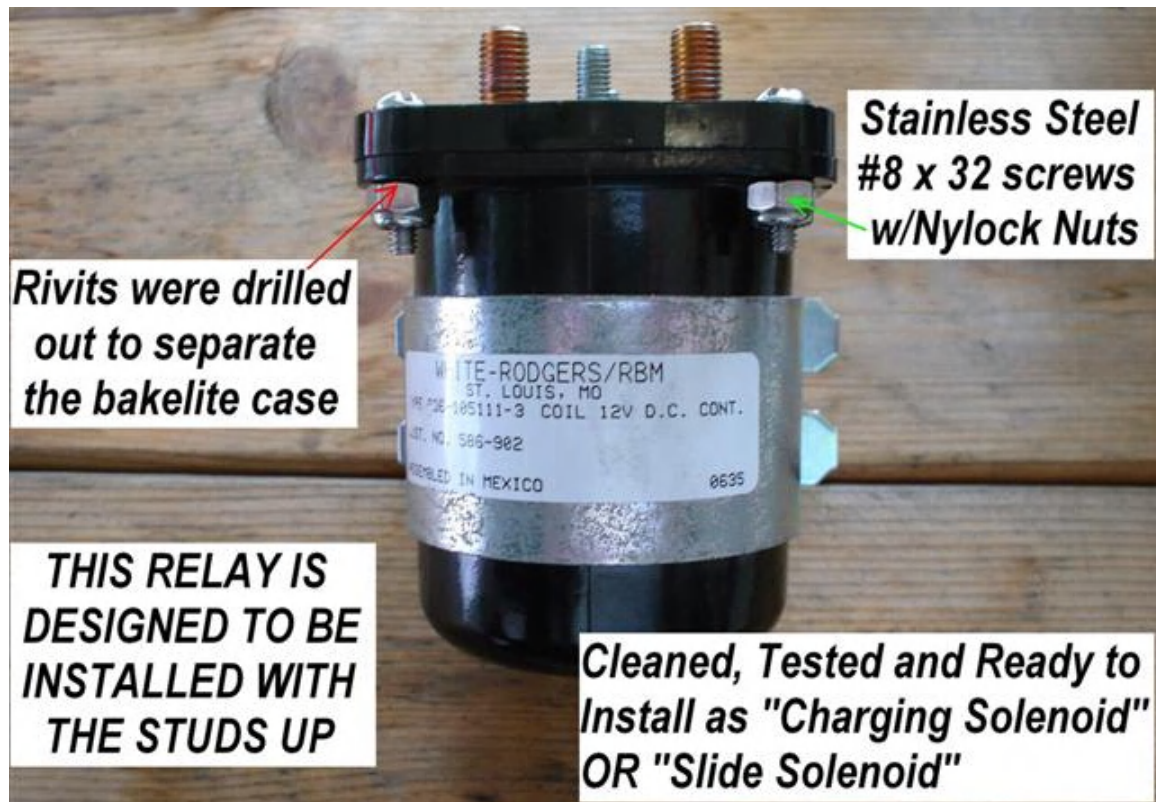
Both solenoids were tested with a 12 volt power source applied across the coil terminals and a resistance test across the two large contact posts. As already reported the solenoid was designed by White-Rogers to be mounted with the terminals pointed UP. After rebuilding both White-Rogers 586-902 solenoids, I installed one as a "Charging Solenoid" re-mounted in the vertical UP position on PS rear electrical panel my 2007 Phaeton, the second solenoid is stored onboard as a ready spare for use as either a Charging Solenoid or a Slide Solenoid.
