2010 43QGP Allegro Bus

12 – FYI – TIFFIN'S BEDROOM SLIDE FIBERGLASS REPAIR.

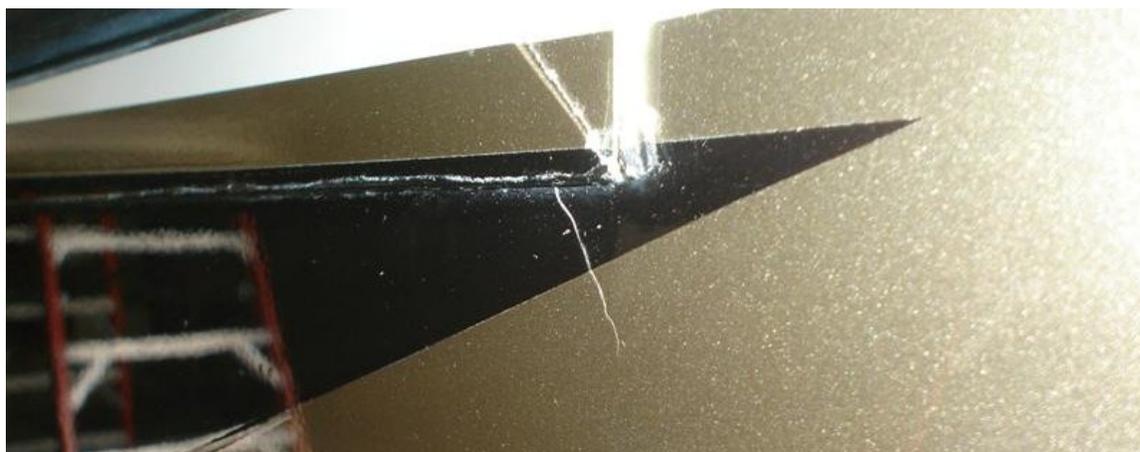
While sitting the weekend out in Red Bay a few weeks ago, I decided to clean the outside walls of the coach. I was sick when I found the INFAMOUS TIFFIN fiberglass crack under our bedroom slide.

We were already scheduled for some minor paint touch up, when I told Jimmy about the crack he made sure to get us in to take care of the crack. His statement, he would rather fix the crack with a 2 hour repair now than with an 8 hour repair later.

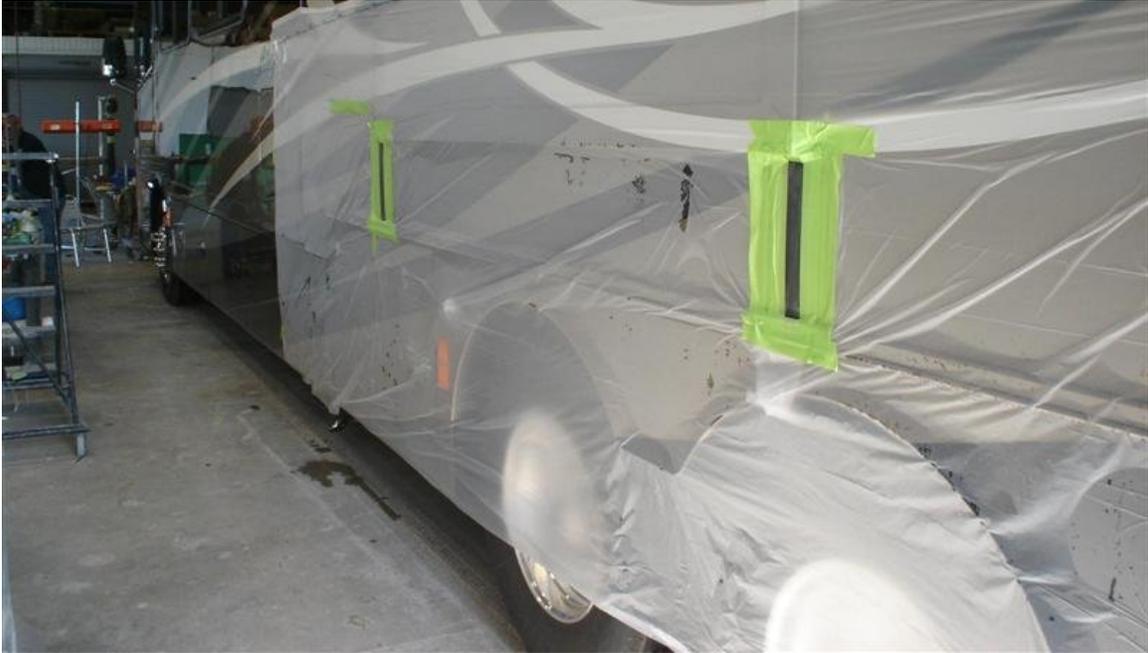
If we had our choice we would not have had the crack appear at all, however I believe this sidewall repair will take care of the cracking problem long term. We are happy our coach did not need nor was subjected to any trial and error metal structural repairs by Tiffin Motorhomes. We will take our coach back to Red Bay for additional repairs IF NECESSARY.

After attaching the trim strips, L.D. very carefully masked the surrounding area to protect other parts of the coach to prevent any paint overspray from being a problem when painting the multiple layers of color necessary to match the Rocky Mountain Brown coach colors.

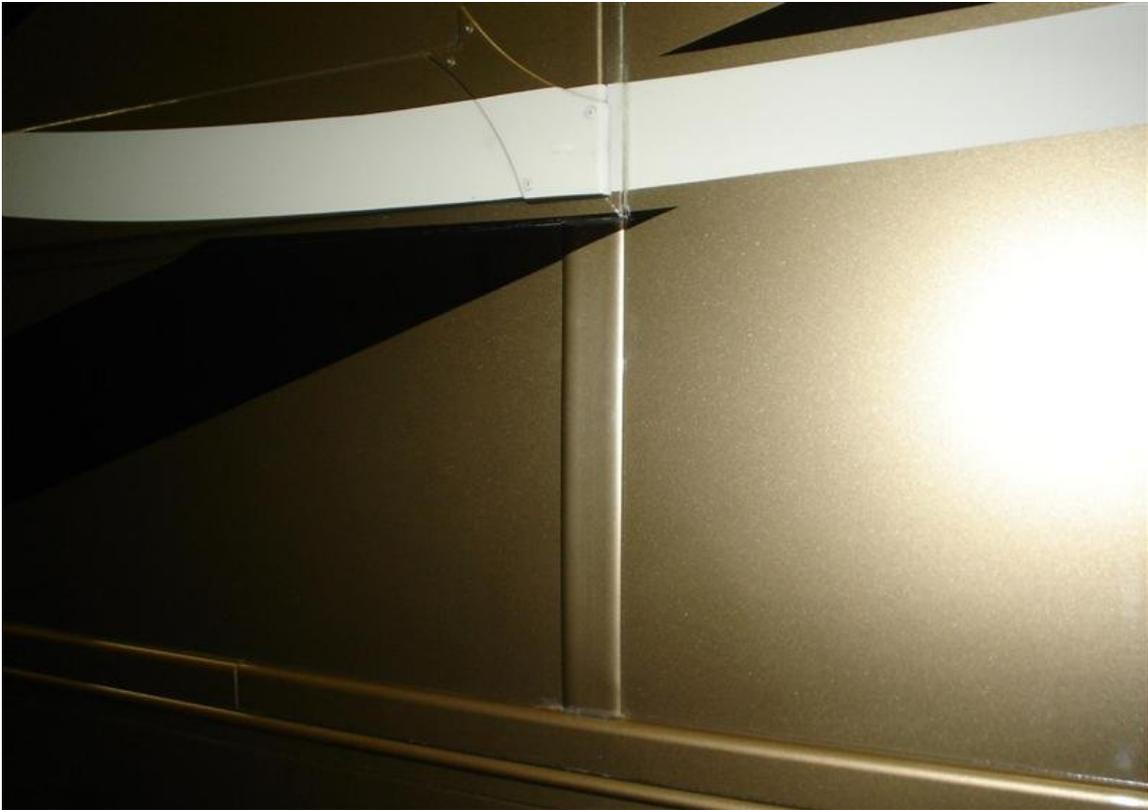
Below is the area of the driver's bedroom sidewall which cracked and repaired by L.D.
