2010 43QGP Allegro Bus

125 - FYI – REPLACED THE ENGINE ALTERNATOR FOR THE SECOND TIME.

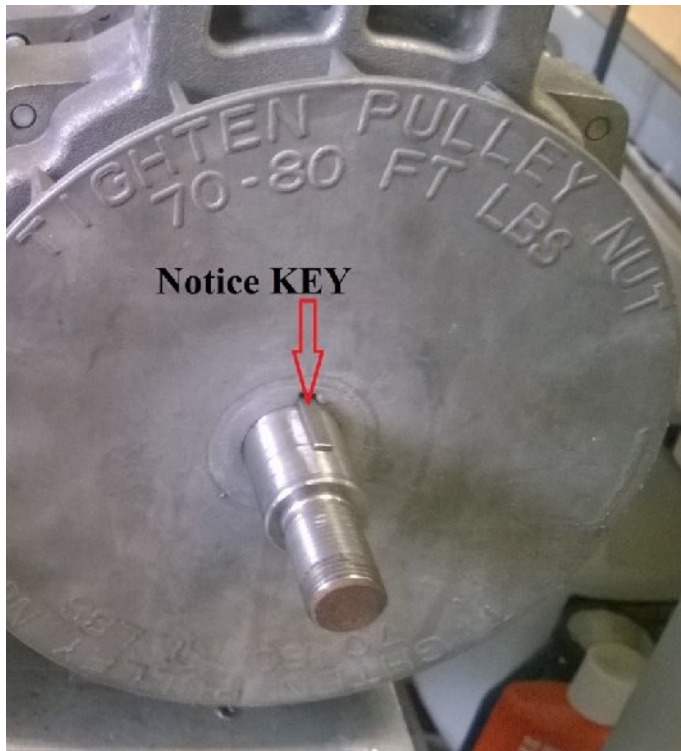
there was no keyway and no taper to the shaft. I was told he would check and call me back. A few minutes later Nathan did call back with the message the Powerglide production manager told him Tiffin was installing the
