## 2010 43QGP Allegro Bus

**133 - FYI – COOLANT LEVEL SENSOR.** During a recent slide open operation a “Check Engine Light” was displayed on the dash. Using dash instrumentation the fault code was checked displaying a, SPN 111 FMI 18 code.

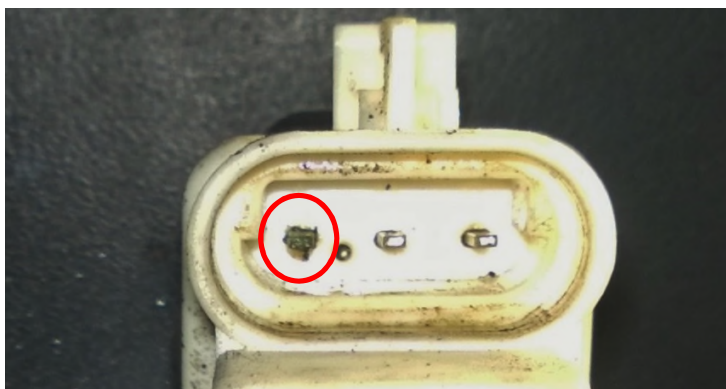
After disconnecting the coolant level sensor harness from the coolant sensor the problem was easily seen, both sensor and harness have a corroded pin. Both sensor pin and harness socket were cleaned however it was quickly apparent cleaning them would not provide a permanent solution. Nathan Davidson in the Tiffin Motorhomes Powerglide shop was contacted. Nathan provided me with the Coolant Level Sensor part number. Nathan then put me in contact with the parts department so the part could be ordered and shipped.

The sensor part number is **31643** cost of the part is \$ 55.96 with shipped adding another \$ 17.71 for a total of \$ 73.68. An additional \$ 0.01 was added to the cost, adding the penny provided a line item so Tiffin could supply me with a few socket pins and a new female harness connector to replace the damaged parts on the connector harness.
