Wet Bay Door "C" Hinge Modification

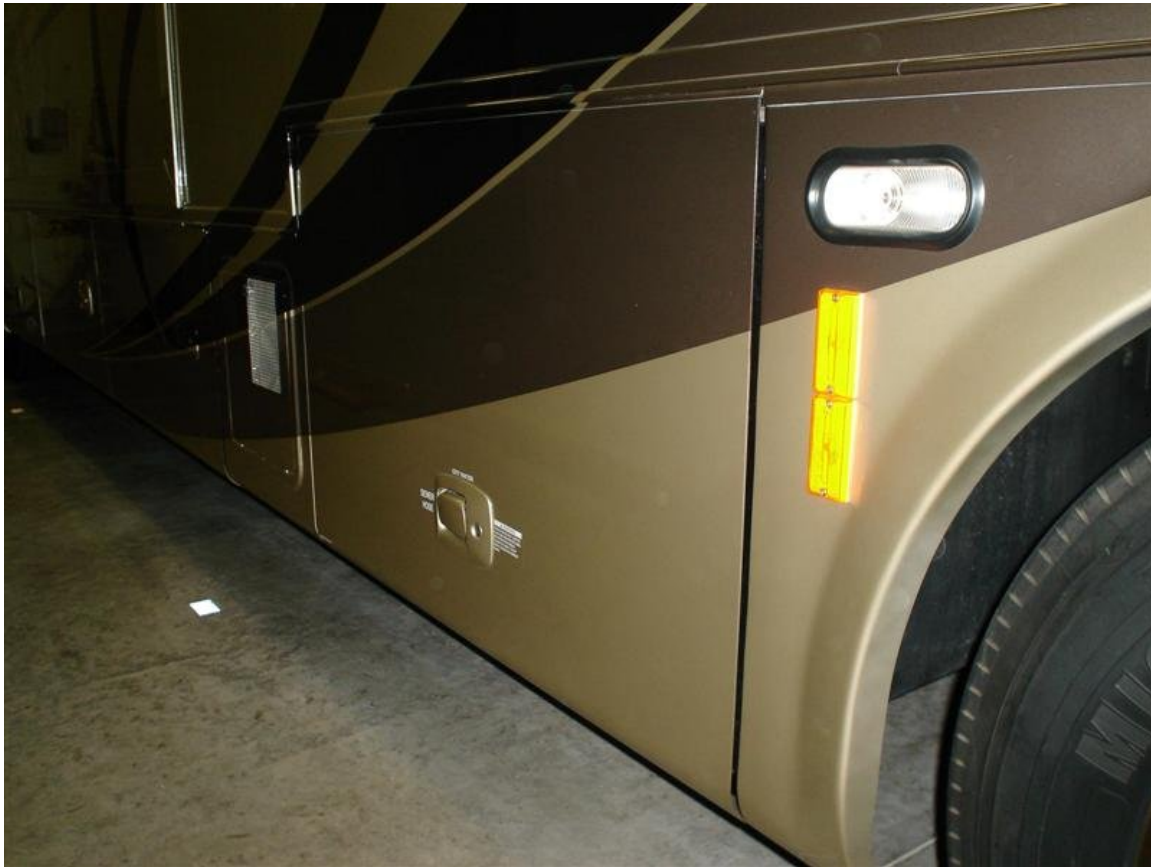
This is a picture of the whole door after modifying the hinge operation.

You can see the small 3/16 inch gap in the upper left top corner of the door. I see no way to correct this assembly error after the fact I'll just live with it. This modification took three hours of my time I used a few inches of pressure treated wood (3/4" x 1 1/2" x 2 1/2") for the blocks. A few dabs of black silicone and few wisps of black spray paint so the wood would blend in with the surrounding black painted metal.
