2010 43QGP Allegro Bus

4/3/2012

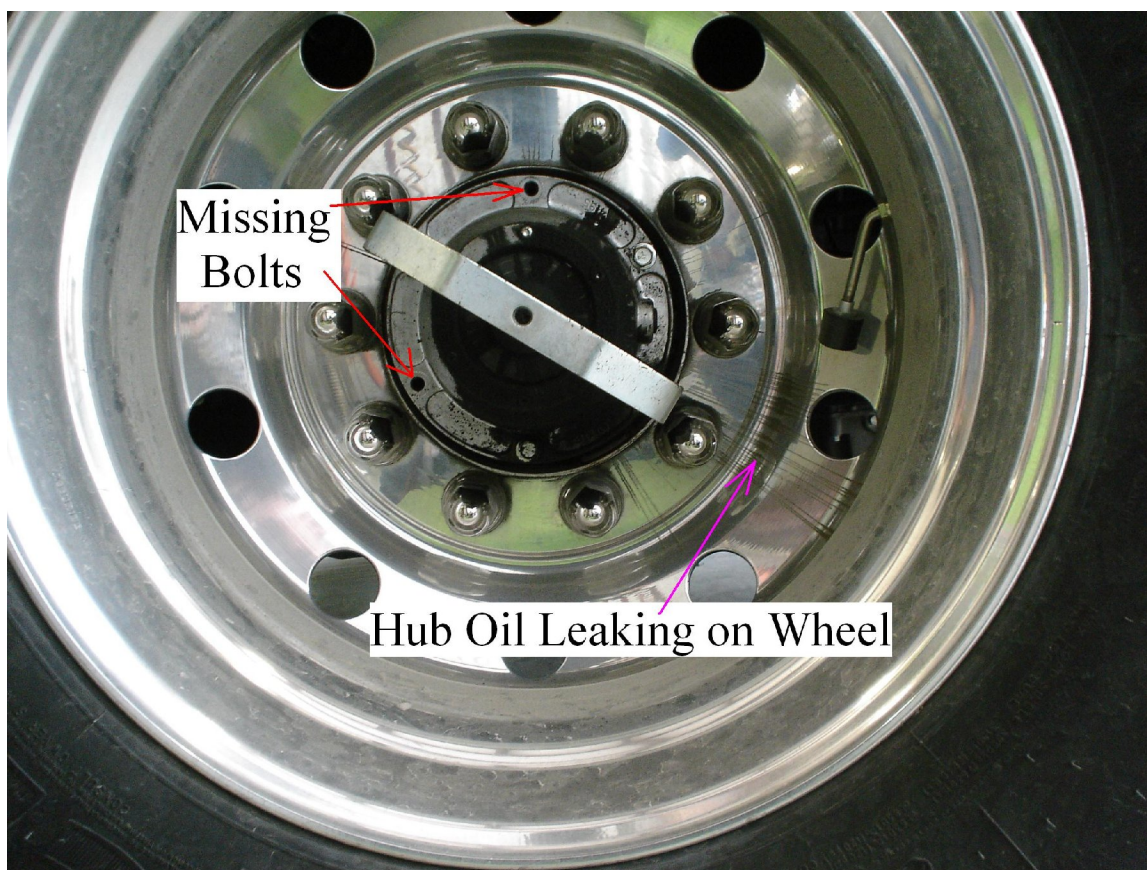
48 – FYI - TAG AND DRIVE AXLE HUB OIL SEALS. During our last visit to Red Bay another owner pointed out this problem to me. I should have spotted this myself however my plate has been full during the past three weeks while we vacationed in Red Bay. He pointed to my tag axle hub and stated I needed to have it checked. Yes, I did but first I took a good look at the other three drive and tag axle seals. As it turns out two hub seals were leaking, one drive axle hub and one tag axle hub.

Fortunately we were headed for the mechanical bays as our next stop. When we got to bay 43, I pointed out the problem to Kyle he proceeded to check all four of the hubs and seals. Below is a photo of our tag axle hub.

Notice two hub bolts are missing! They were completely missing they were not even contained inside the wheel hub. Makes me wonder about things?
