2010 43QGP Allegro Bus

79 – FYI – WHIRLPOOL WASHER DRAIN FILTER ACCESS. After reading a recent discussion on the TRVN forum about cleaning the various clothes washers drain filter I went looking for the filter on our washer. Sadly this filter service had not been performed before now because I was ignorant of our Whirlpool WFC7500VW1 Washer having a filter in the drain line. None of the manuals found mentioned this washer having a drain filter. Today I went looking for the filter did finally find the filter hidden behind a service panel on the lower front of the washer. However there is a problem Tiffin in its wisdom screwed down two wood blocks to prevent the washer from sliding forward in its little closet. With the four screws and two blocks

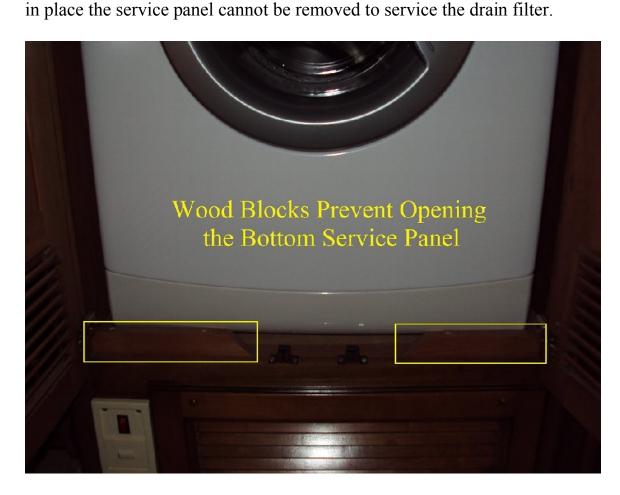
Fortunately removing the screws and wood blocks was not a large problem.

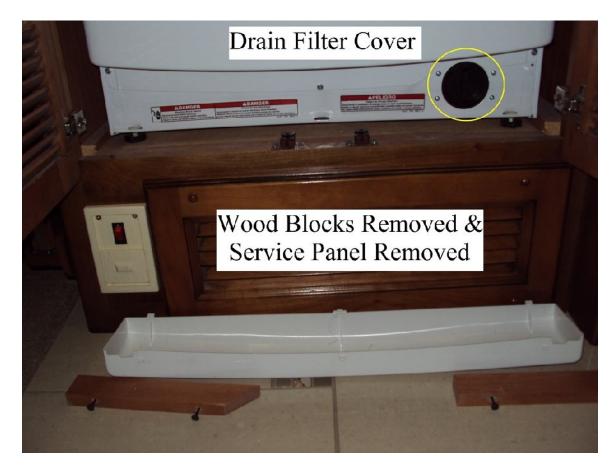
After the blocks were removed the service panel was removed by inserting a flat blade screwdriver at one end of the panel in the joint between service panel and washer.

With the service panel removed the Drain Filter Cover is easily seen as noted by the yellow circle above.

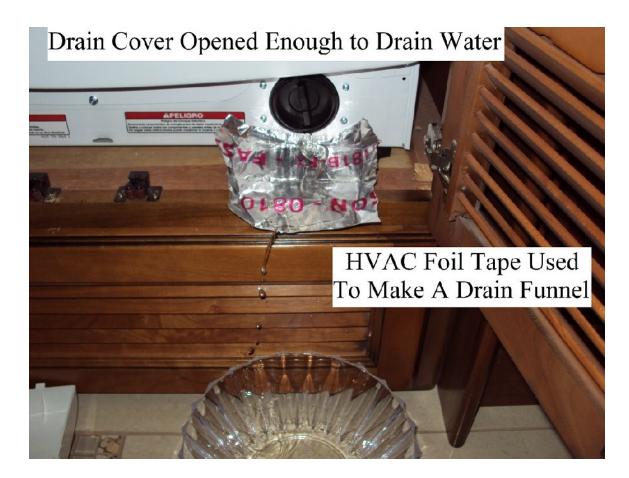
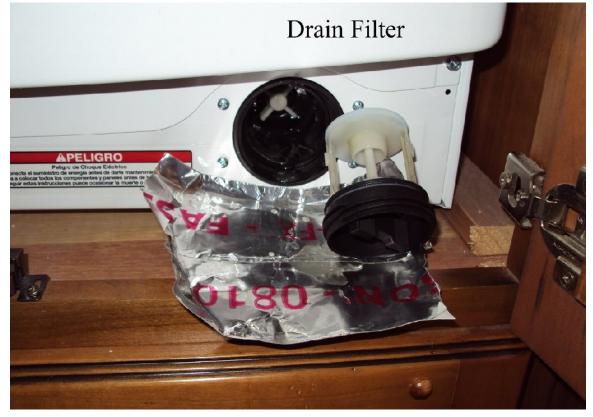
Based on information from reading other members problems while servicing their washer's filter I was prepared to have a small amount of water attempt to escape when opening the drain's cover. To prevent this problem a piece of HVAC foil tape was applied to the front of the washer under the drain filter's cover, the foil was made into a wide funnel which allowed the water to drain into a small bowl. The water was about a pint total, the drain's filter was very clean for a filter which had not been checked for over two years. After servicing the drain filter after some thought it was decided to modify the method by which the washer was installed to prevent future removal of the Tiffin installed wood blocks the next time the drain filter is serviced. I will not allow another two years to go by before the next time the washer's drain filter is serviced.
