2010 43QGP Allegro Bus

83 – B - FYI – REASONS TO CLEAN YOUR RV'S TAG WHEELS AND TIRES. To begin the tag axle wheel removal I start by PUTTING ON MY SAFETY GLASSES, then loosen the lug nuts with the weight of the coach on the wheels otherwise the wheel will spin as I attempt to remove the lug nuts. After the lug nuts have been loosened the tag axle is jacked up using a 20 ton air over hydraulic jack raised just high enough to allow removal of the wheel and tire.

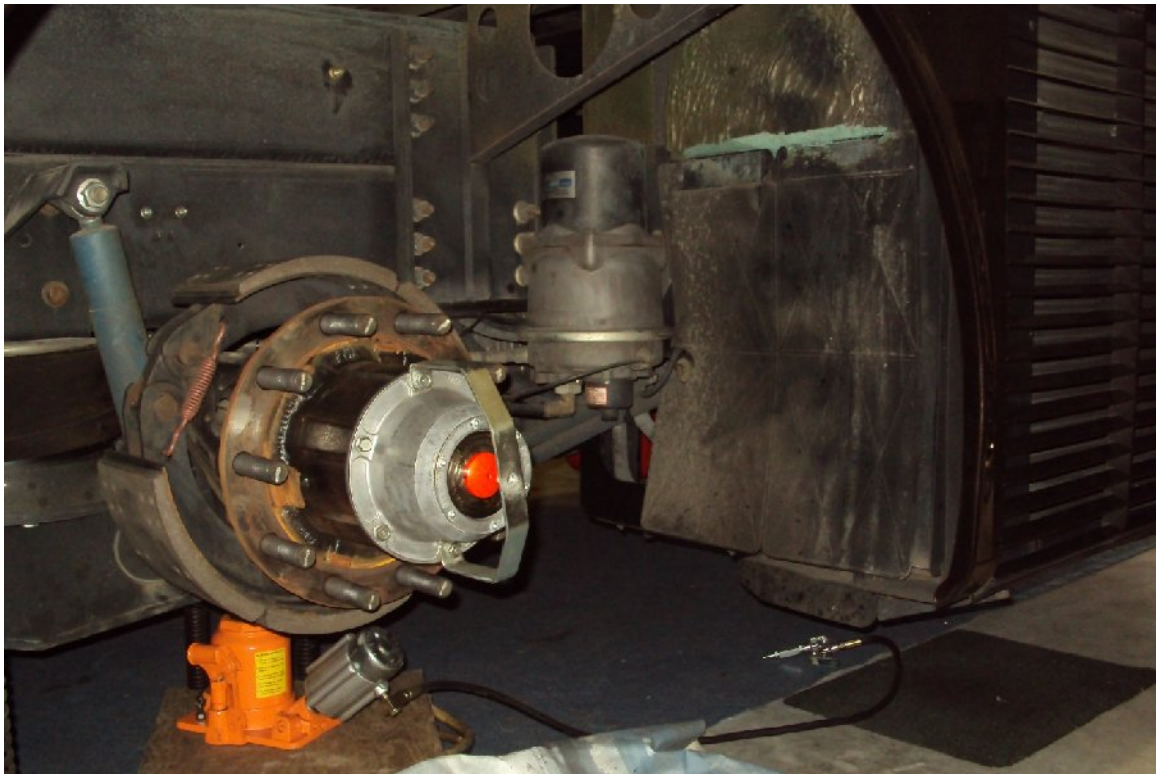
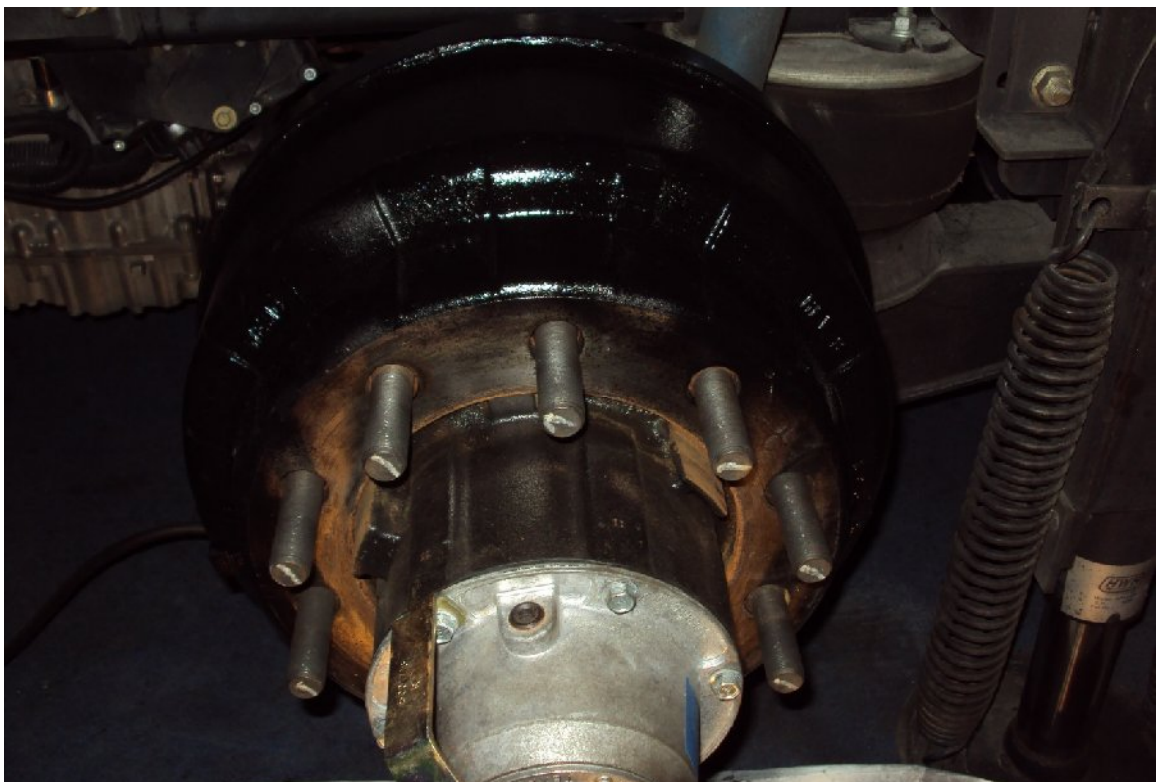
The next step is to SAFELY remove the brake drum so it can be cleaned and painted. The drum weights over 100 pounds and is very awkward to handle, I find it is best for me to use one of my creepers with a couple of wood blocks laid on top of the creeper. The creeper is slid under the brake drum the drum is slid off of the axle onto the creeper. The creeper can be rolled outside which allows me to clean the brake drum before painting it. The next dirty step is the cleaning of the brake foundation and brake shoes. This is a dirty job and it is easy to get injured if not careful. I always wear a

mask to protect my lungs from brake dust. I always wear safety glasses when working outside the coach even when just washing it.

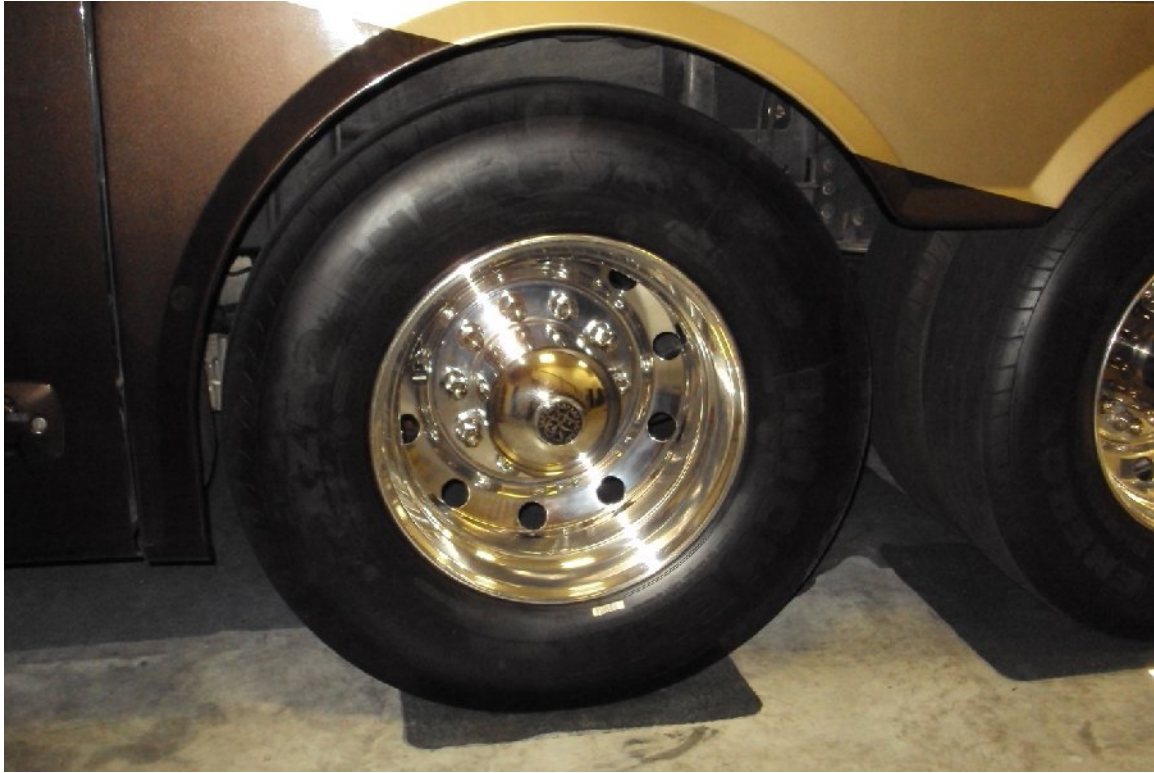
The brake drum is back in place after being cleaned and painted. The painting is to prevent as much rust as possible from being flung onto the wheels where the rust stain can be seen if it gets on the outside of the aluminum wheel hub.
