2010 43QGP Allegro Bus

3/11/2014

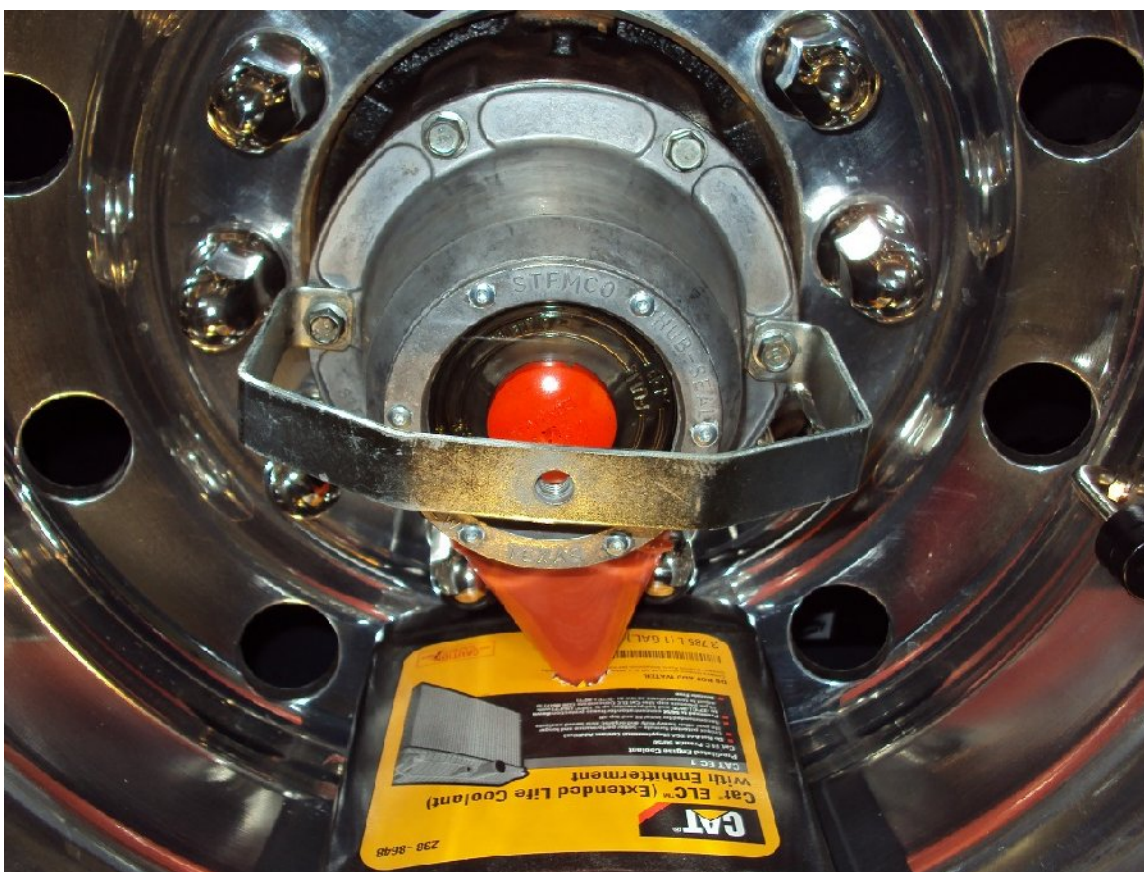
106 - FYI – CHANGING THE TAG AXLE HUB OIL, is another Powerglide chassis maintenance chore requiring regular scheduled service to keep the chassis maintenance up to date, this service is scheduled at 50,000 miles **OR** 36 months whichever occurs first. A floor jack was used to lift the center of the tag axle enough to rotate the tag axle wheels. The plug on the Stemco hub was rotated up-right so the plug could be removed without oil leaking all over everything. A capped one gallon oil container was used to capture the old oil. A one inch hole was cut into the side of the container for the old oil to drain into through a funnel. The funnel was stuck into the container thru the hole then the hub was rotated around until the hub oil began draining through the funnel into the container. The 80W-90 lube oil is thick and slow to drain so after the oil began to drain I go off to perform other maintenance duties until the oil has finished draining from the hub.

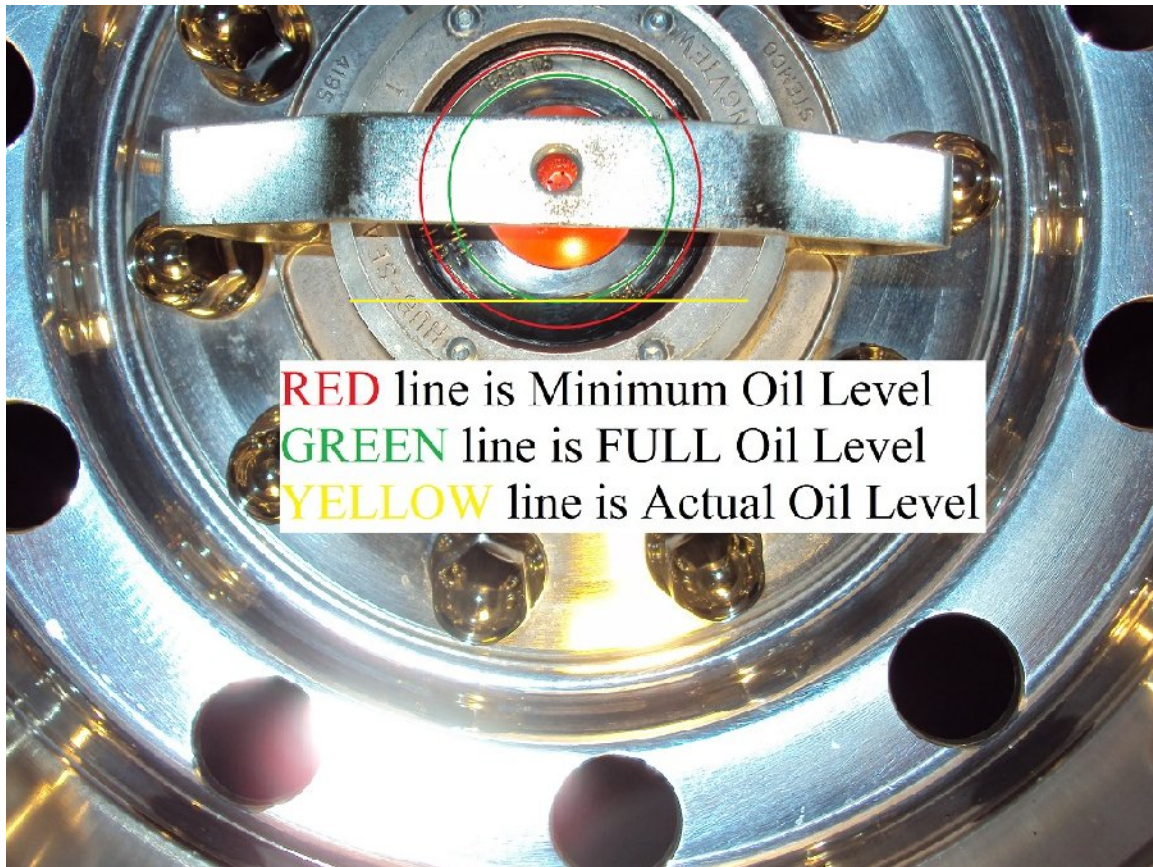
After the oil has finished draining the wheel is rotated so the drain is up-right. The new oil is SLOWLY poured into the drain plug until you begin to see the oil in the site glass in the below photo. As noted the **RED** circle is the MINIMUM oil level, while the **GREEN** circle is the FULL oil level and the **YELLOW** line is where the actual oil level was filled to.

RED line is Minimum Oil Level
GREEN line is FULL Oil Level
YELLOW line is Actual Oil Level

After both tag axle hubs had been drained and re-filled with new 80W-90 gear oil both hub plugs were reinstalled after coating the pipe threads with pipe joint compound, the floor jack was lowered and the coach was ready to hit the road for another 36 months based on this service.
