2010 43QGP Allegro Bus

NINETH coach modification CORRECT THE FUEL FILL PROBLEM

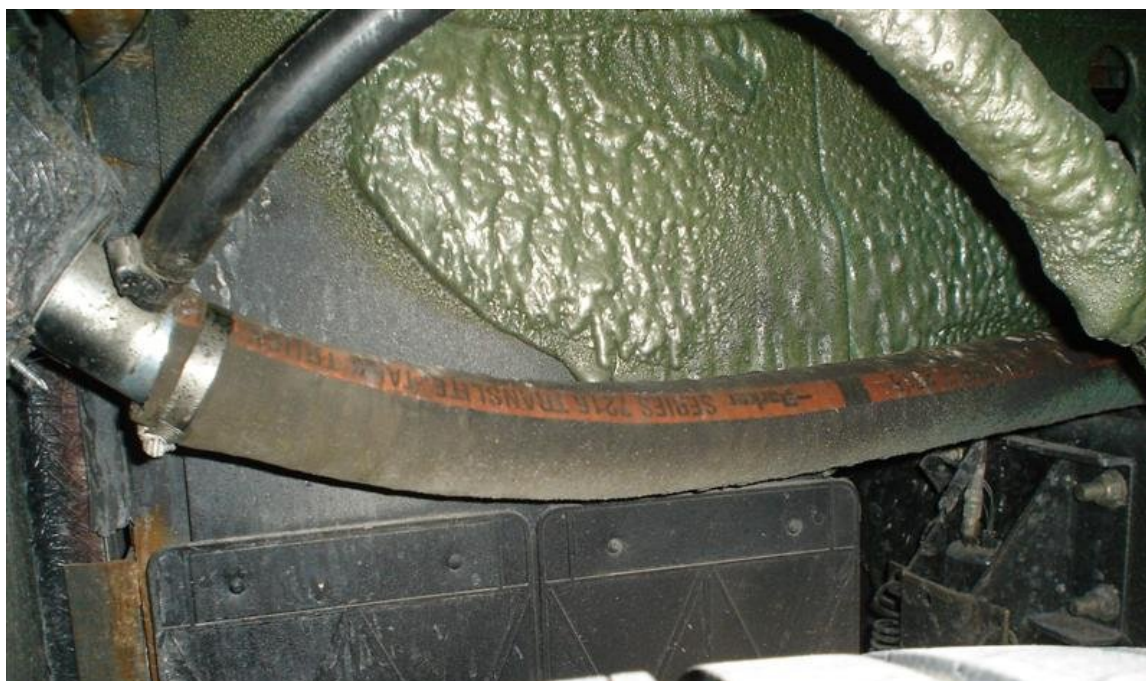
Tiffin with almost every coach they build creates a fuel fill problem when the fuel fill hose is installed. The length of the rubber fuel hose allows the hose to stretch over time which then allows the hose to sag creating a low point or belly in the hose. That sag prevents the adequate venting of air in the fuel tank, as air attempts to vent through the fill hose the fuel in the low point is expelled which turns OFF the fuel nozzle. Below is a picture of our passenger side fuel fill hose as Tiffin installed it at the factory. The angle of the picture does not really do justice to the actual amount of sag in the hose.

I decided to modify the way both fuel fill hoses were mounted. Alas the first attempt did not help at all. I had been told to loosen the hose clamps on both ends of the hose, then turn the hose (rotate the low part of the hose to the top) then re-tighten the hose clamps. It did not take long for me to realize that at best this was a short term fix, as when the hose bowed again due to gravity the bow/sag would be back at the bottom.

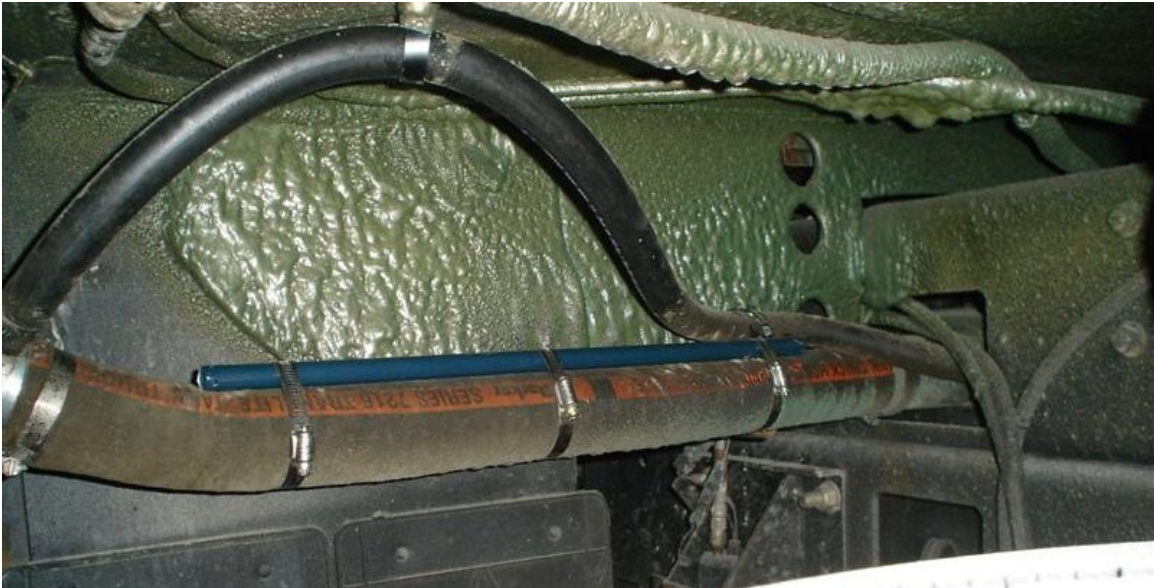
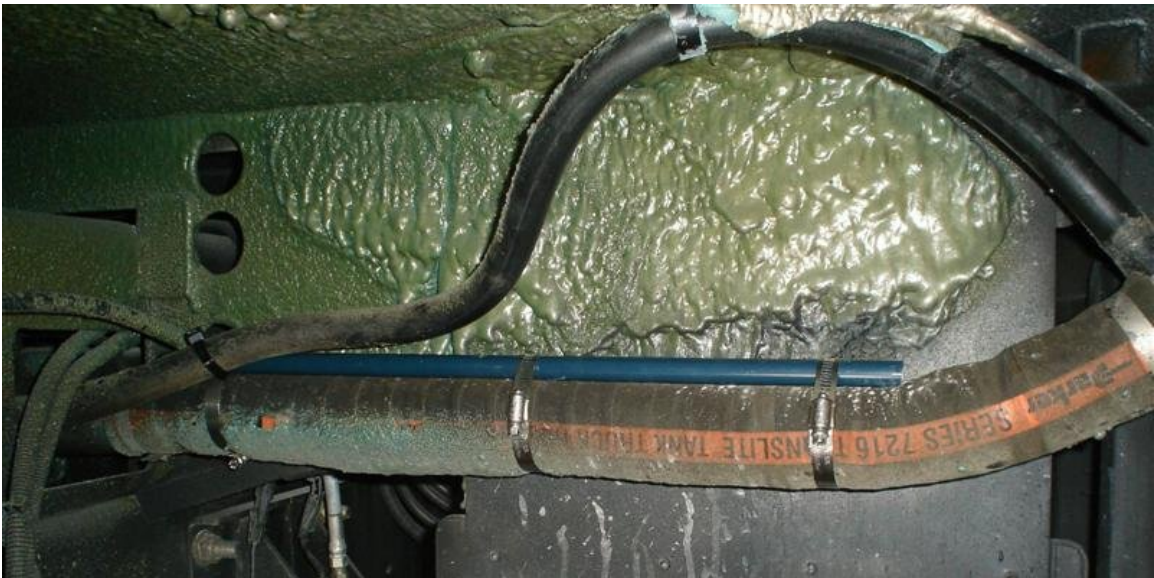
The above DS fuel fill modification shows the downward slope of the fill pipe between the fuel fill and the fuel tank and it also shows the tank vent hose does not have a low point in which fuel can collect which then shuts OFF the fuel nozzle when a fuel bubble is expelled.

After scratching my head, I decided to add a 20 inch piece of 1/2 inch steel tubing to the top of each fuel fill hose using three hose clamps. That way a

hose clamp would be around the rubber hose about every 8 inches supporting the hose rather than having a 24 inch hose without any support.

As with most side filled tanks, the tank cannot be completely filled, however by design the tank should not be filled more than about 90% of its capacity. My fuel tank after the modification turns OFF the fuel pump at a consistent point each and every time I fill the fuel tank from either side of the coach.
