# Revising the Drivers Side Console

## << A Crusingator Document >>

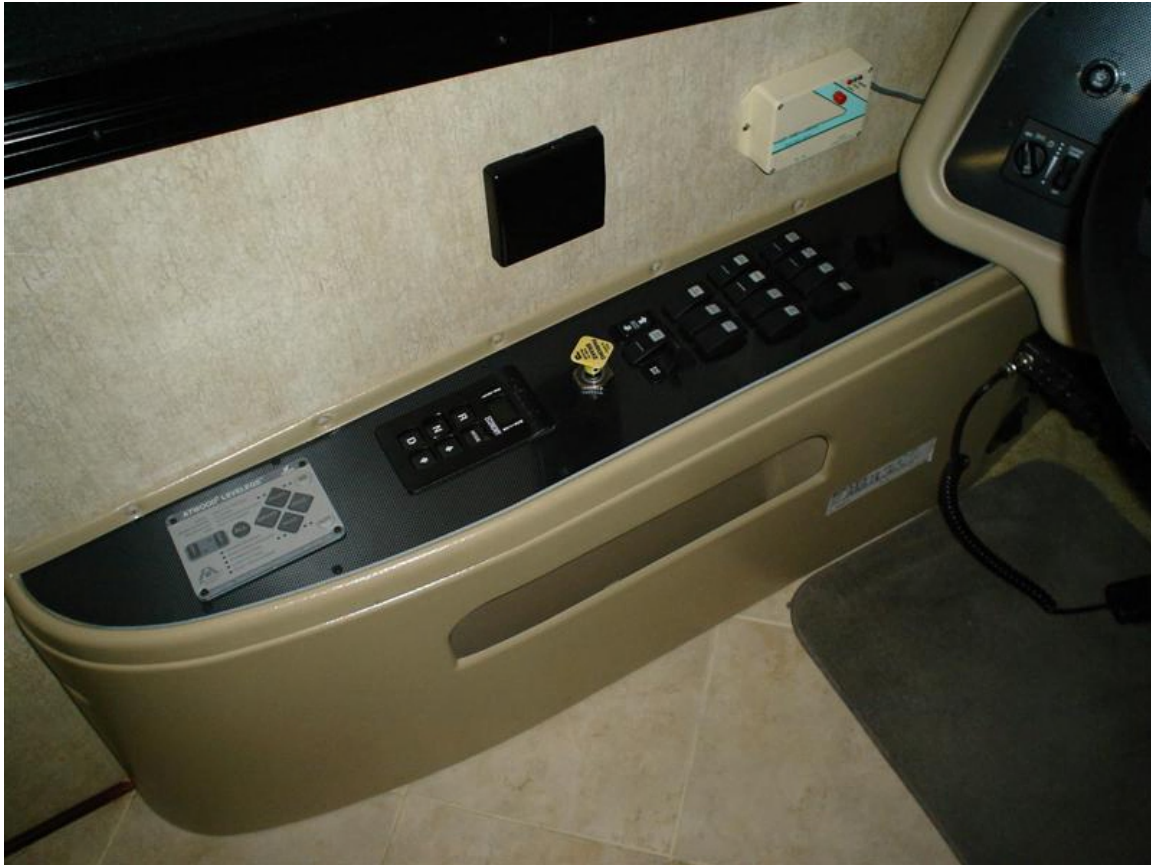
I just finished revising the Drivers Side Console on my 2007 Phaeton. The new console has repositioned various console switches, the Park Brake Switch and Allison Transmission Shift Pad. My Phaeton is on a Freightliner chassis and the two switches supplied by Freightliner are the only two switches with a wiring harness, all other switches have individual wires routed to them. Some switches had four wires and others had up to eight wires. Tiffin did not do a great job labeling the various wires so care must be observed in removing each wire from the switch. After removing all of the wires from a switch, the switch can be removed from the original panel and moved to the new panel. The wiring is a rat's nest and is almost impossible to un-tangle. My panel has fourteen switches plus the transmission pad, park brake switch and the Atwood jack panel. This is the original driver's side console.

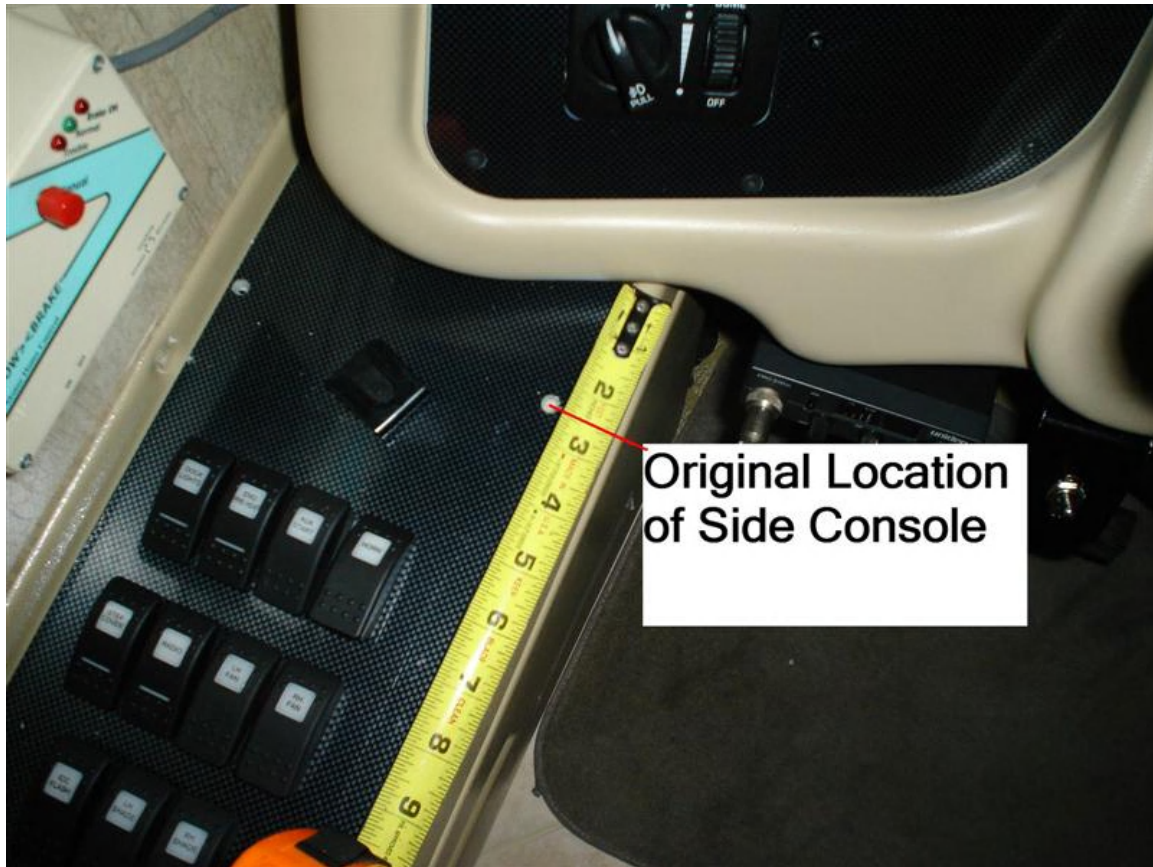
I had been told that Tiffin had actually made three console panels, the original and then two more recent newer panels. While researching, measuring and obtaining the new console panel I believe there are only two versions, the original and the new angled design. As you can see in the following picture, the original side console measured 2 1/2 inches from the dash to the first panel screw hole.

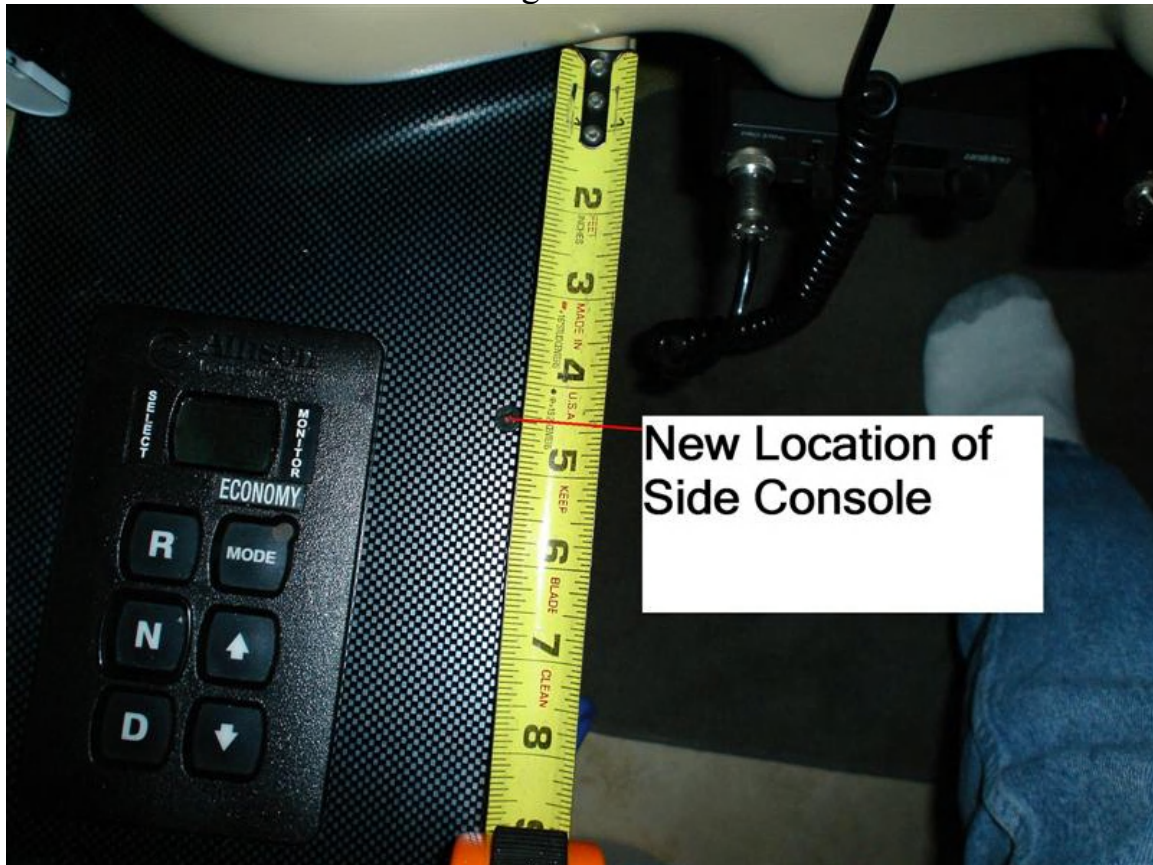
New Location of  
Side Console

This is a picture of the new console position from the dash. The same hole is now 4 1/2 inches instead of the original 2 1/2 inches.

The revised panel when Tiffin first began installing them had the transmission shift pad too close to the dash making the indicator lights impossible to read. Tiffin was able to correct this problem by simply shifting the side console two inches farther away from the dash. That is not and was not a problem for Tiffin they drove three screws through the bottom lip of the side console into the floor. They did this before the driver's side wall was installed it's a lot harder job to remove the three screws with the wall in place. I was able to remove two of the screws from the middle and rear portion of the console' lower lip. The third screw is under the dash about four inches from the firewall and almost 2 inches long. After scratching my head and a few other things I broke out the crowbars and pushed one on either side of the screw and applied pressure until the screw head pulled through the lower panel lip. After that I was able to move the driver's side console panel two inches further from the dash, along the wall. By moving the console this two inches the Allison transmission pad is now located four inches from the dash and it is easy to read both indicator lights. I made new holes for the console to mount to the side wall then cut the trim strip shorter and reinstalled it at the rear of the side console at floor level.

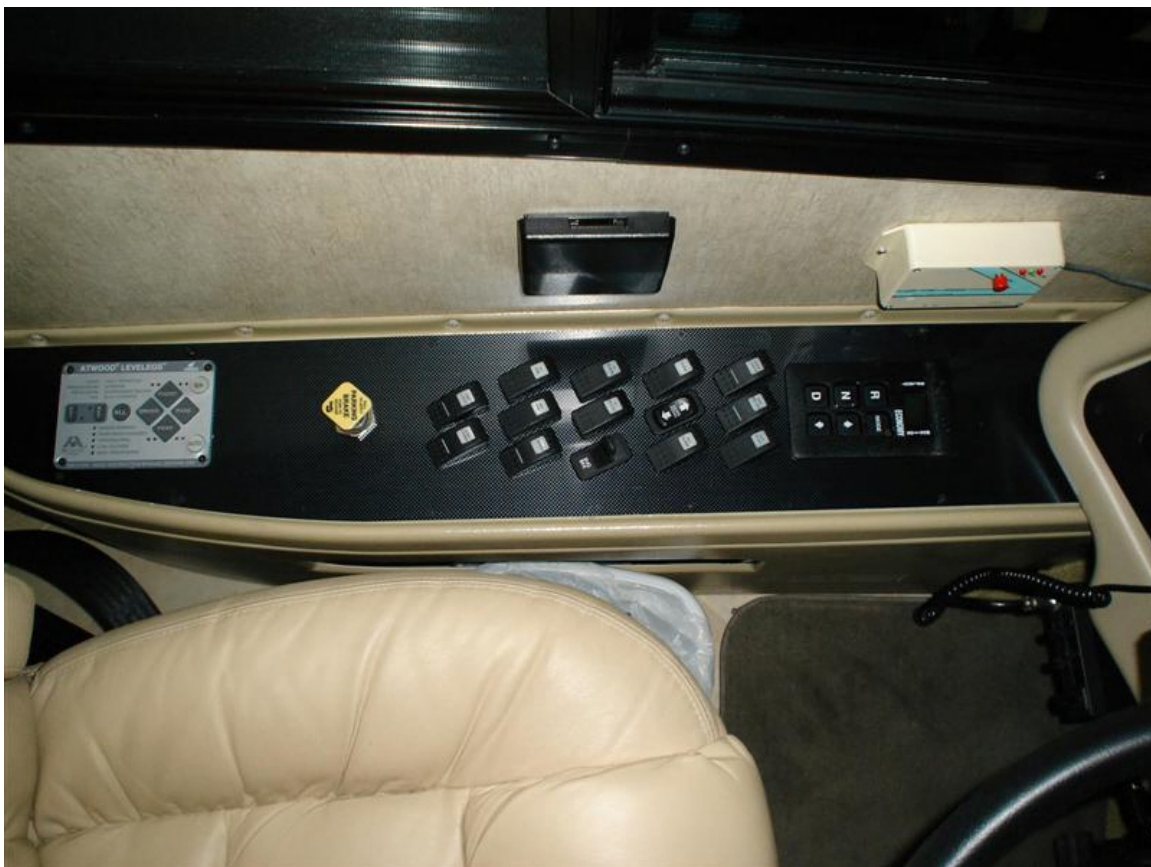
Finished installation of the new driver's side console.
